## FN82 Turret update October – November 20

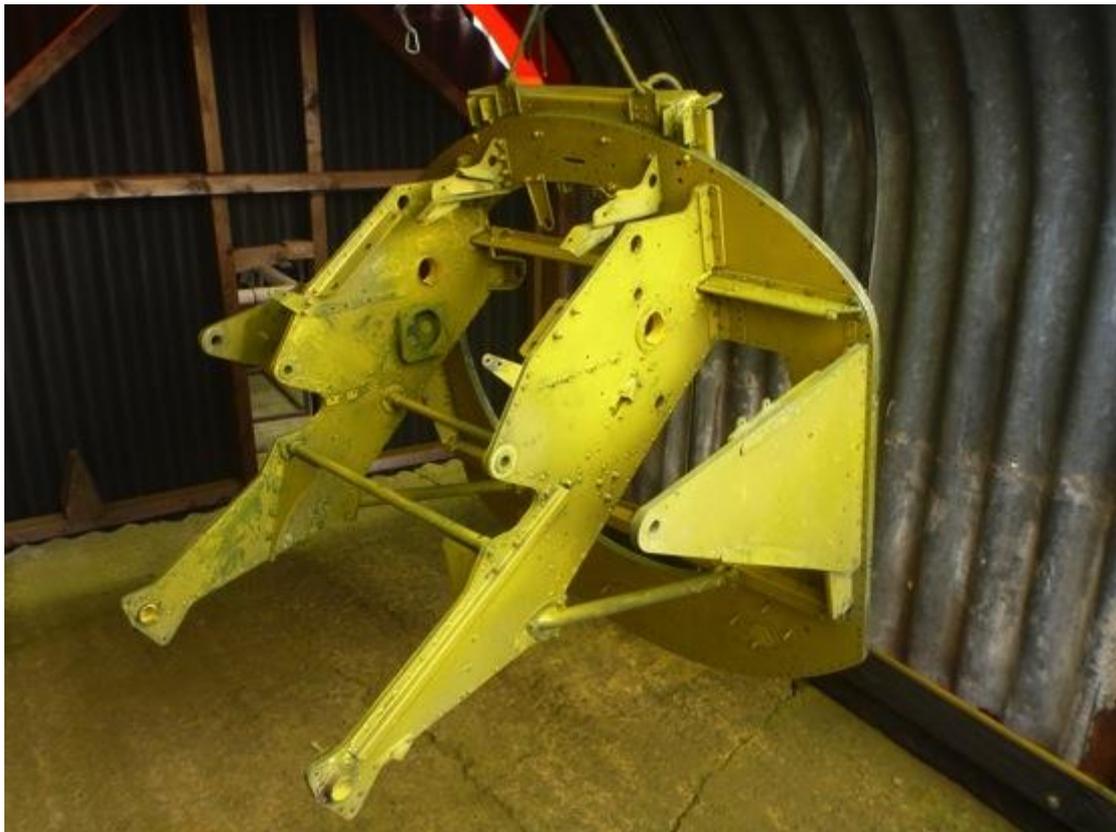
With the non chromate wash applied, above, the etch primer could then be applied. This gives a very smooth, pleasing finish as seen below.

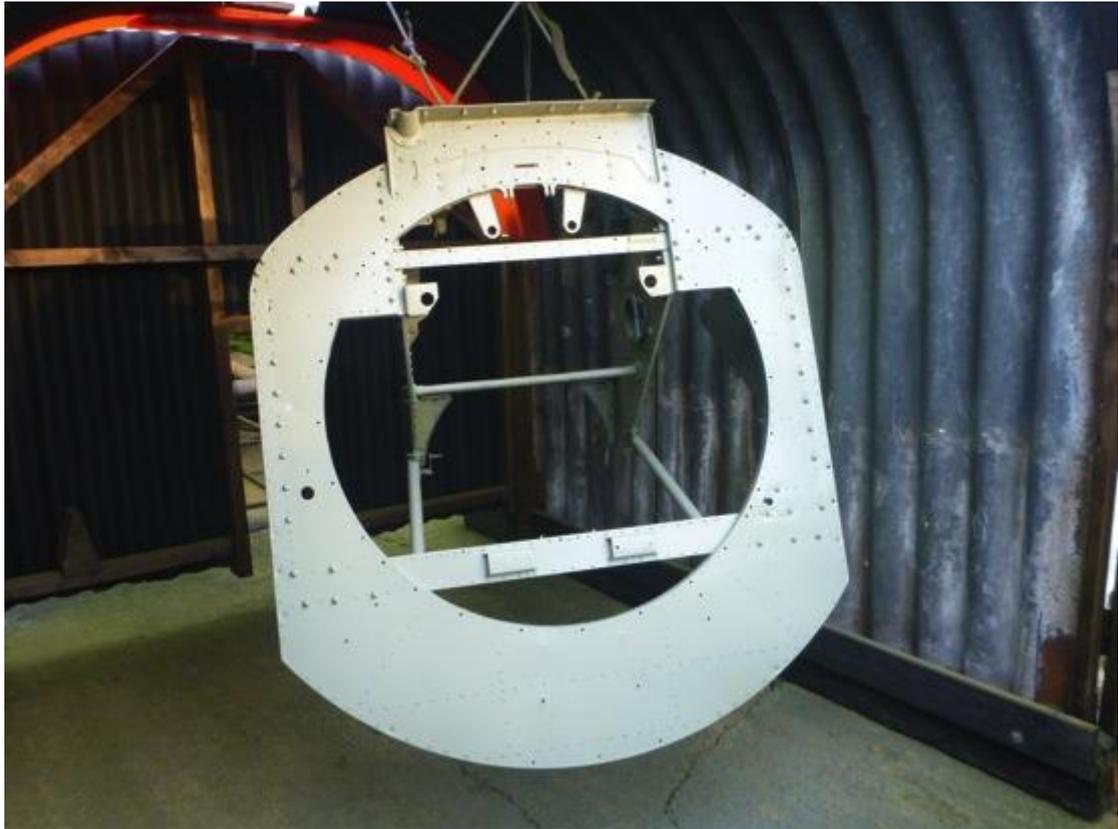
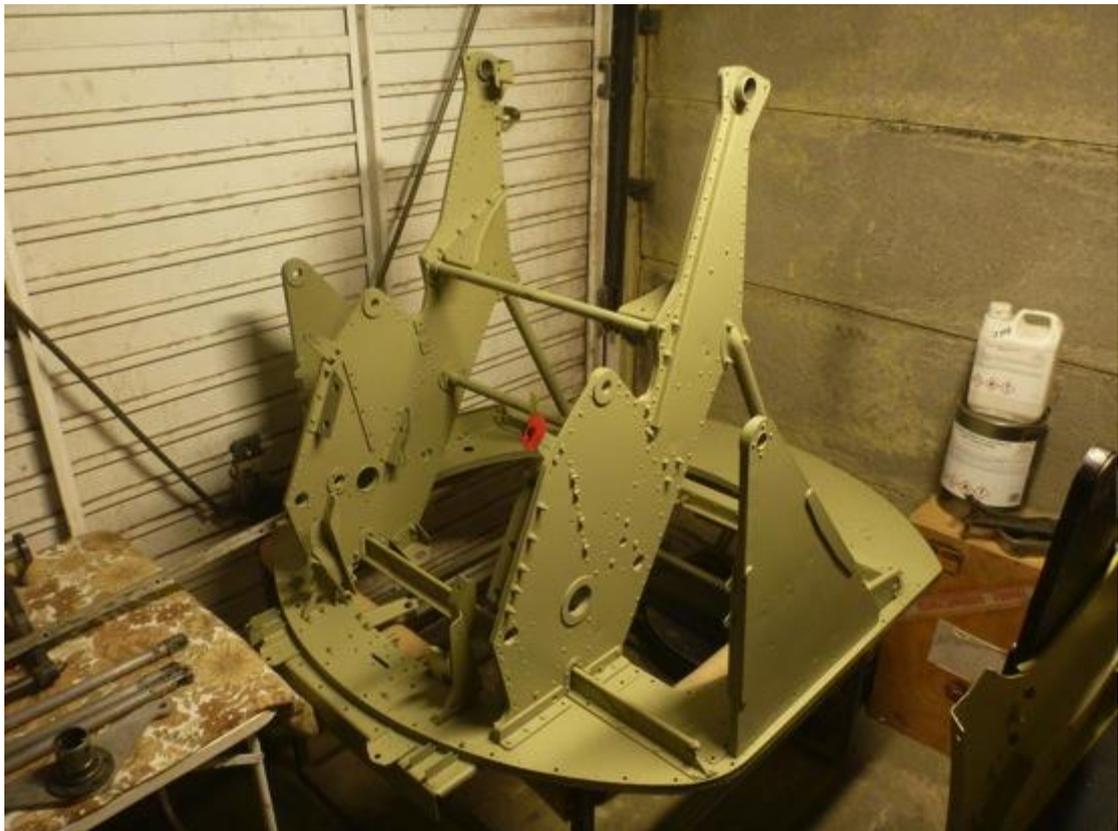
The superstructure (accommodation floor and side frames) was then moved back into the main workshop and allowed to harden off.

Although it would be possible to continue building assemblies into this structure, it would make re-fitting the turret rings much more difficult. Therefore, this assembly has now been progressed as far as is possible for the time being. The next stage will be to fit the rotating and non-rotating turret rings once they become available.

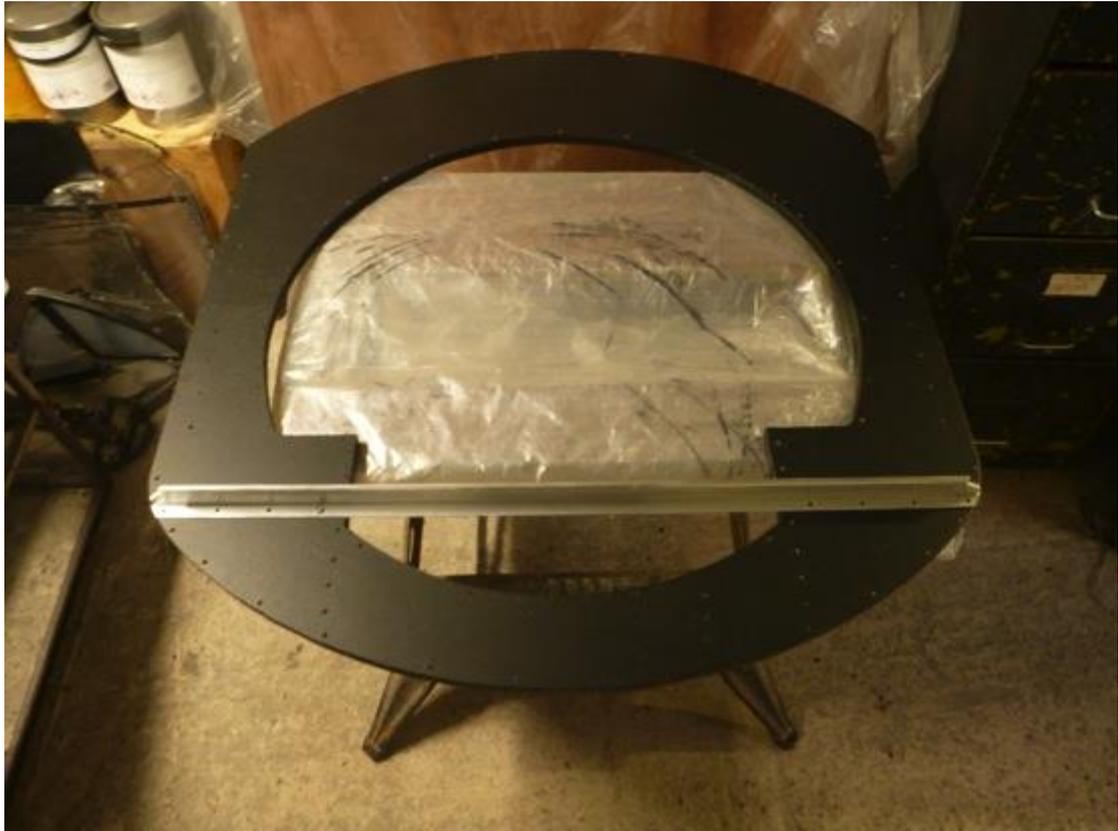
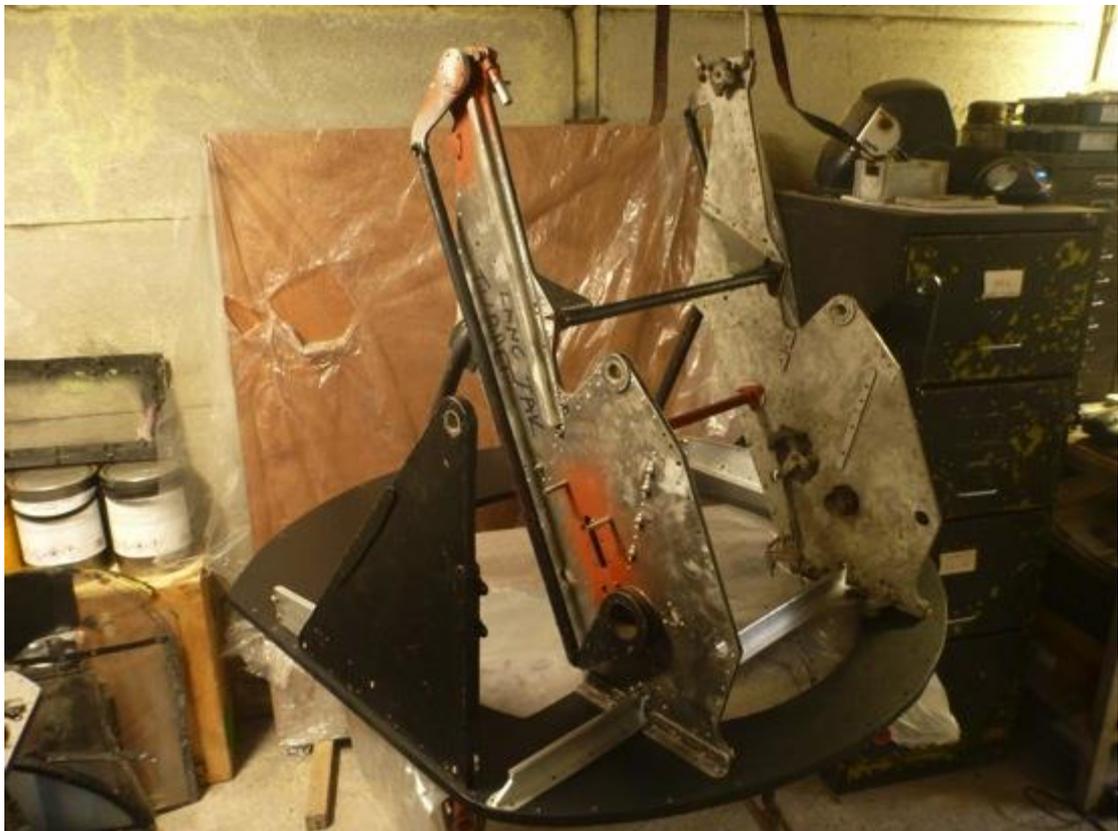
The next stage was to start working towards re-building the cupola. As mentioned in the September issue, this was to be built on a reproduction accommodation plate. The plate was improved by cutting the central hole and transferring across the

myriad of bolt holes that are required. Also, a reproduction cross member was built and fitted.

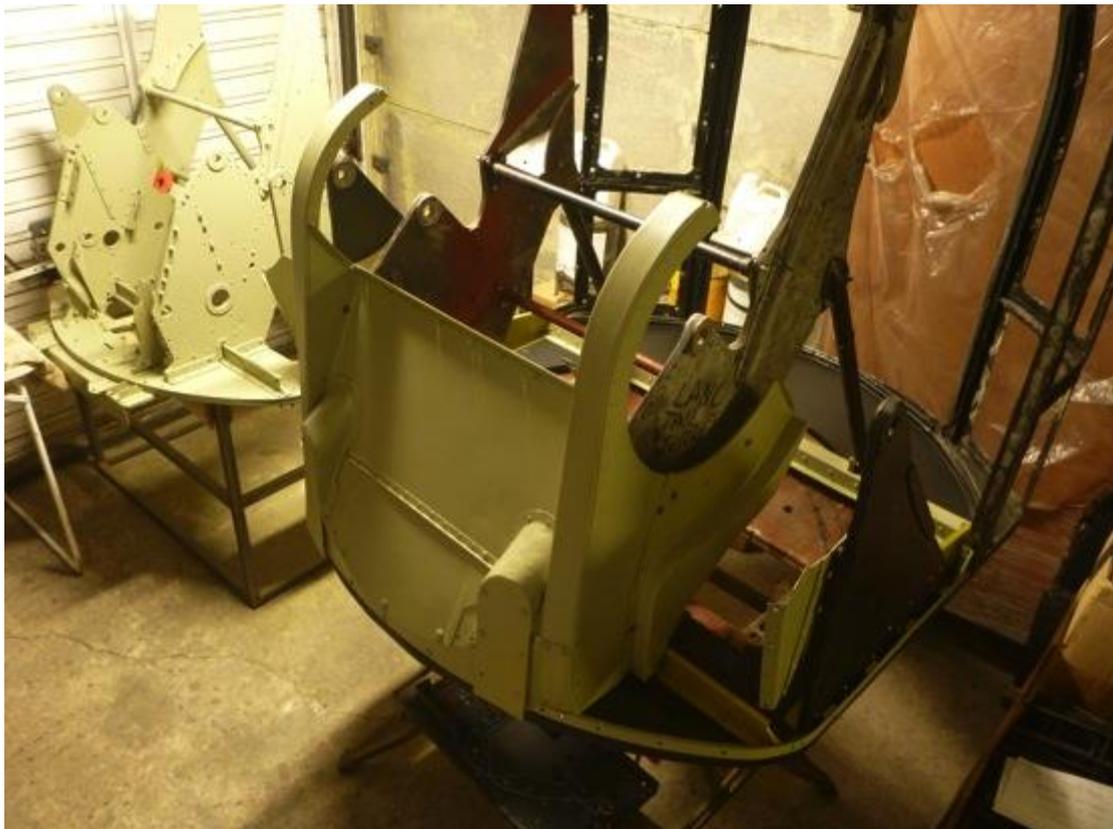
By this point, it was possible to start fitting the cupola components. First, the cupola rear half was bolted in place to add support for the front half. This will have to come off again for restoration as it is not yet fully stripped out.

The cupola front half components were then stripped back to substrate and any minor repairs carried out. At this point any missing or faulty anchor nuts could be replaced. The components were then treated to the same paint regime as the superstructure and could then be built onto the accommodation plate.

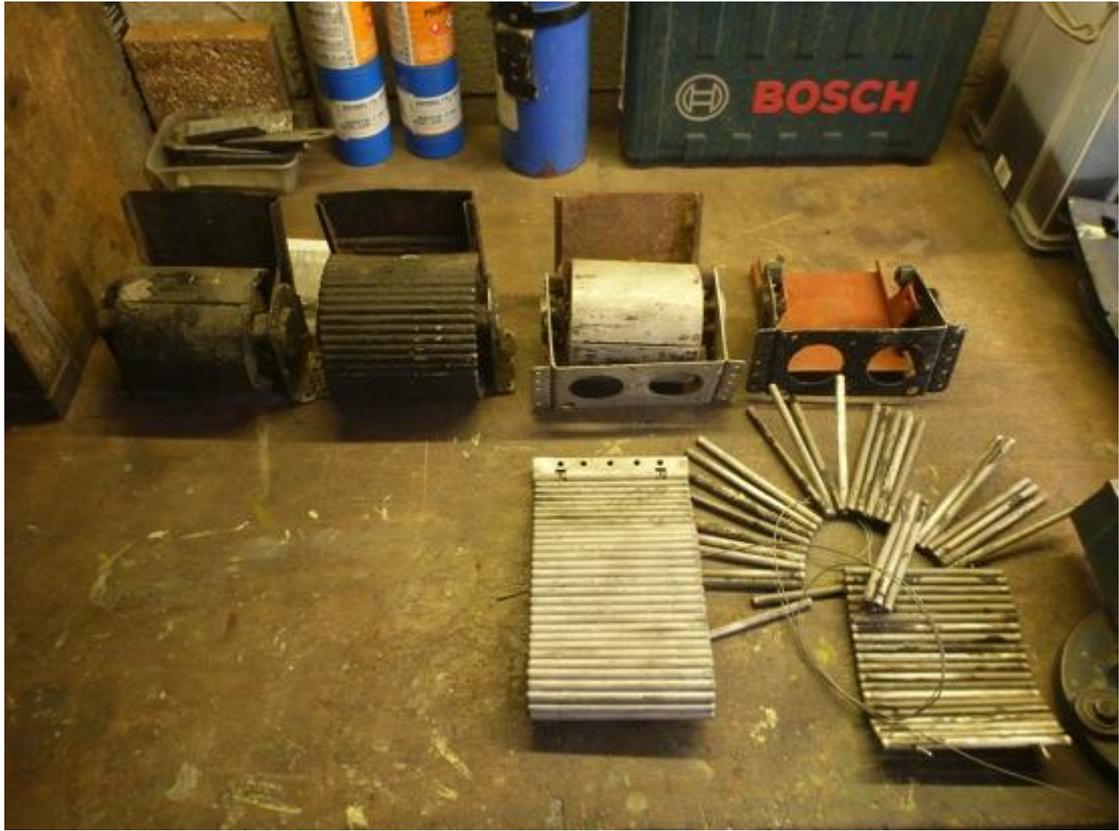
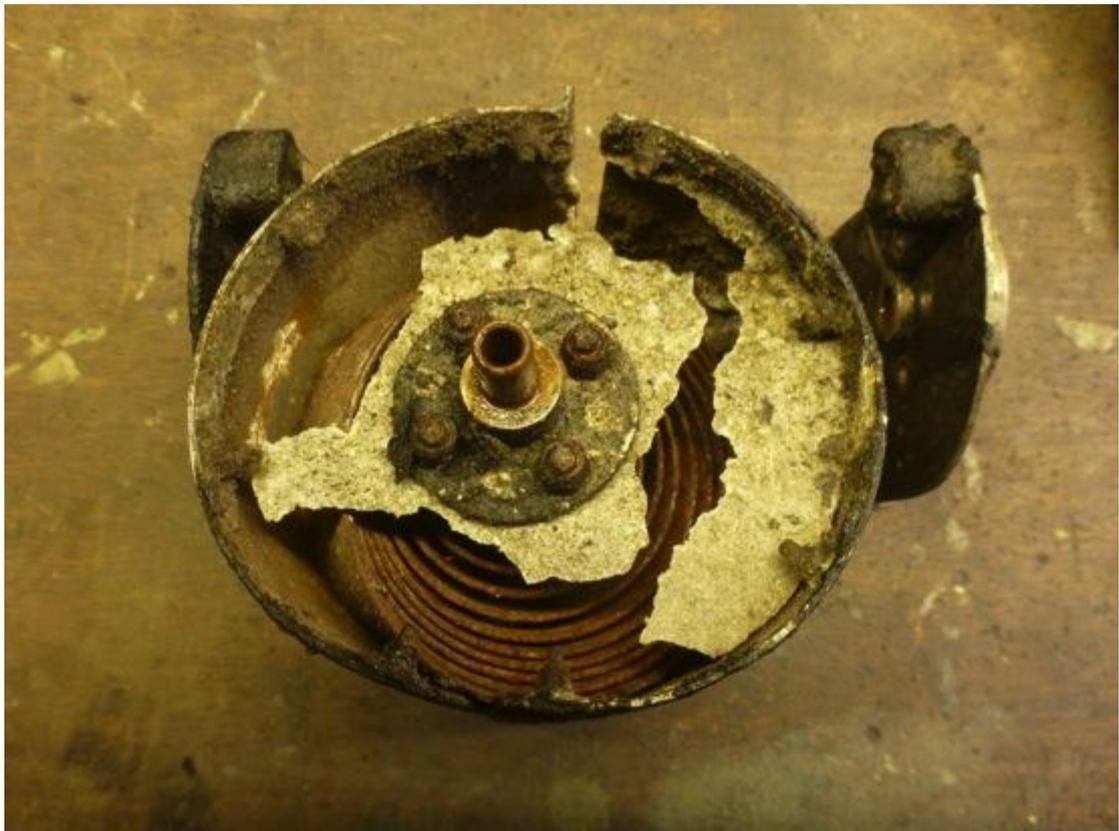
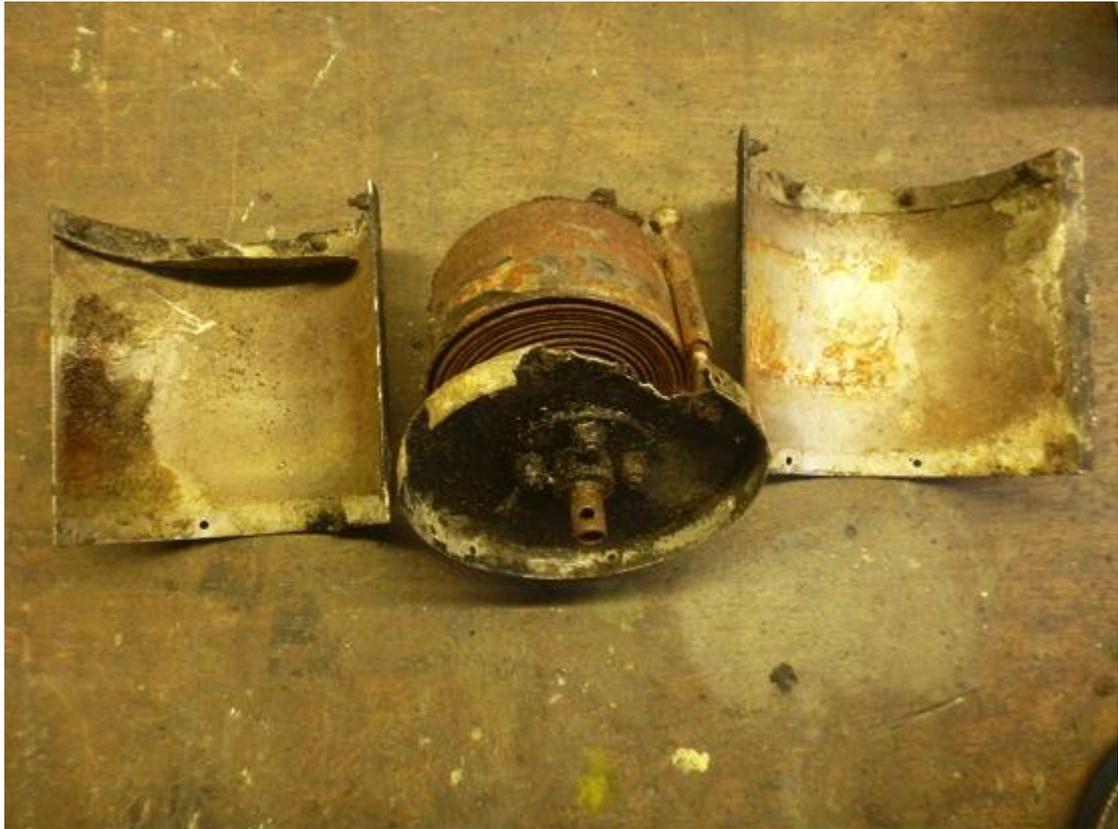
The fixtures and fittings had to be started somewhere and so I chose the very tired looking roller draught excluders. Seen below is the selection of four examples that I had available for the job. The two on the left are the originals and the other parts are from the second FN82. Luckily, amongst the other parts are some unused components that can be quickly swapped across.

That said, the actual roller assemblies have suffered some very serious corrosion and the end plates on most of them are beyond recovery. The only way to strip out these components was to carefully drill out all of the fasteners and so there will be a lot of searching about for AGS parts before the rebuild.

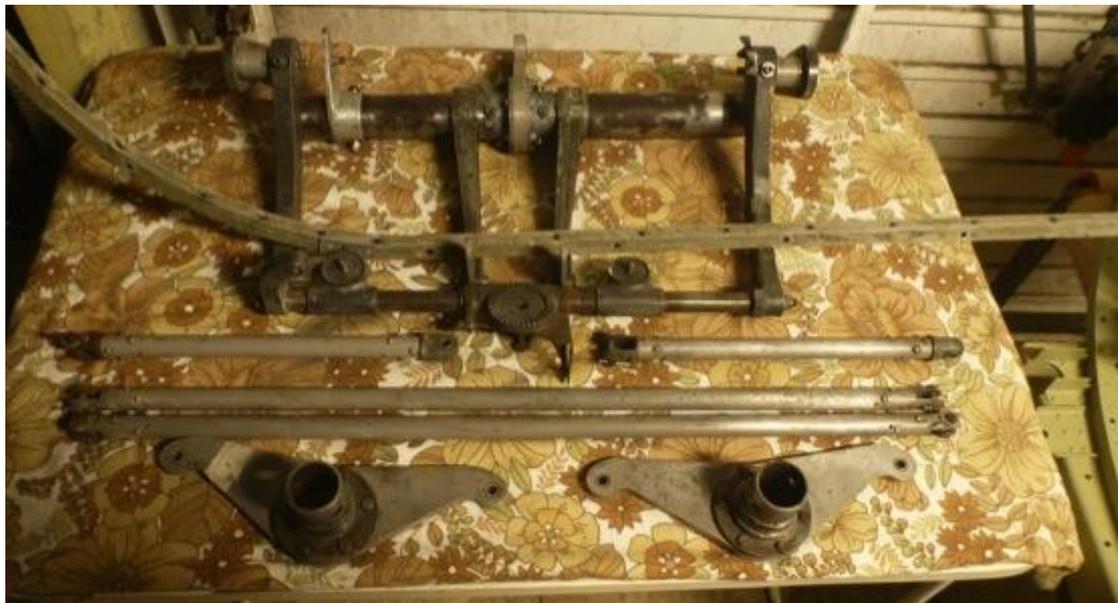
With the roller draught excluders fully dismantled and awaiting the re-manufactured end caps, attention turned to the control system. This revealed fewer horrors and was mainly a matter of carefully removing the many layers of old paint. Seen below is a collection of parts waiting for the next painting session
