FN82 Turret update September 20

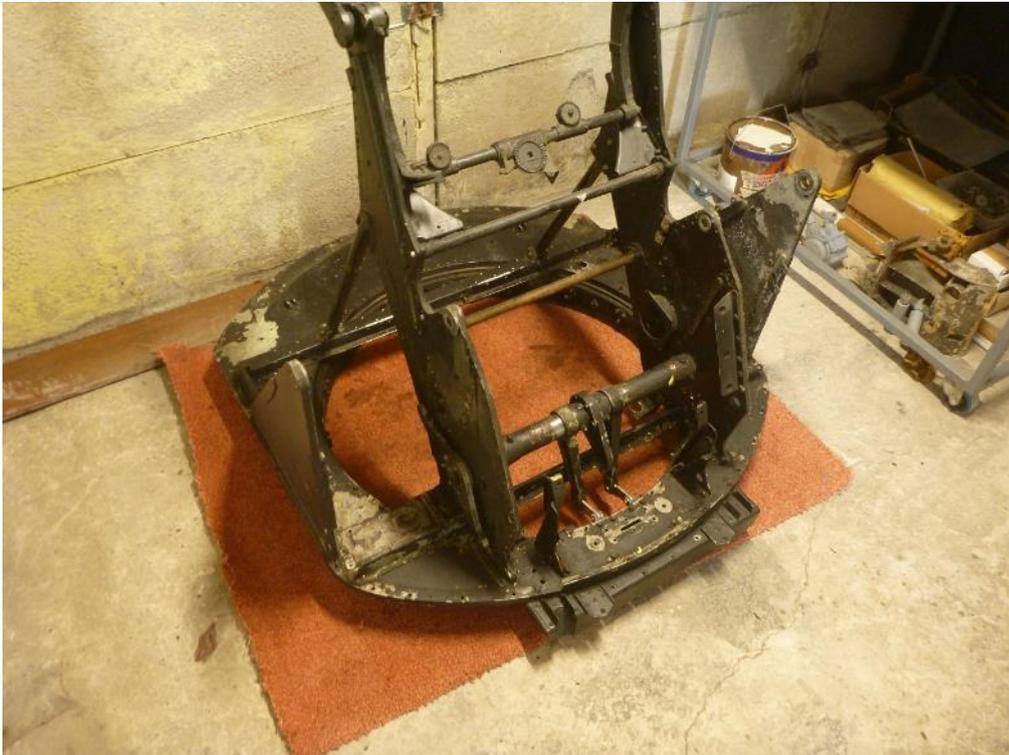
At the end of the August update the turret had been reduced to the condition shown below and I had hoped that this was as far as I needed to strip out.

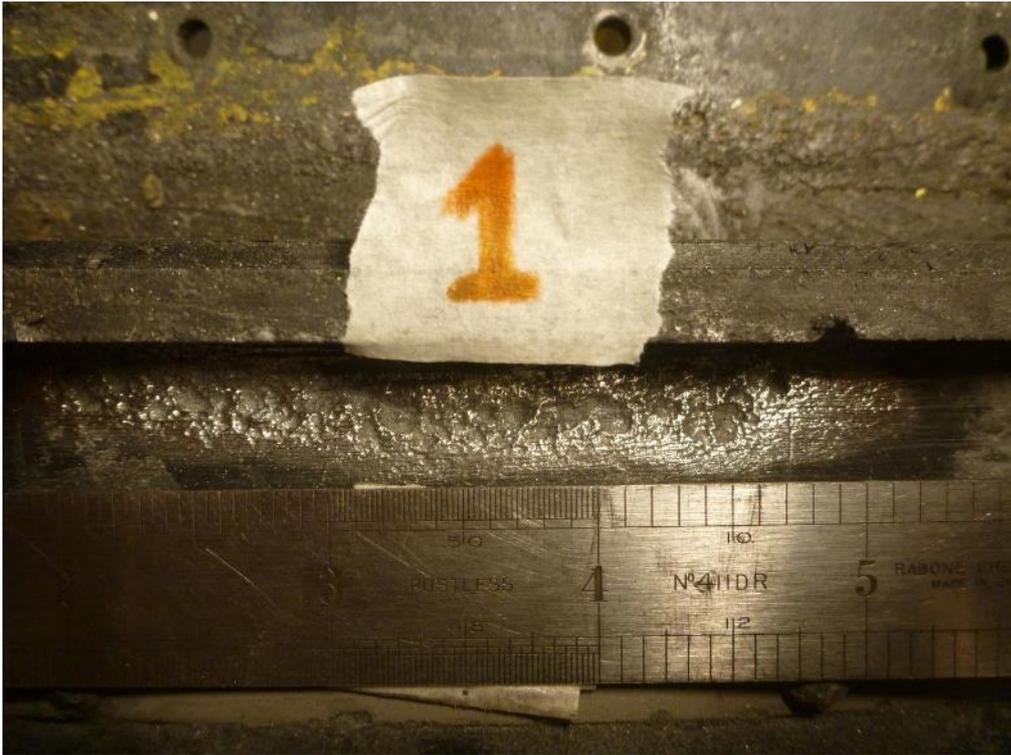
I was, however, mistaken and problems with the torque shaft and sight shaft ensured that they both needed to come out. Worse still, there was significant corrosion on both the fixed and the rotating turret rings. This corrosion is going to have to be dealt with at an early stage and may require an amount of re-manufacture.

The corrosion pictured below is typical pitting found on magnesium alloy components. There are four such areas around the ring which provide the ideal stress raiser from which cracks can develop.

So, out came the fixed and rotating turret rings along with dozens of special bolts and the horizontal and vertical bearing assemblies which can now be cleaned and re-greased.

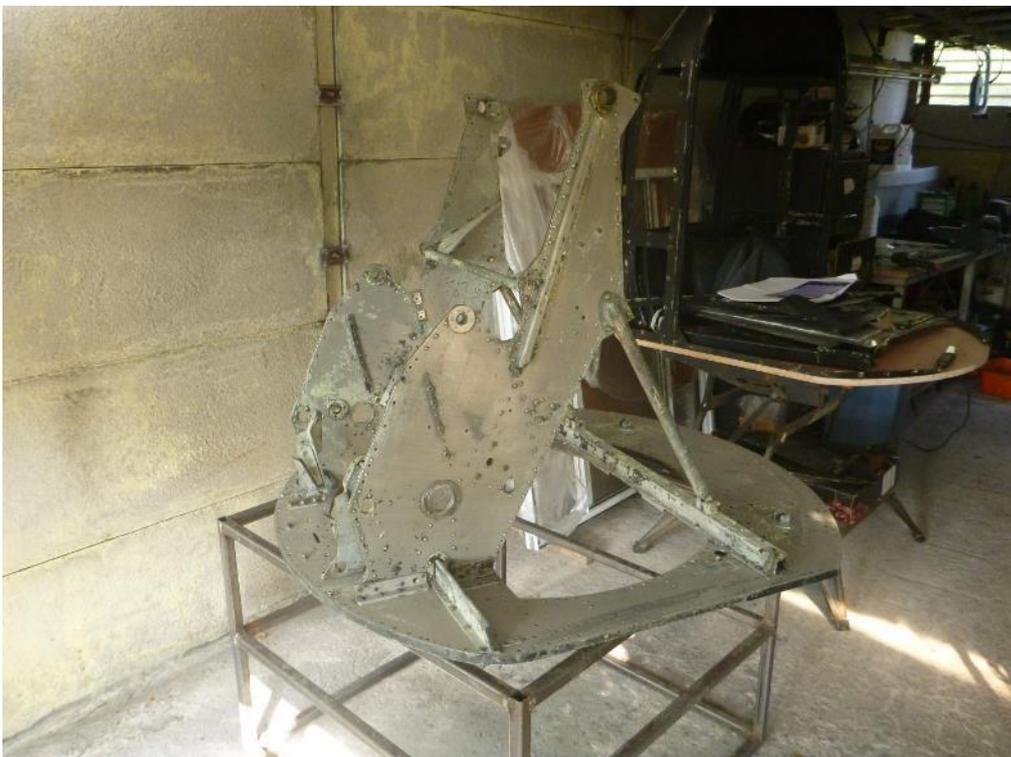
Many hours of paint stripping resulted in an accommodation plate and inner support frame structure with an almost perfectly intact anodised finish. At this point any remaining bolts were removed, checked, greased and refitted.

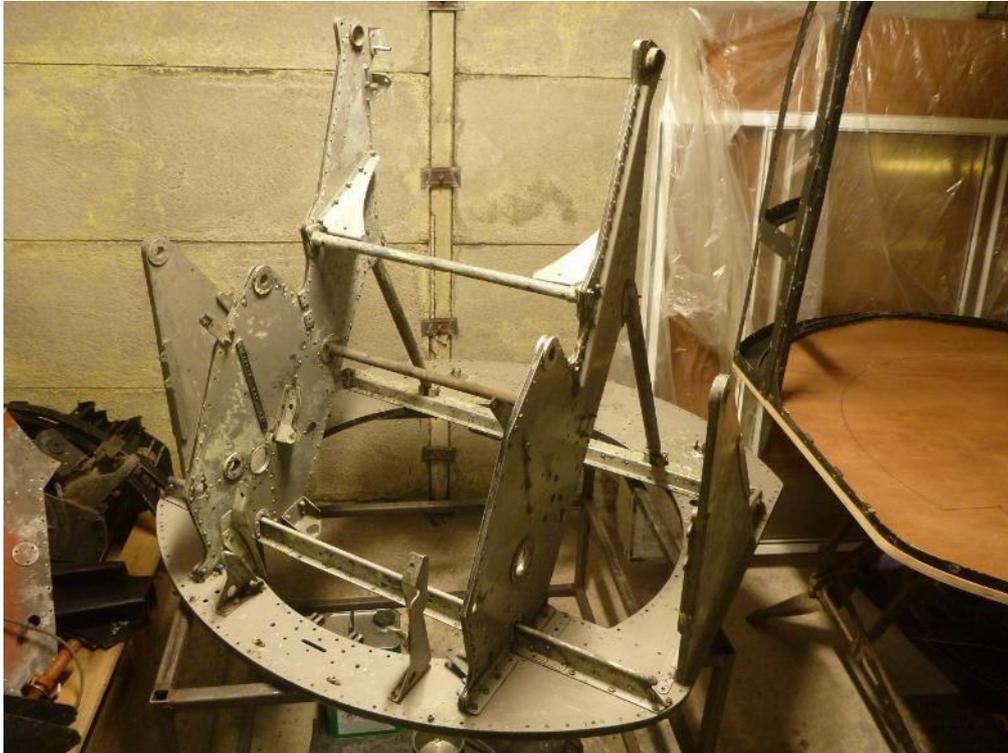
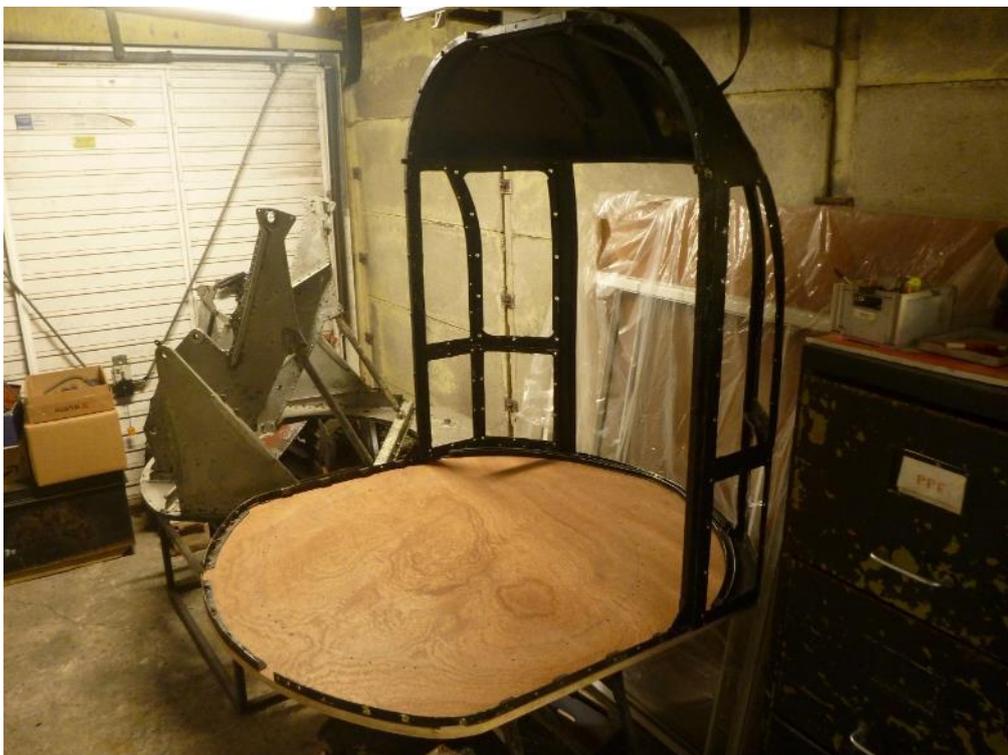
Above is the partly stripped out cupola which I am planning to rebuild alongside the main assembly of the turret. It seemed to wise to make a marine ply copy of the accommodation plate to support the cupola during the built. This plywood copy will then come in very useful for another project that has developed out of this one.

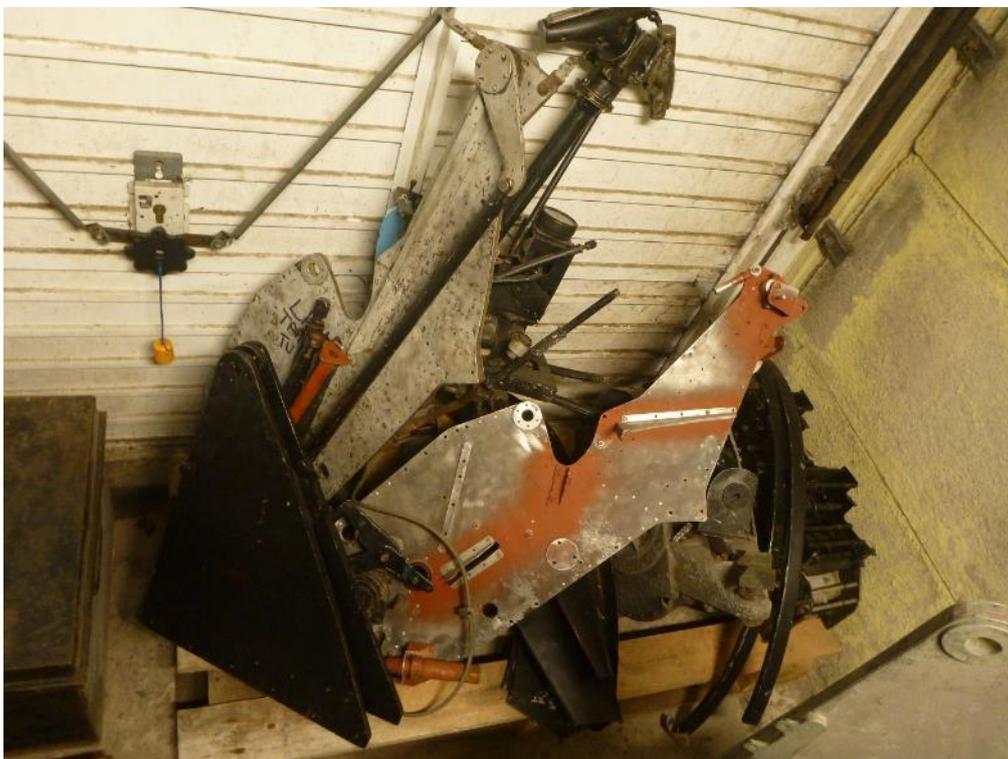
Pictured below is a very large percentage of a second FN82 turret. Whilst it definitely doesn't have all the parts we need for the first turret, it does have a large number of very handy parts to swap across.

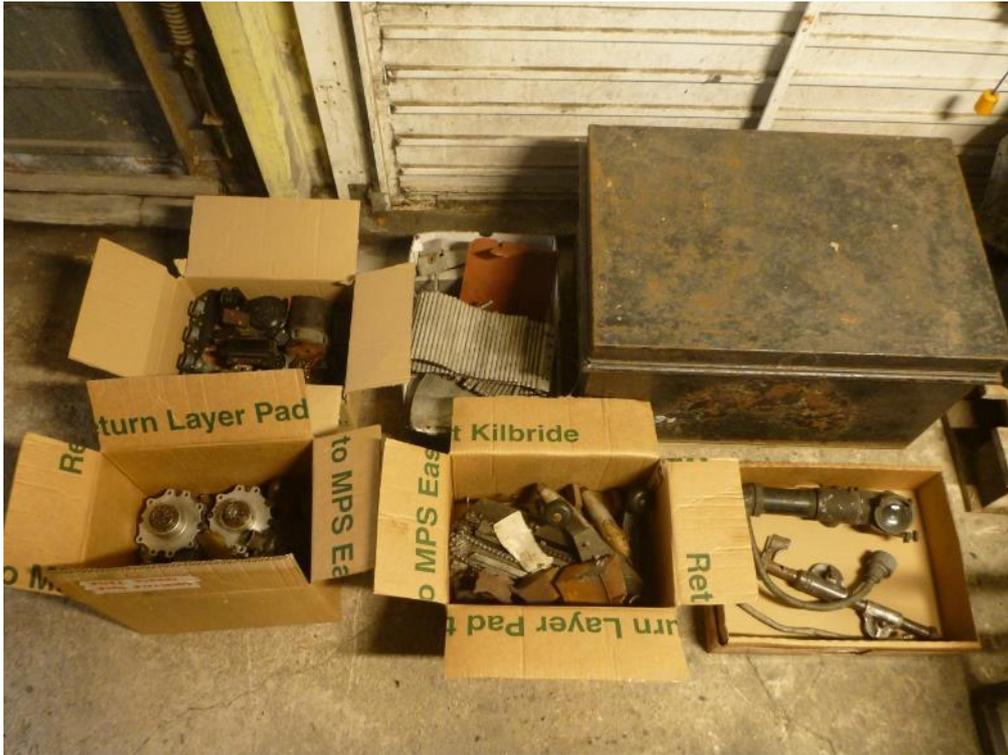
More parts below, including most of the electrical components and a CRT collimator which should sit next to the Gyro Gun Sight.

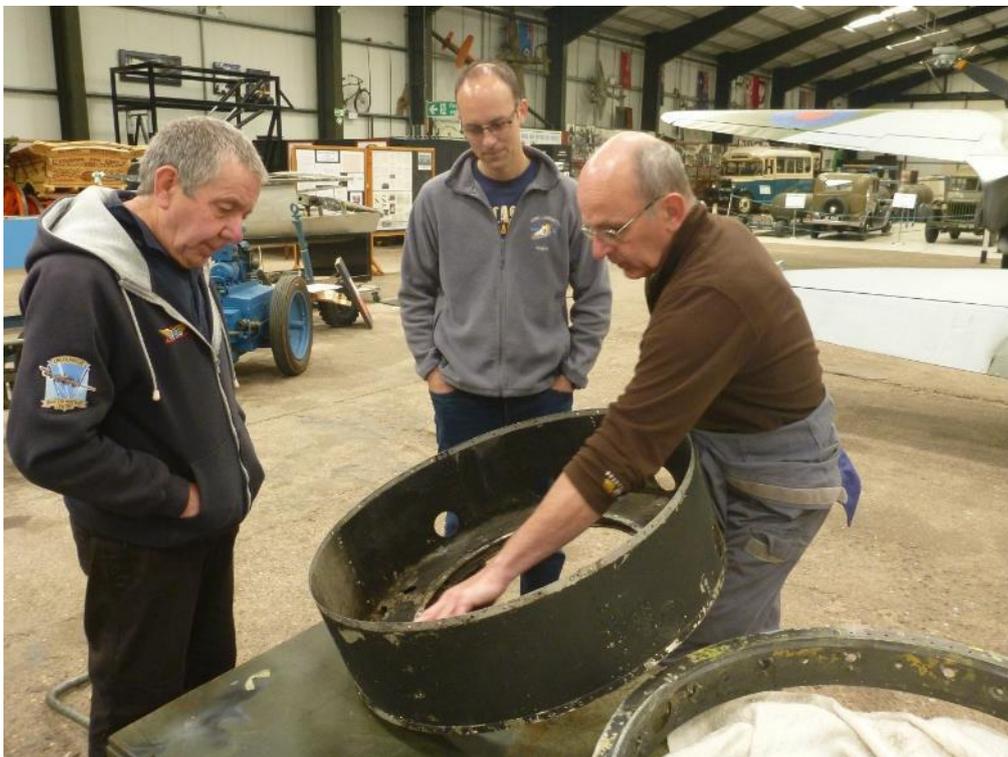
With the threat of further lockdowns on the horizon, it seemed like a good idea to get the badly corroded parts back to East Kirkby to discuss repair or re-manufacture options. Here can be seen the drum and floor assembly being discussed and, next to that, the turret rings.
