FN82 Turret update August 2020

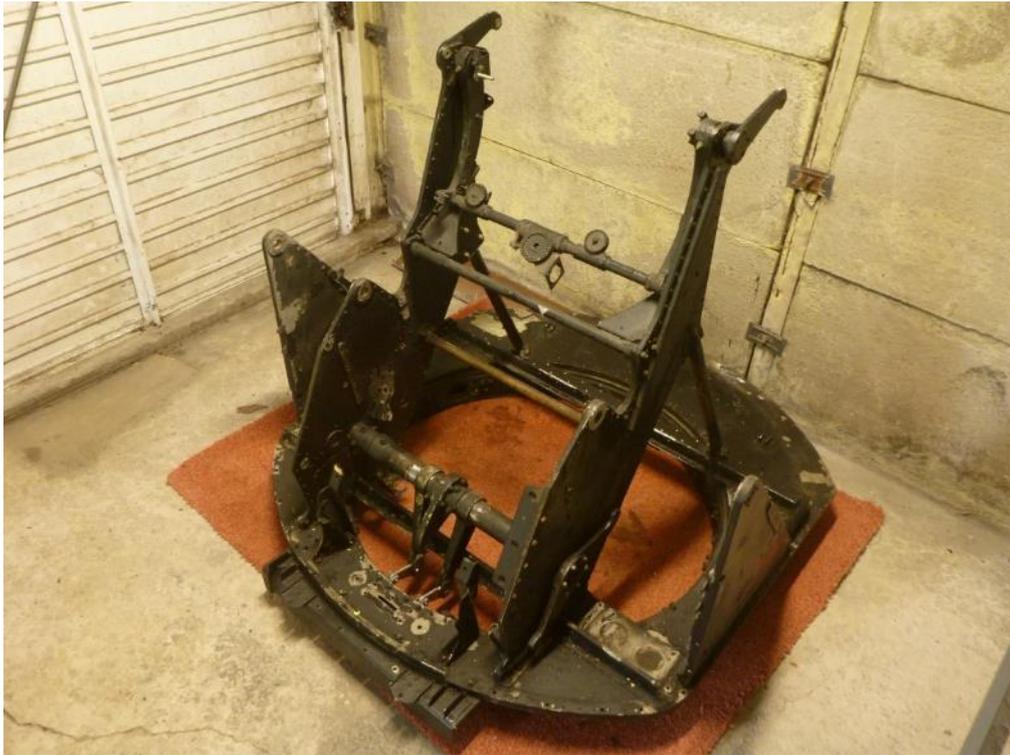
The first task with this assembly is to remove several layers of paint and have a good look for cracking and corrosion. Once this is done the turret rings will need to be separated, cleaned, greased and re-built. If anyone out there knows the modern equivalent to 'Grease, Low Temperature, Aircraft – Stores Ref 34A 174' could they let me know please.

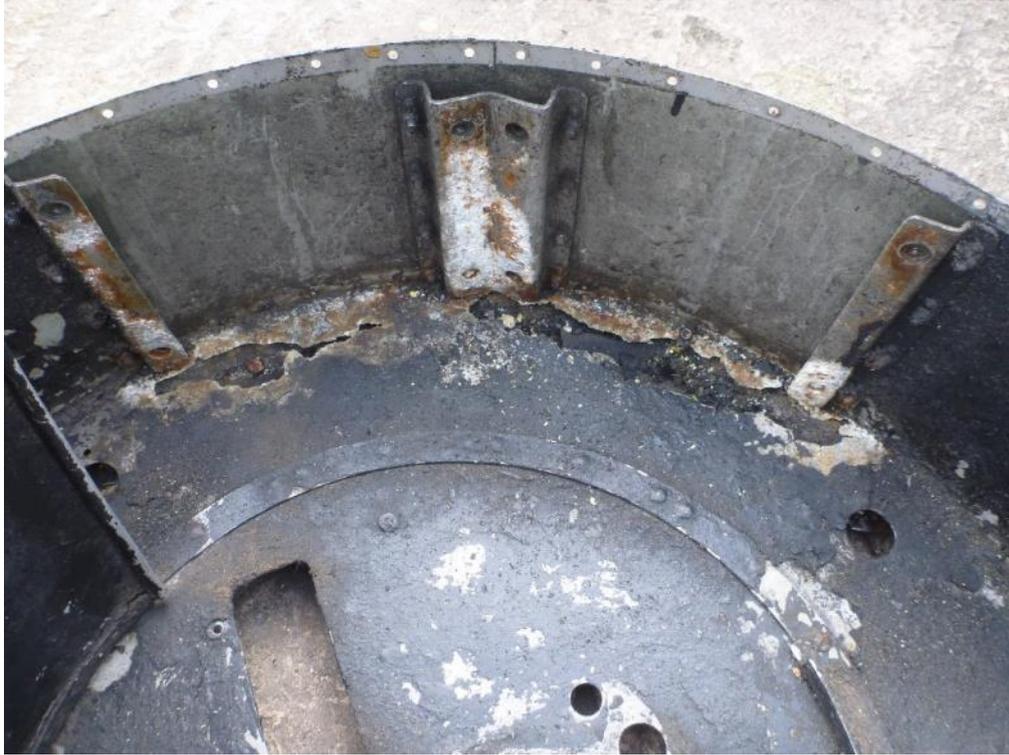
The first major horror found was this area of corrosion in the drum and floor assembly. At the very bottom of the turret, this is the area where all debris and dampness collect and is also where the lower armour plates touch the drum. With almost perfect conditions for electrolytic corrosion the inevitable result has been some serious damage in a difficult to repair, double skinned, area.

Luckily, this assembly can be re-fitted quite late on in the restoration so there should be time to come up with a repair plan or consider re-manufacture. To prevent this problem in the future I think it would be best to omit the armour plates and their mountings especially given the lack of German night fighters these days.

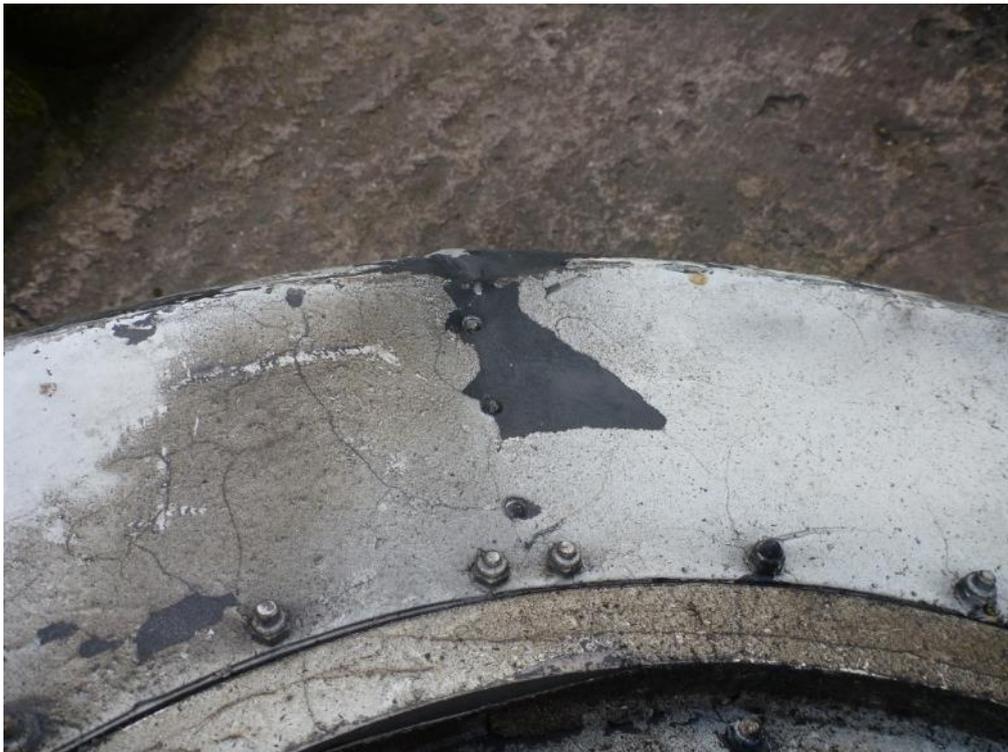
Much more difficult to photograph (and repair) is the damage to the underside of the drum. At some point the turret has suffered an impact from below, or possibly been stood on its base. The result is a creased outer skin and the floor has been pushed up about an inch. Furthermore, the leg shields have been pushed up, their rivets have torn and their upper mounting bolts have folded up. In all this assembly is in a very bad way.
