FN82 update February to April 2022

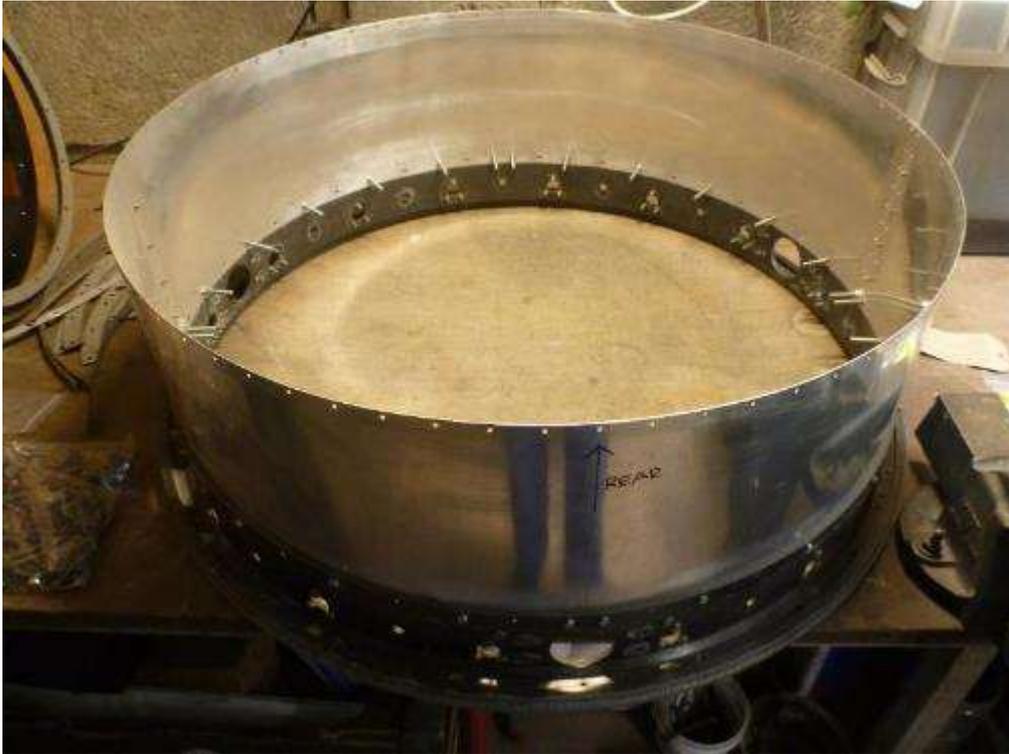
Firstly, the sides were temporarily bolted to the rotating turret ring in order to establish the correct circumference at that end.

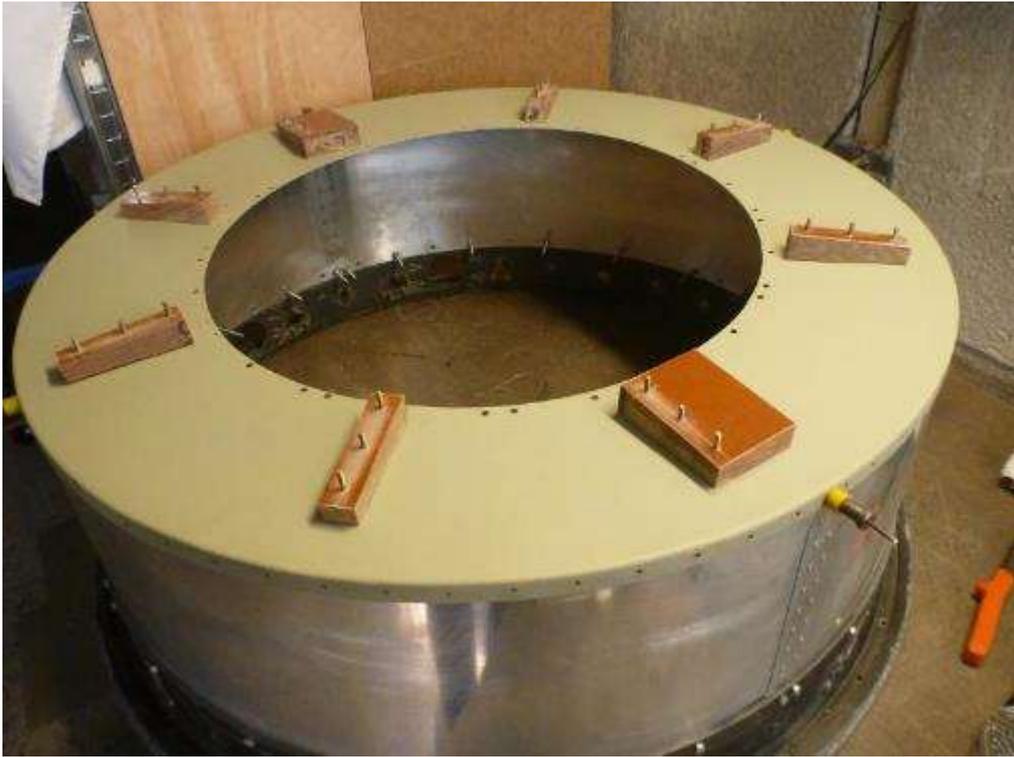
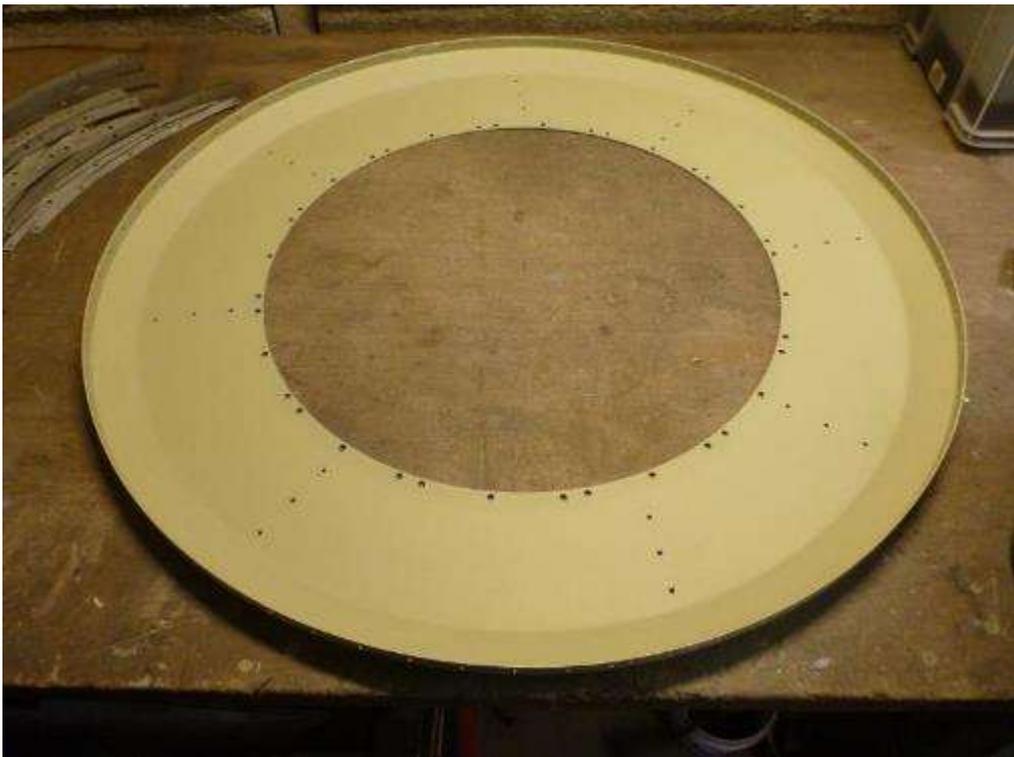
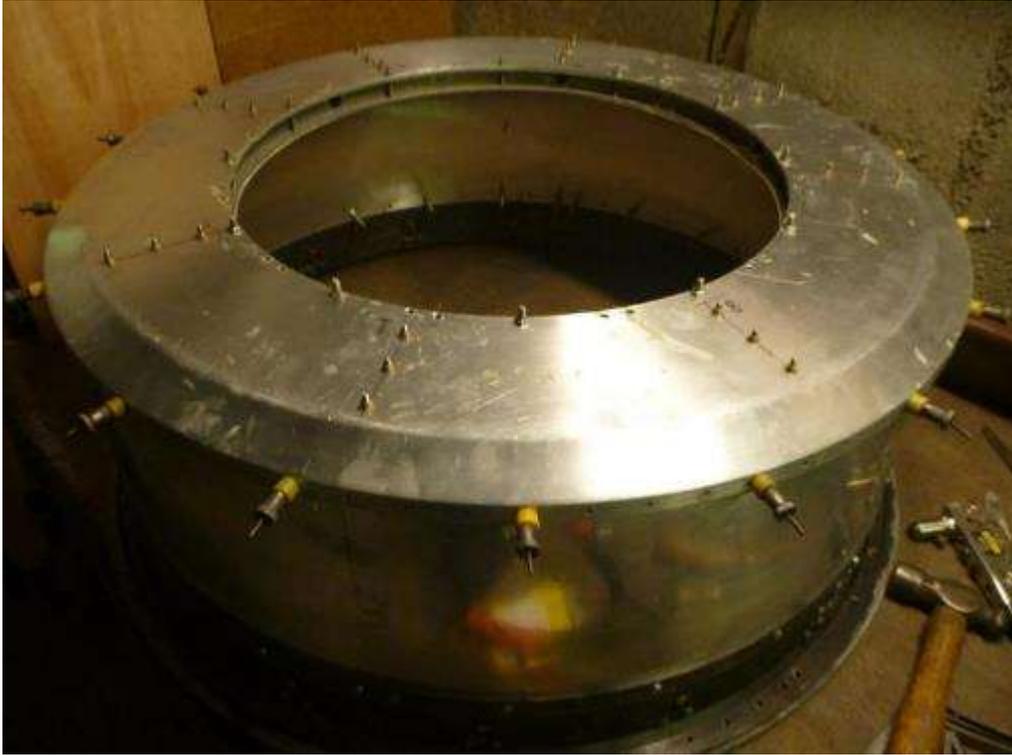
Then the inner floor could be gripped to the sides to establish the circumference at the other end and allow all of the rivet holes to be transferred across. The 'inside' of both of the two floor skins were washed and primed at this point to better prevent corrosion. The originals had no surface finish applied but, I assume, that they weren't expected to last that long.

The two floors are held apart with Tuffnell spacers which had to be manufactured as the originals had all cracked.

During final assembly of the drum and floor jointing compound was used on all of the joints as this area of the turret is particularly prone to corrosion due to the moisture collecting in the drum.

Probably the hardest part of this assembly was getting the outer floor in place. All of the holes in the bearing mount and the eight spacers have to be aligned before the outer skin can be gripped to the inner floor and drum sides.

Once aligned and bolted and riveted together the next stage was to fit the fixed floor assembly – there are many parts.

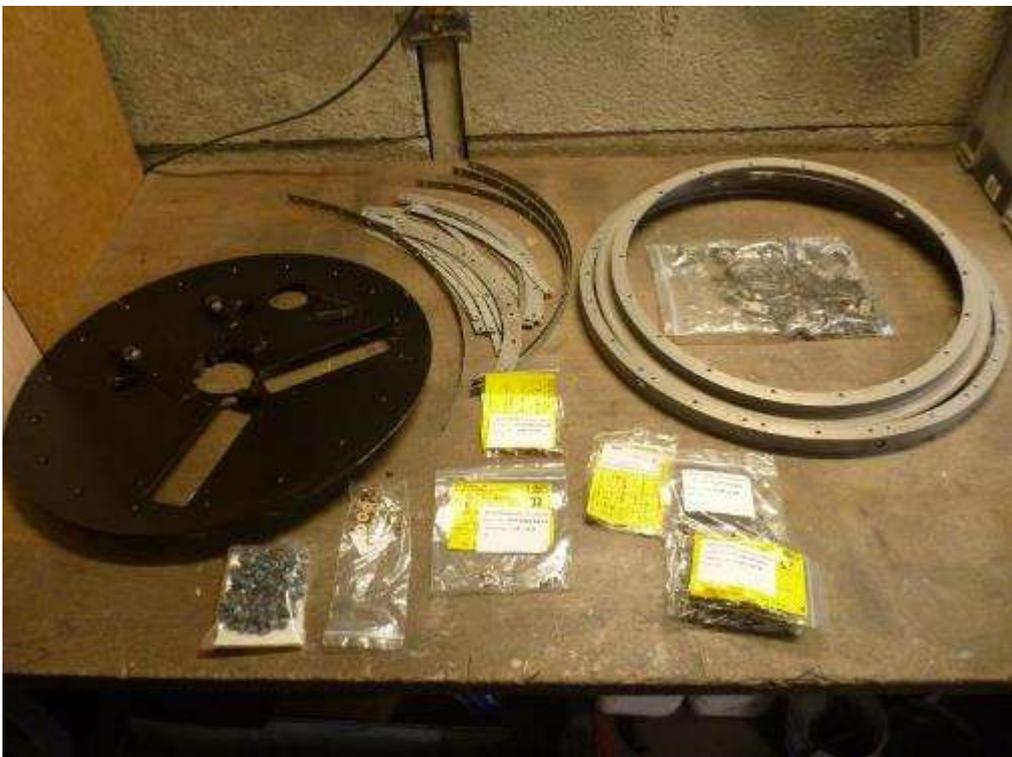
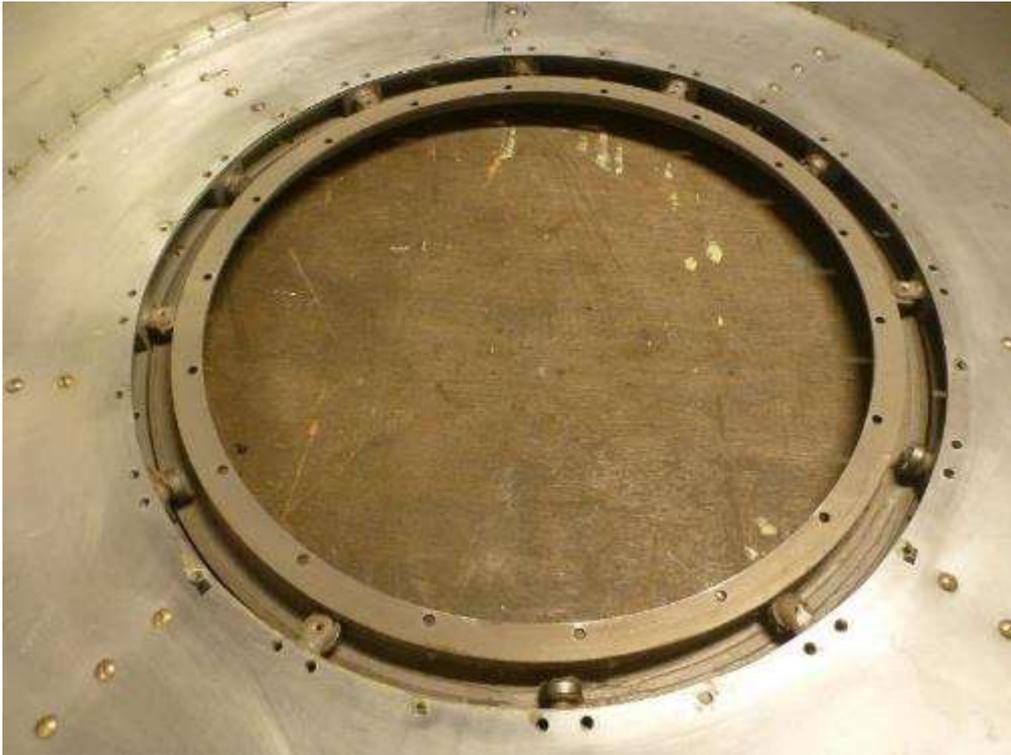
The components of the fixed floor are seen below. Firstly, the bearings are greased and then slid into place. The other bearing mount and floor are bolted around them.

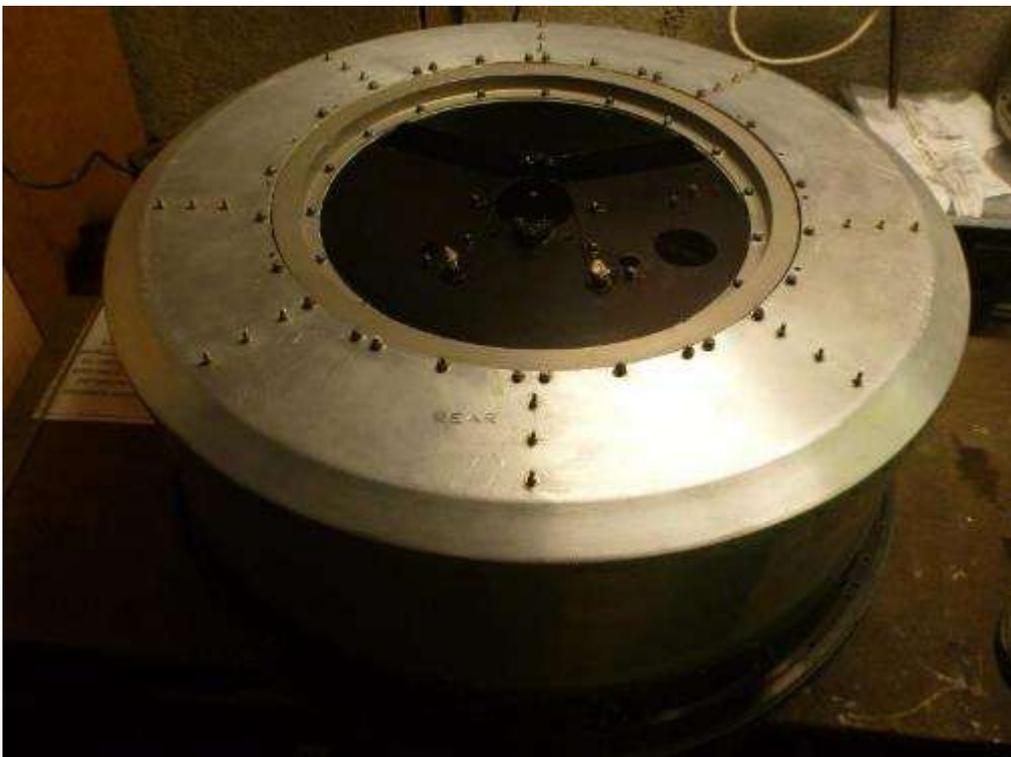
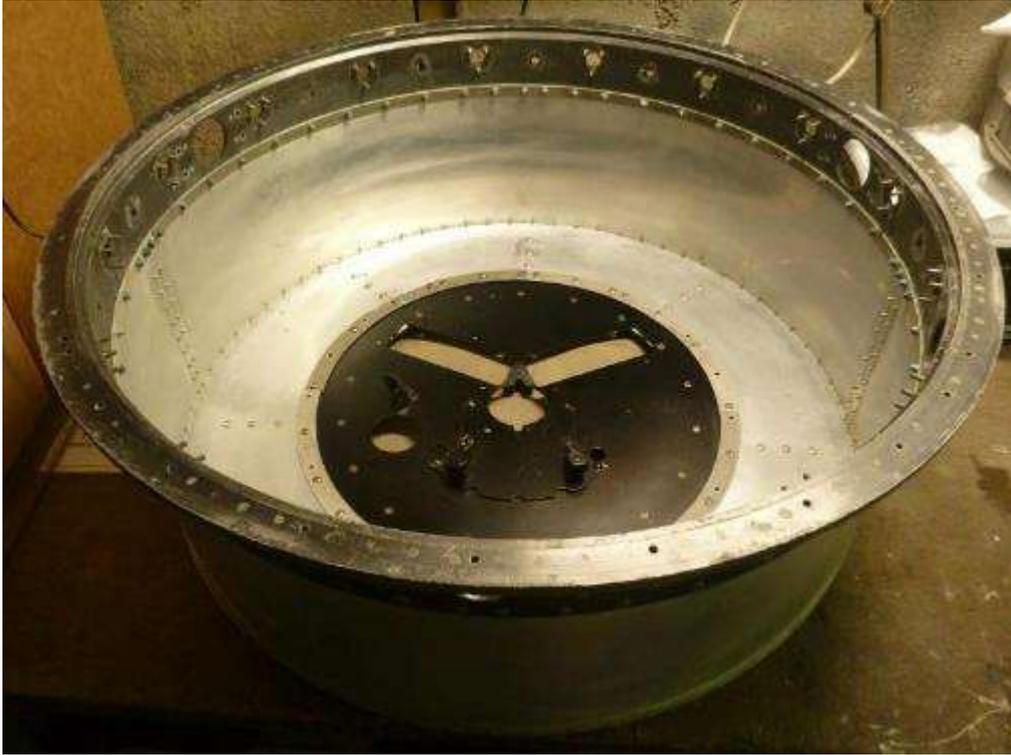
Seen below is the completed drum and floor assembly which has been bolted to the rotating turret ring. Once this assembly has been sprayed it will need to be fitted to the fixed turret ring and then the whole thing bolted to the underside of the turret.

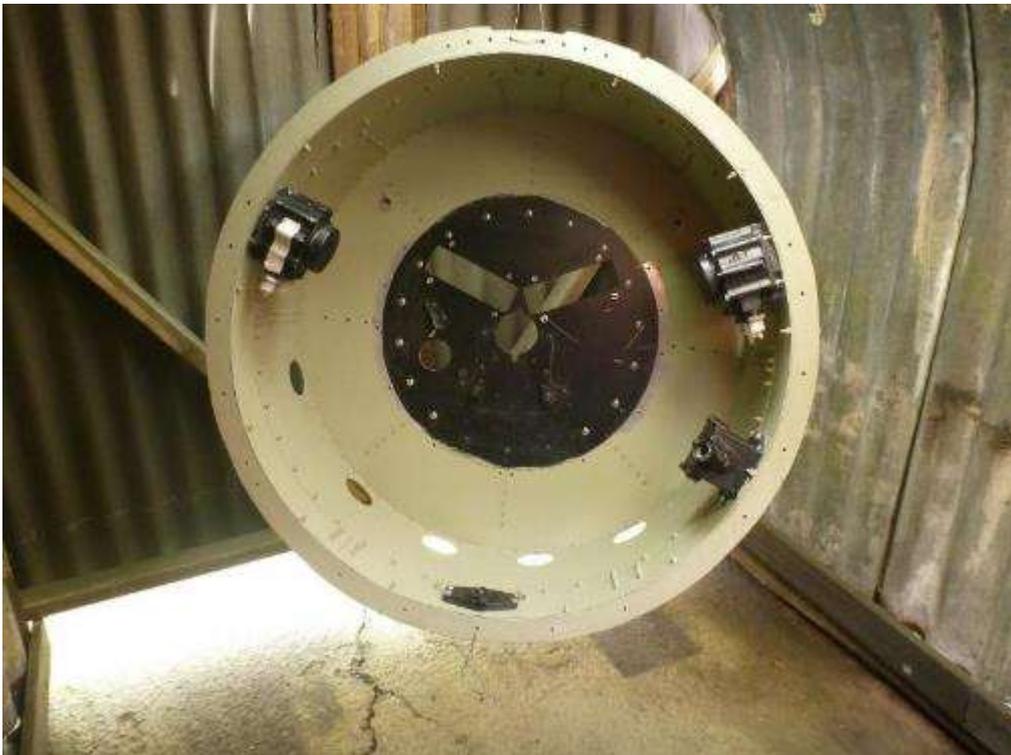
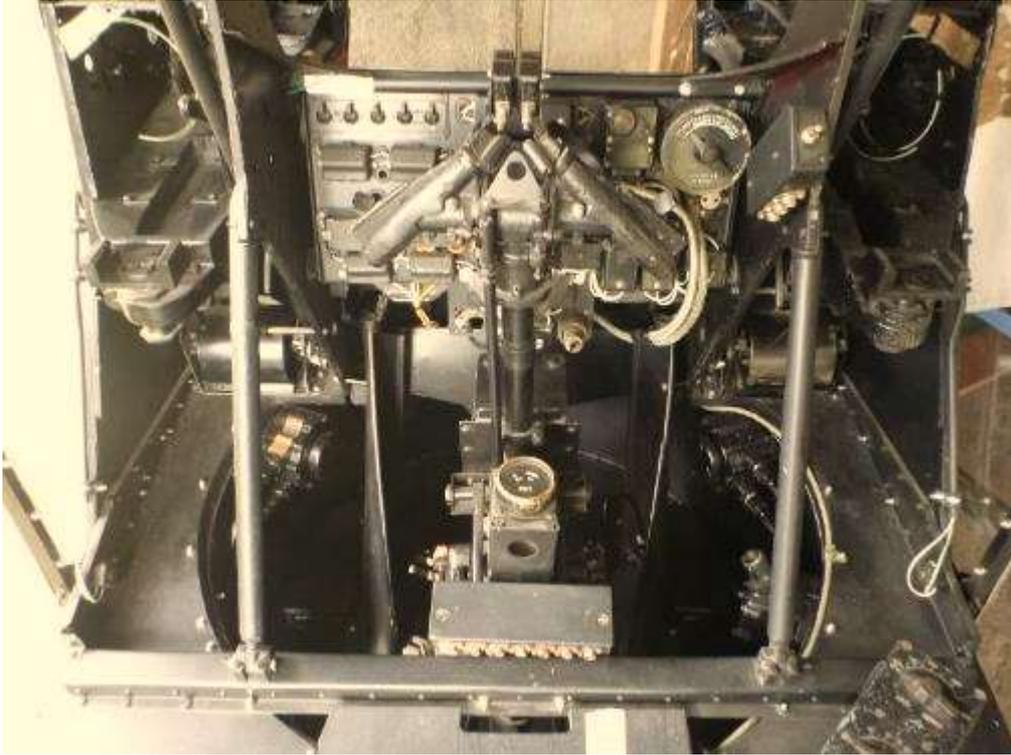
By way of a change, progress was continued on the display FN82 Series 2. Here is a similar assembly hanging in the spray bay (an Anderson shelter). Once done this assembly was bolted to the turret and the control column fitted.

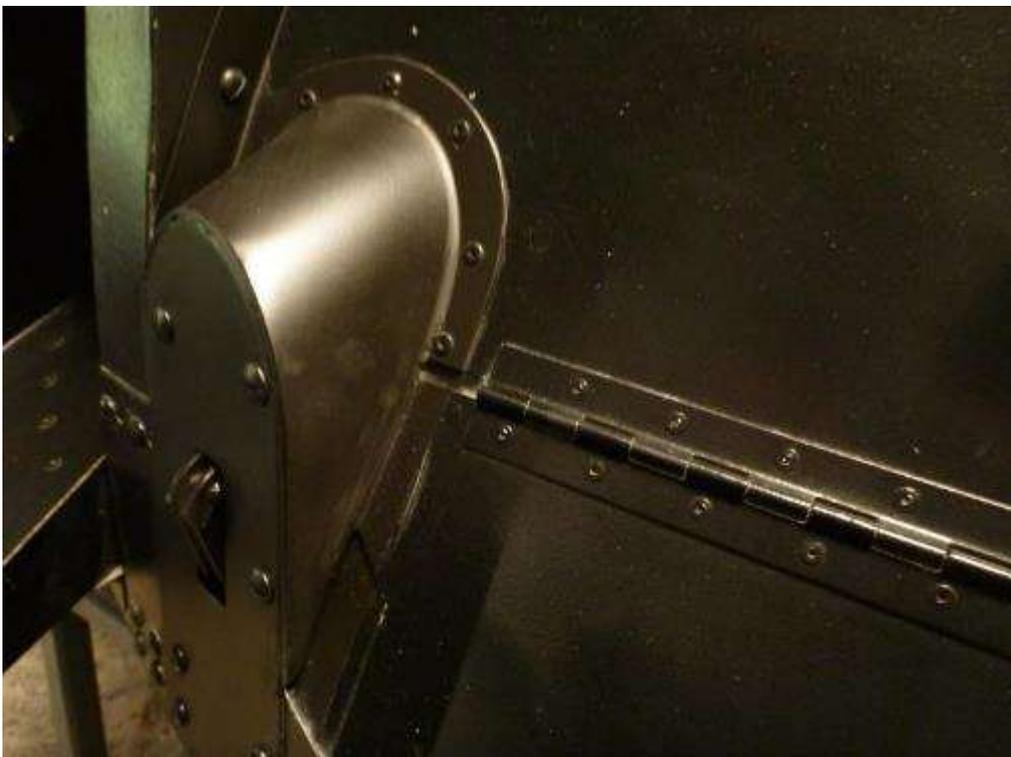
One job I had been avoiding was the last two fairings on the cupola. In the end, making these proved a lot easier than expected and resulted in a complete cupola front half.

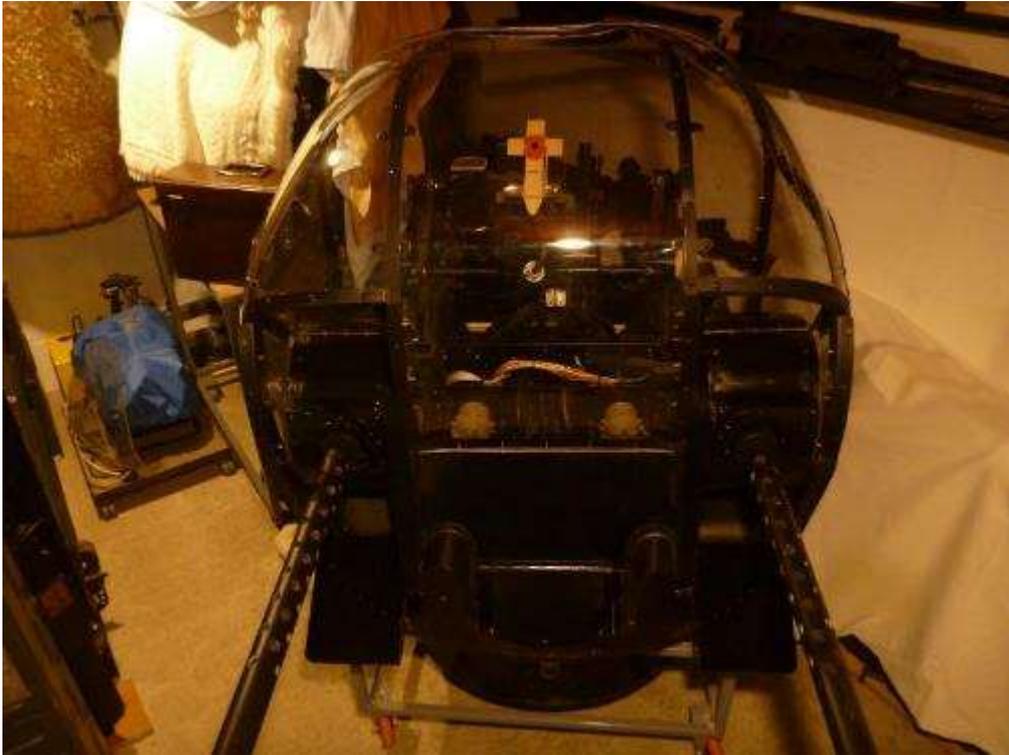
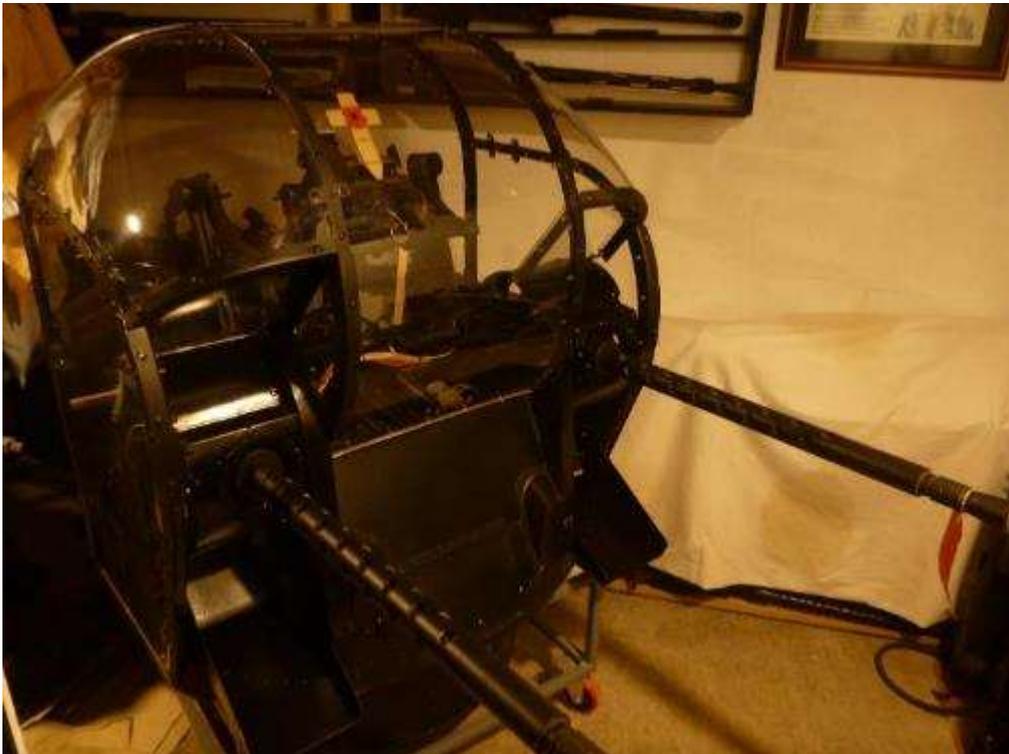
Finally, for the display turret a pair of reproduction .50 cal's were made and fitted and so the turret was completed as far as it can be and is now ready for return t East Kirkby.

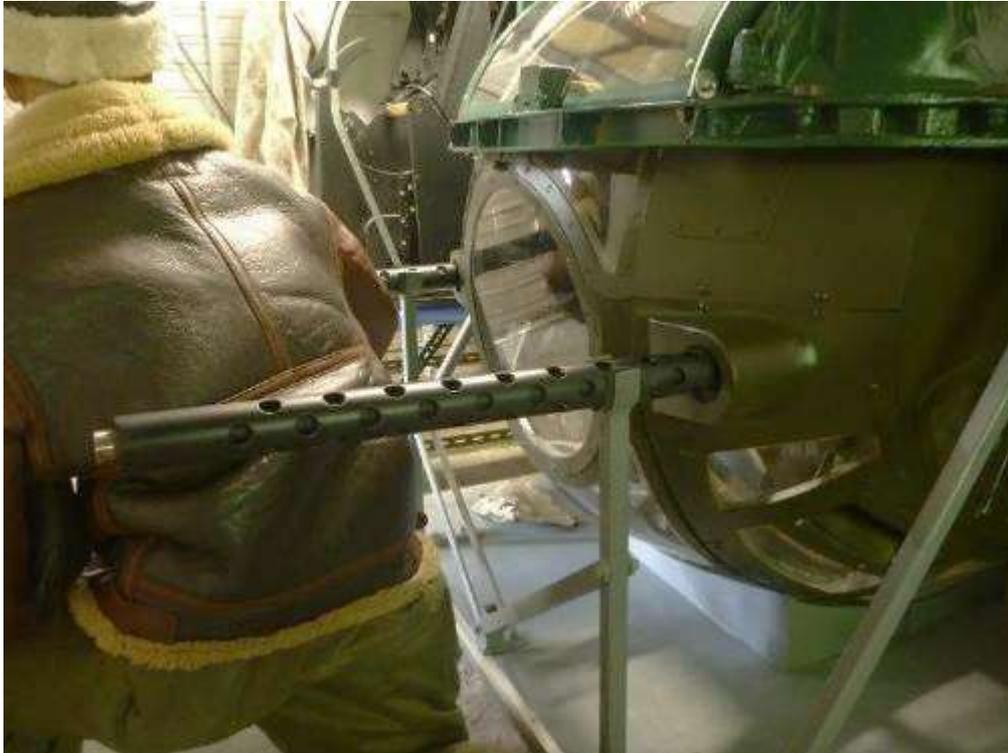
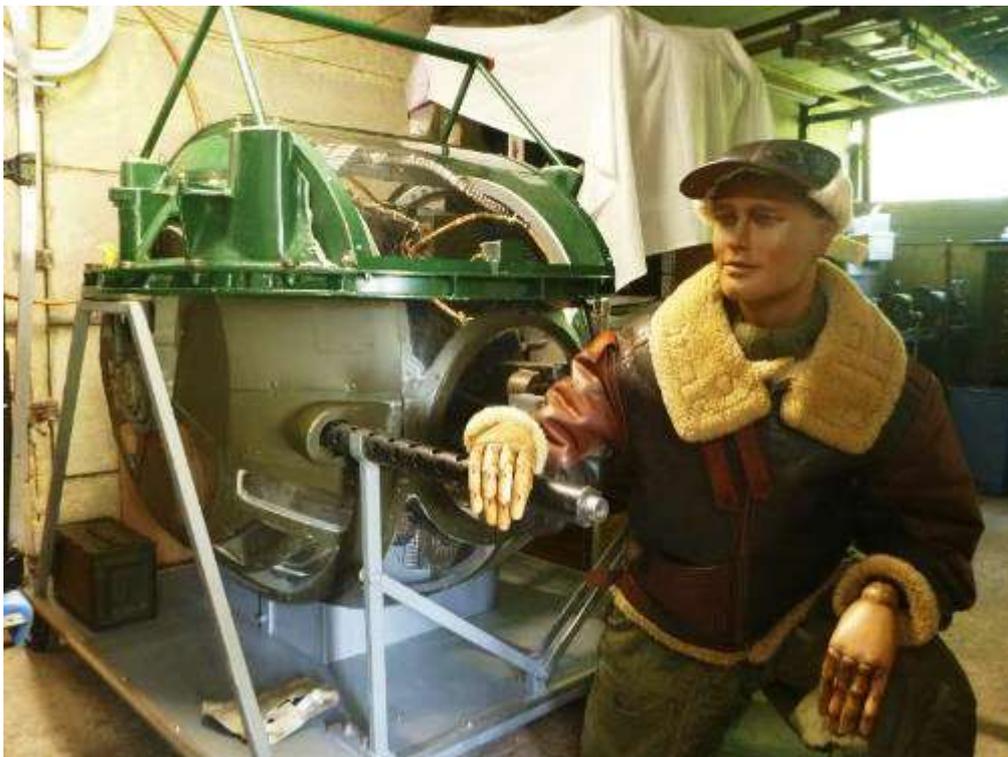
This period also resulted in the production of the last two fairing on the A-13 ball turret. These were built in a similar manner to those on the FN82 and their production resulted in the end of this restoration as well. The completed turret is shown below with a late War USAAF gunner and will, hopefully, be on display at East Kirkby in the not too distant future.
