### FN82 update April 2021

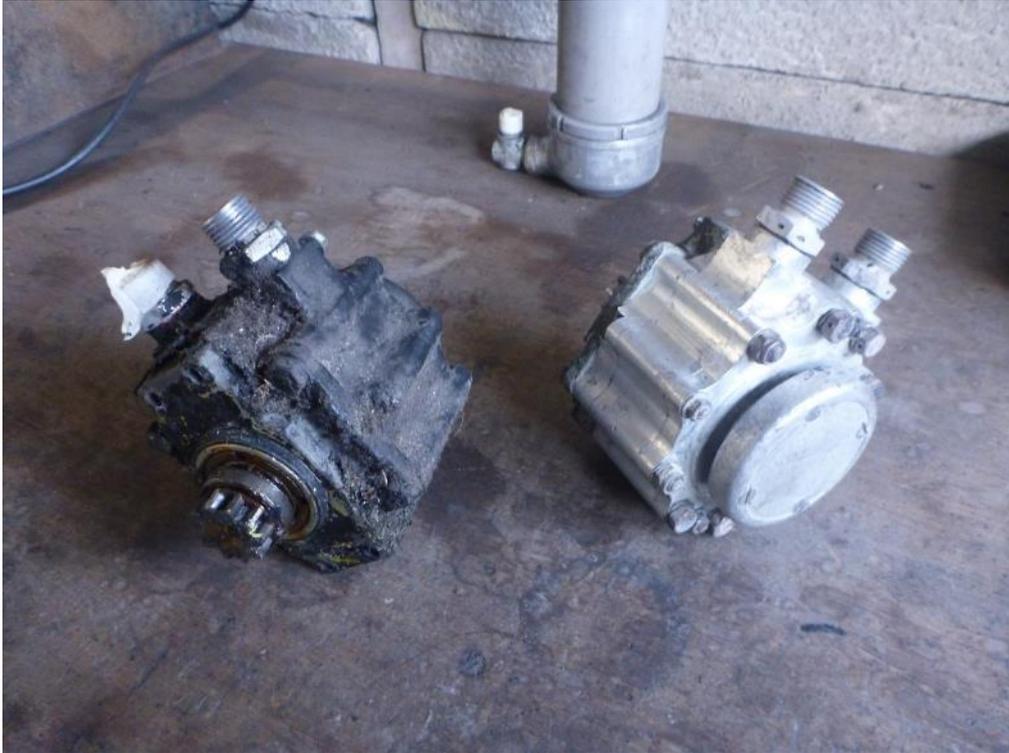
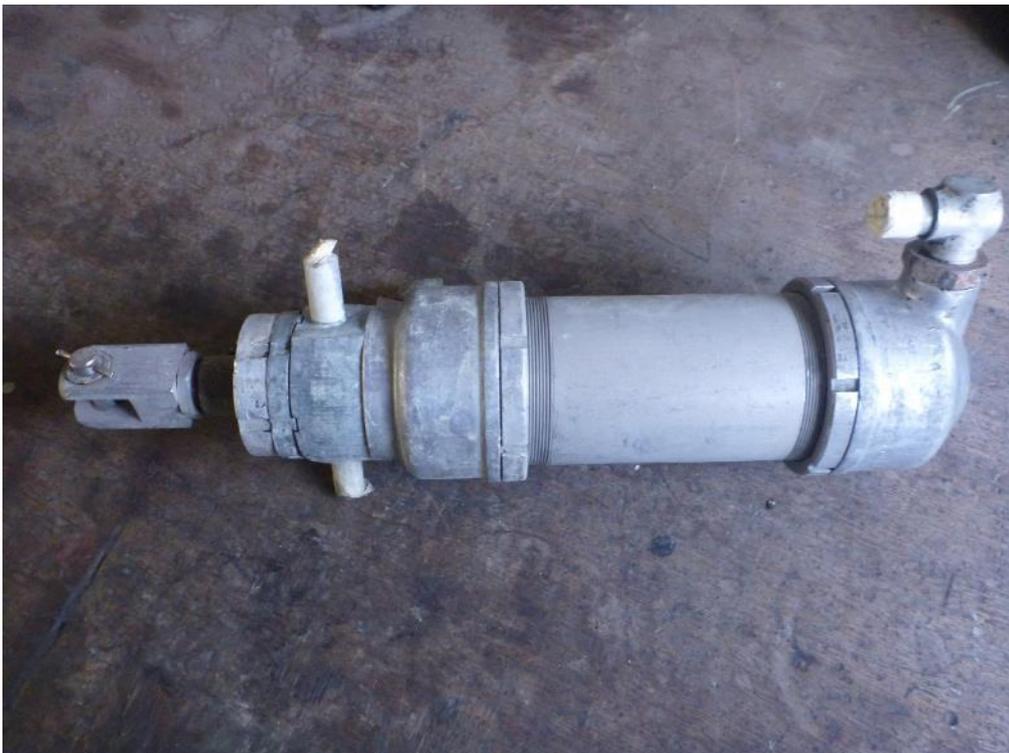
The plan for April was to progress the hydraulic components and small detail items in preparation for the turret re-build. This seemed likely to be a painstaking business and I was not disappointed. Seen below are the two rotation motors which had collected a thick layer of paint, hydraulic oil and dust. This gave up reasonably easily to reveal un-corroded motors and perfect data plates.

The view above is of the main (elevation) ram which also benefitted from a good clean before being prepared for painting.

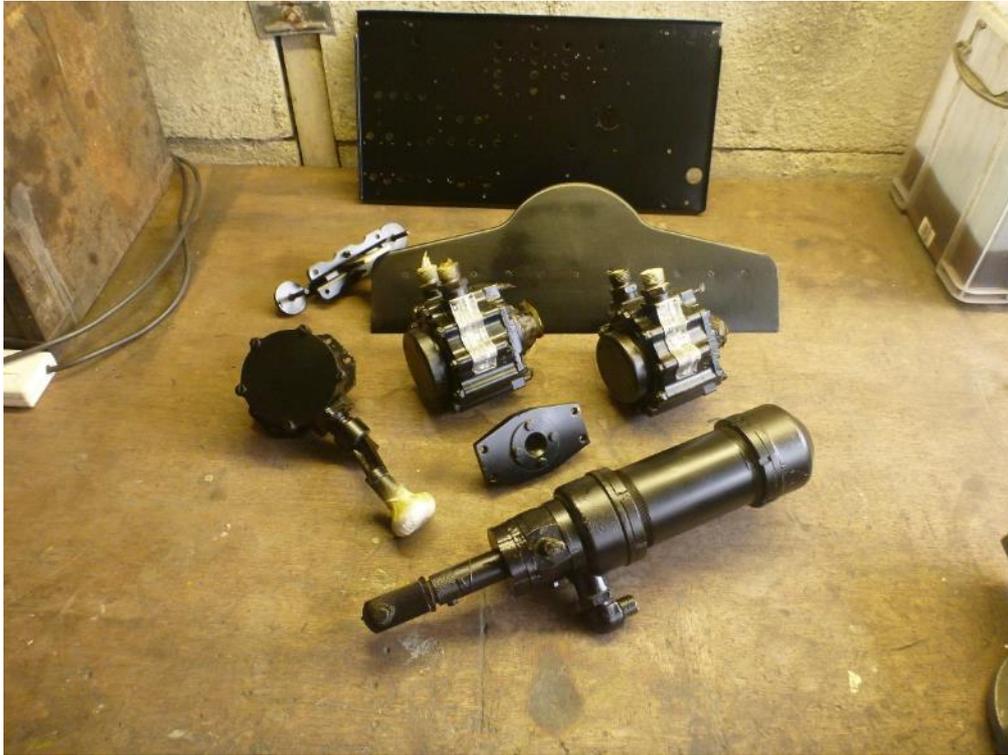
Below are several of the major components that fit around the turret rings pictured with the travel stop, knee guard and control panel. All of these items are now bubble wrapped and stored away to await rebuild.

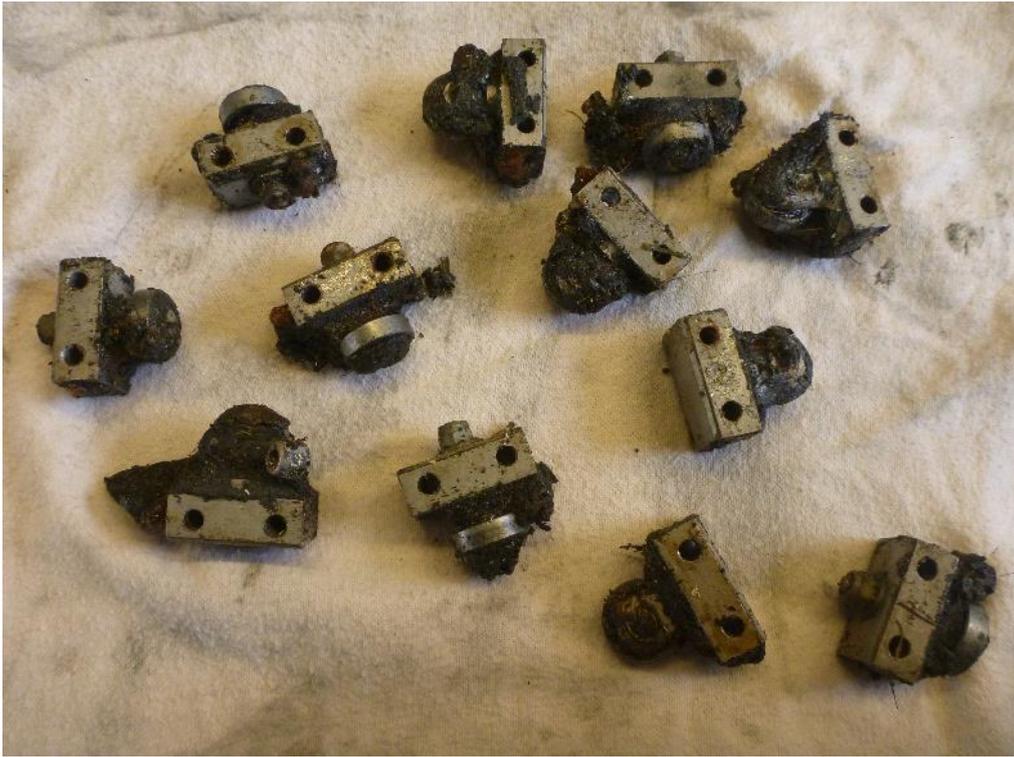
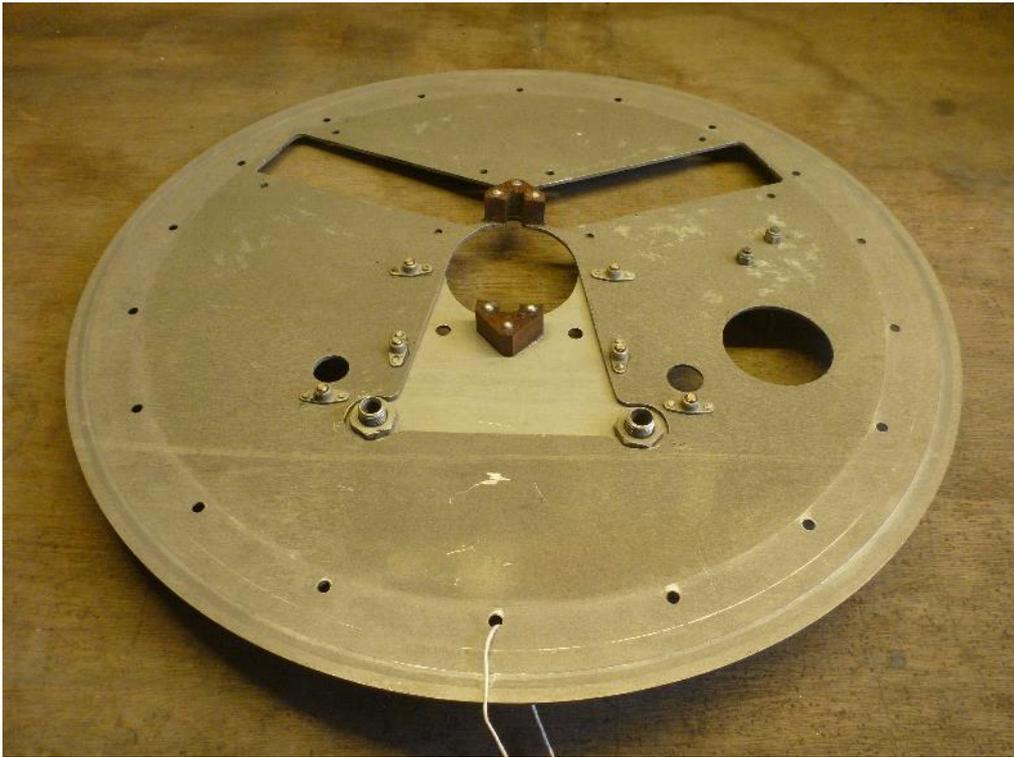
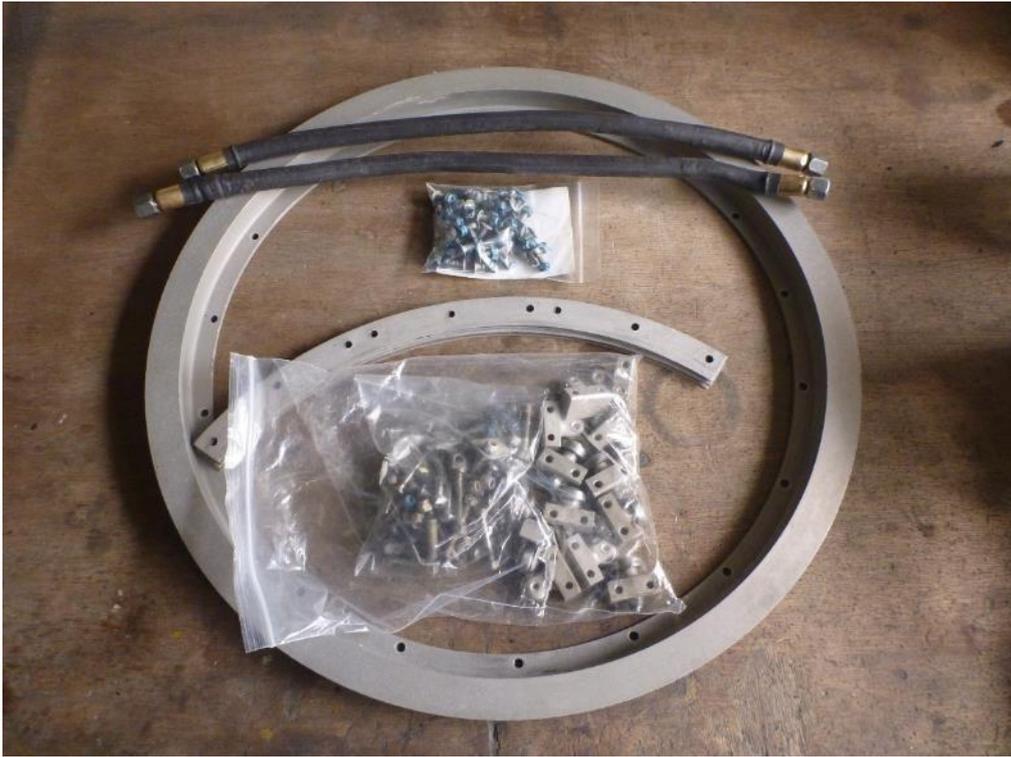
Next on the agenda were the components removed from the damaged drum and floor assembly. Within the floor assembly there is a fixed floor that does not rotate with the turret and so has a number of horizontal and vertical rollers to allow this to happen.

Installed right in the bottom of the turret, I was concerned that these bearing assemblies might well be corroded and stuck. However, a lifetime spent coated in very thick grease had saved them in perfect condition.

Similarly, the actual fixed floor assembly, the bearing race and the doubler plates were found to be perfect under a very thick layer of paint, oil, grease and dirt. Once cleaned, these could be packed away to await the rebuild.

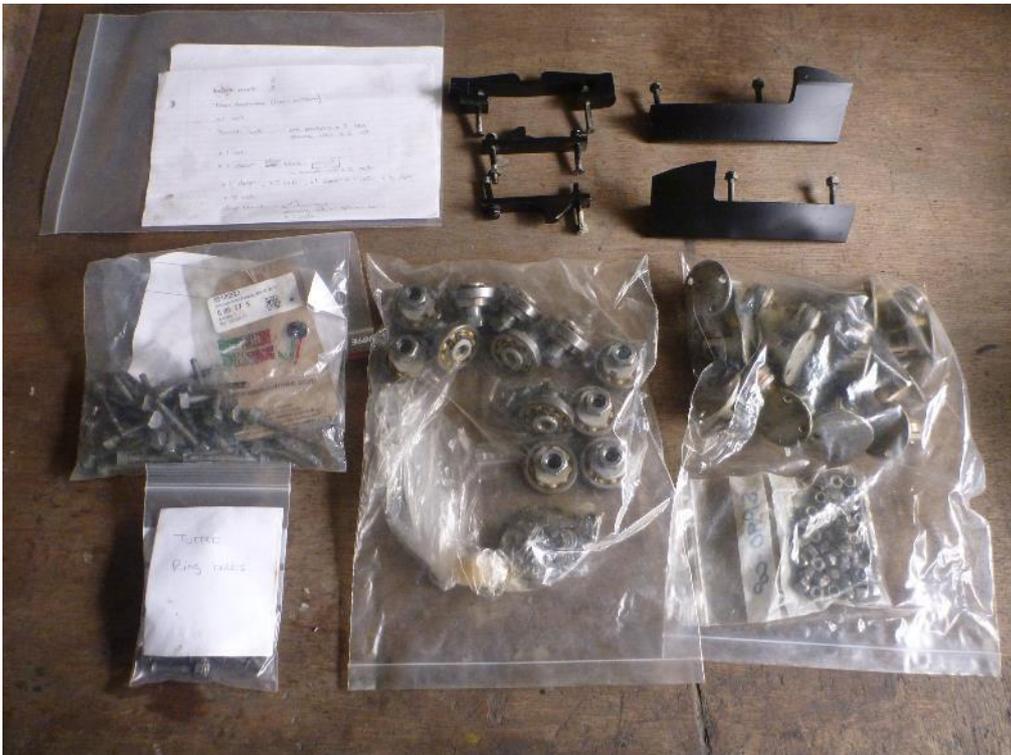
Seen below are the cleaned and packed components from the main turret rings. In bags there are the special bolts, vertical rollers and horizontal rollers. Above them the turret rotation stops and turret lock castings. Again, these were in very good condition especially given the corrosion found on the actual turret rings.

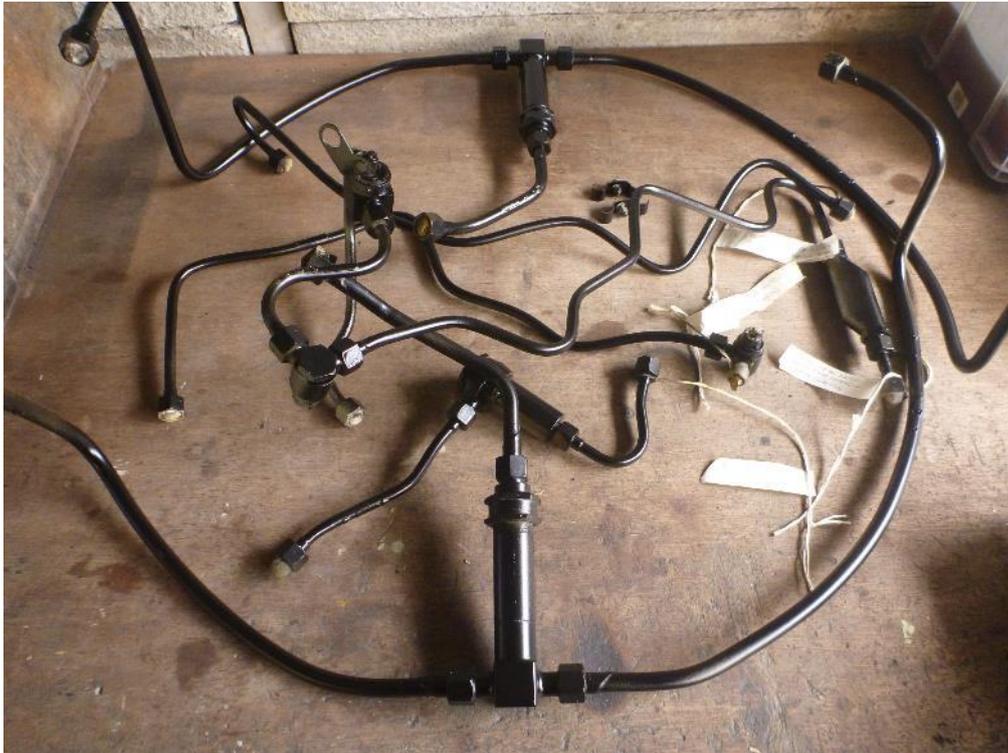
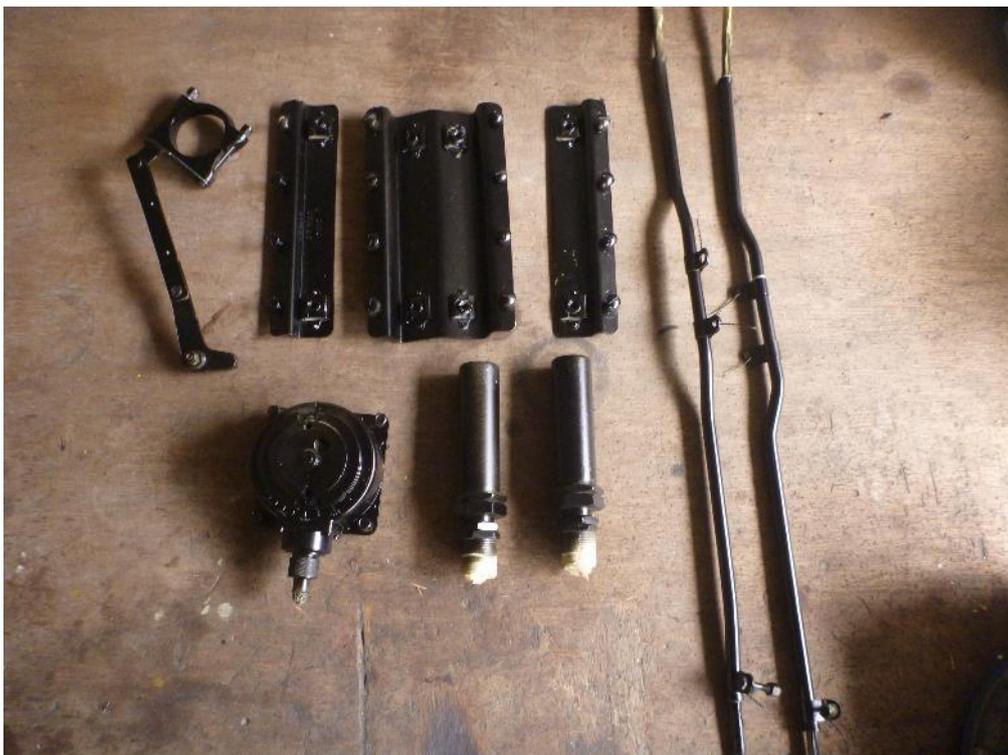
Next on the list were the hydraulic pipelines, filters and check valves. These were in slightly poorer state as they are easily damaged when entering or leaving the turret. That said, they all cleaned up well and proved very fiddly to spray.

The final image shows the last of the small detail components to be restored. With these items finished, the main assembly of the turret has progressed as far as it can go until the turret can be built onto the turret rings.
