FN82 Turret update March 2021

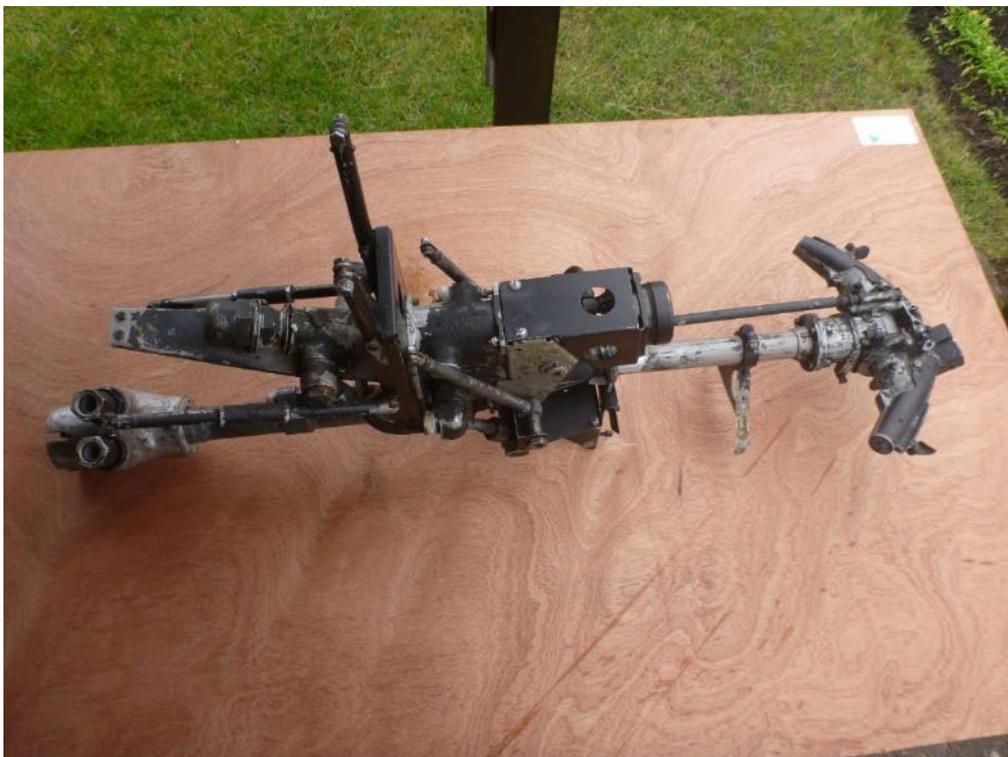
We have a spare turret control unit which also has problems but, in general, had the parts required for the original unit

The first job here was to strip down both of the units and identify the best components to build one to use on NX611 and a second for display purposes.

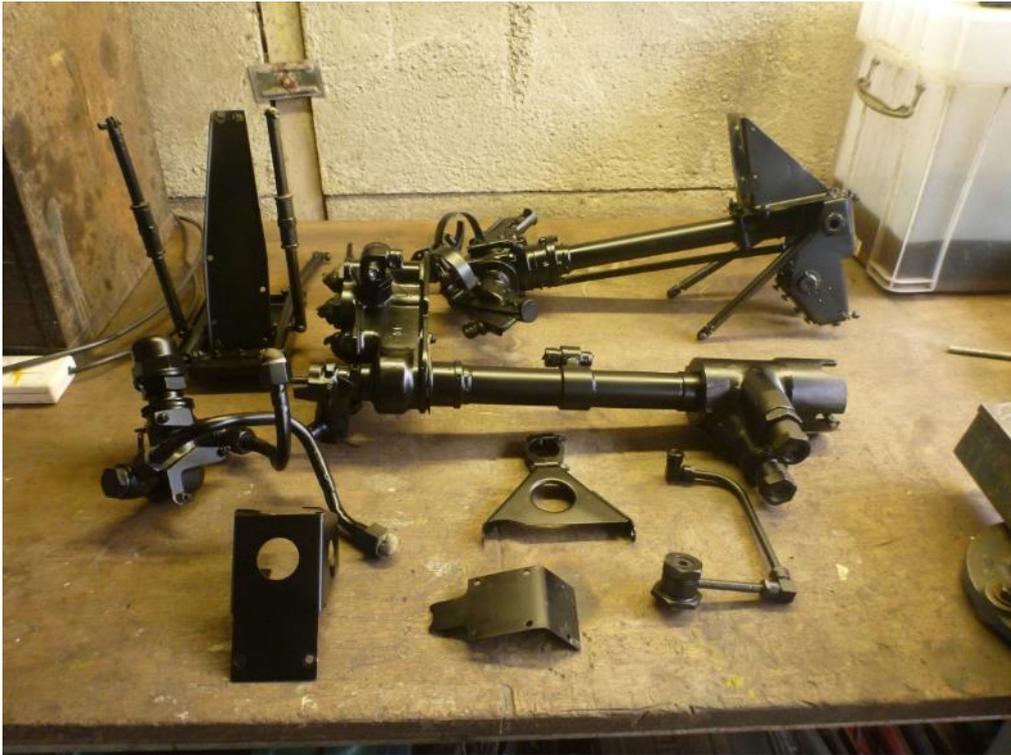
Once this had been done the components were cleaned and sprayed before the assembly could be re-built. The best of the components after having been sprayed can be seen below.

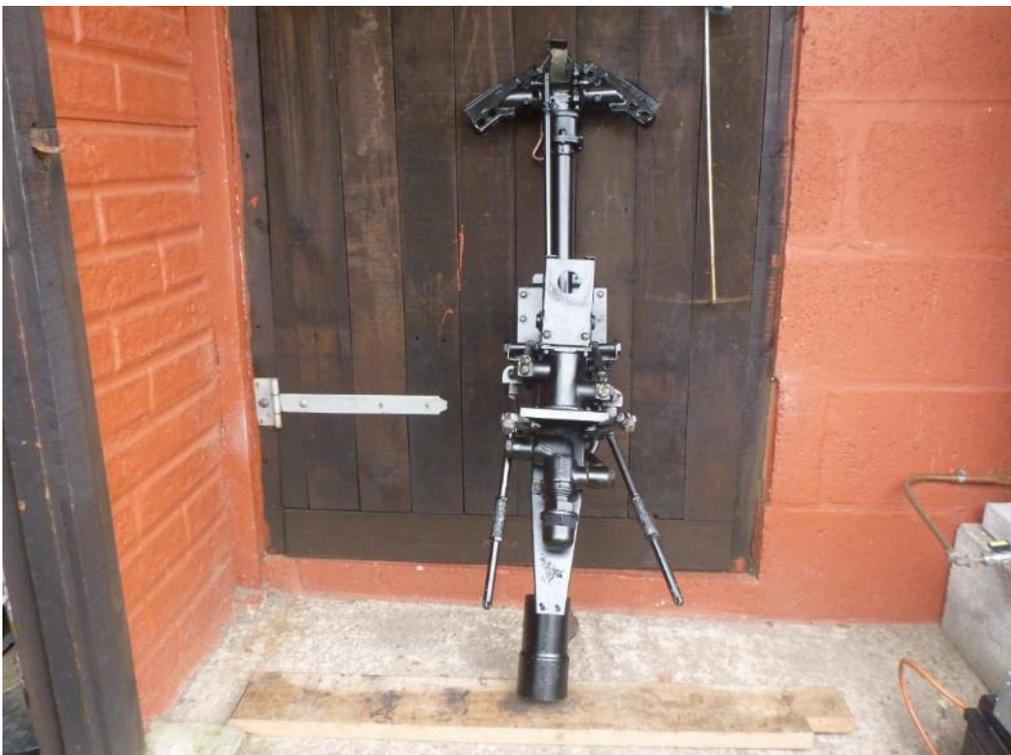
The unit was then assembled and then given a final dusting over in preparation for being finally fitted at some time in the future.

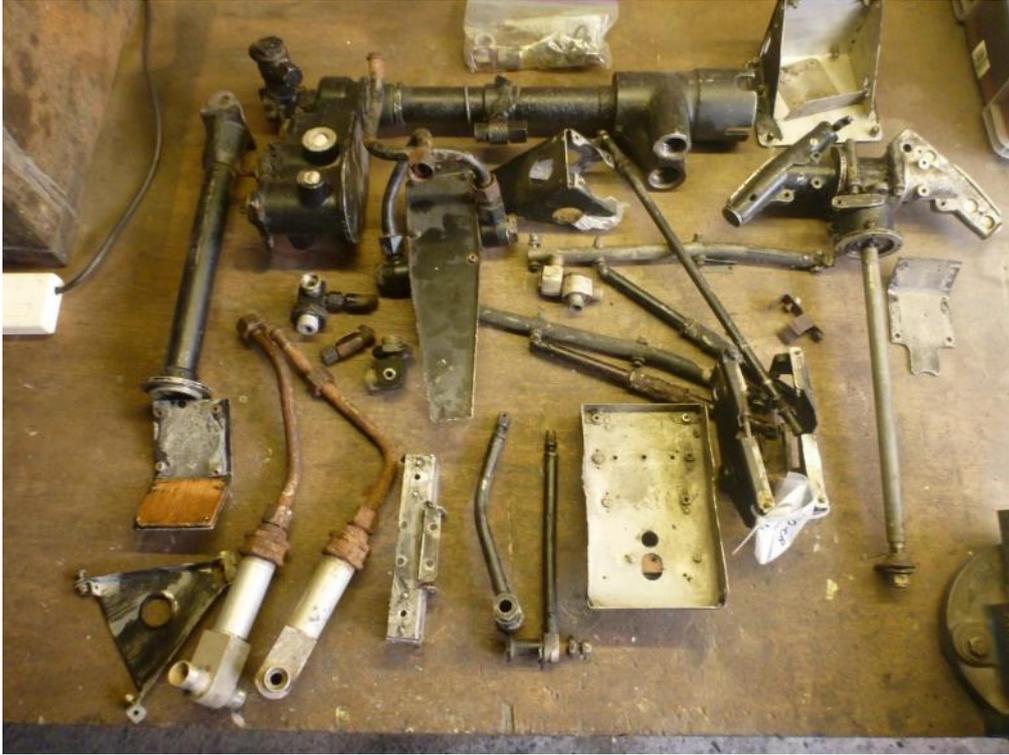
That then left the matter of all of the damaged and reproduction parts that need to be built into the display turret.

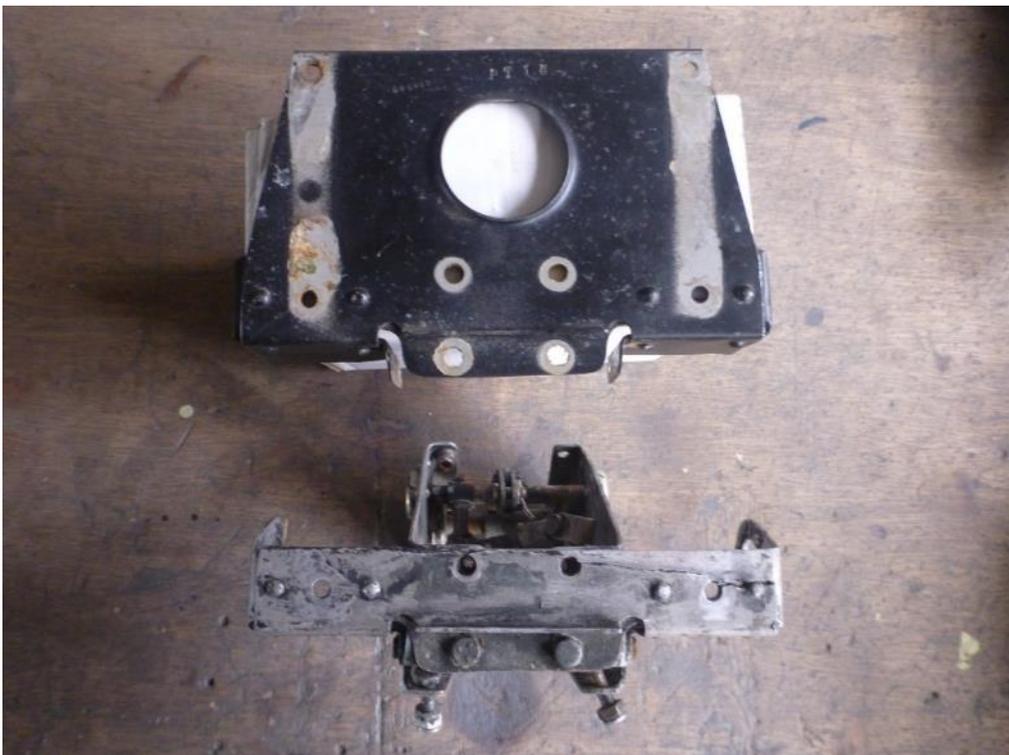
Shown below is an example of the damaged parts. Both are the same part, but the lower example is missing about the top two thirds of the azimuth controller bracket.
