## FN82 update May 2021

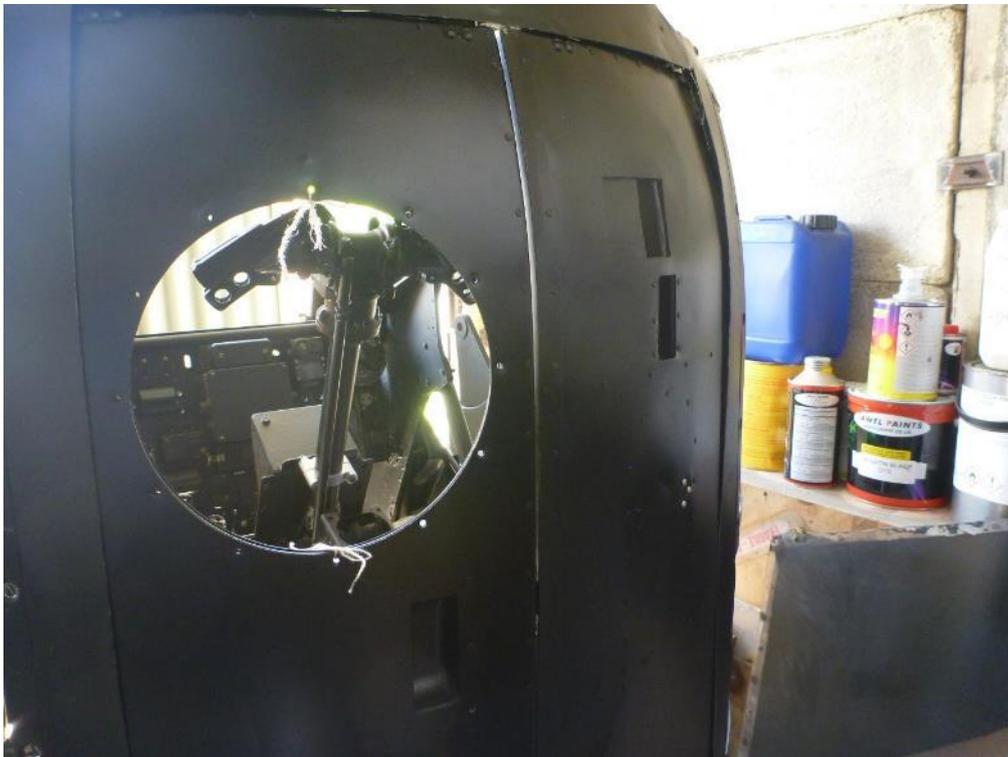
Once re-assembled the doors were sprayed and left to harden before being fitted to the frame and functionally checked. Seen below, the doors now just need their 'open', 'closed' and 'locked' markings re-applied – once I can find a set of ½” stencils.

Well, the plan for May was the cupola rear half and so that is where I started. There was a significant problem with the right hand door in that the locking mechanism was siezed solid and would not lock.

Because of this both doors were dismantled to gain access to the inner mechanism. With this done it was relatively easy to fix the latch and, before re-assembly, the void areas were treated with a wax based preservative to improve their long term corrosion resistance.

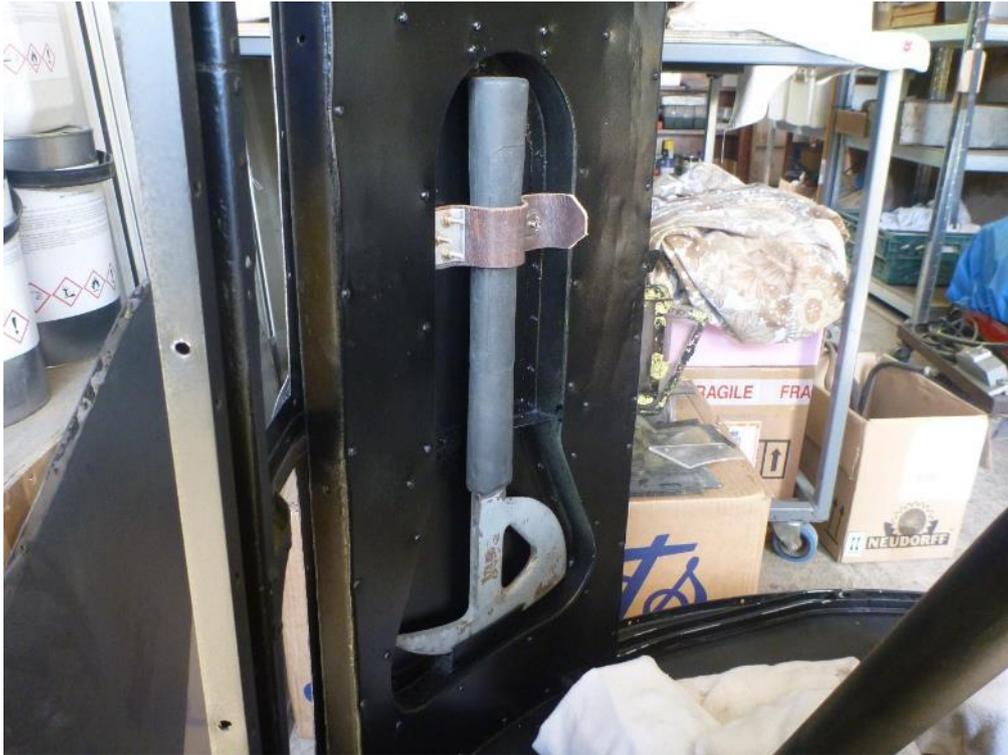
Seen below is the inside of the right hand door fitted and working, if a little stiff with all of the new paint.

The right hand door also houses the fire axe, which was treated to a new leather retaining strap and fastener as the original had suffered the dreaded leather red rot. Red rot is a curse for collectors of vintage flying gear or, indeed, anything made from tanned leather.

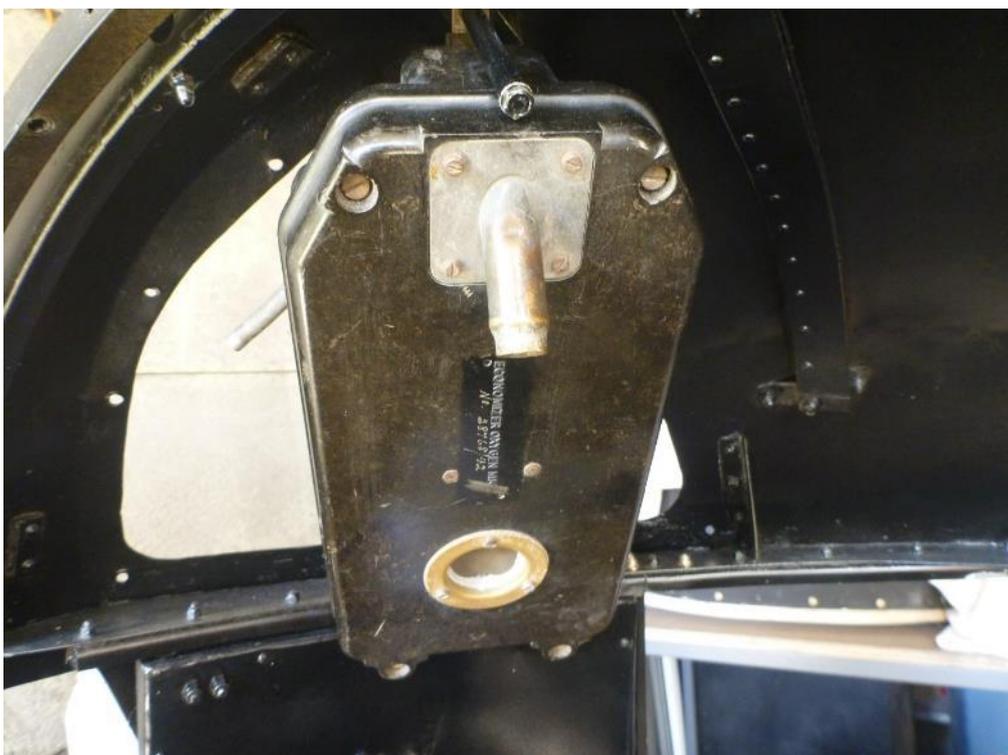
MOD ARM 971 repositioned the oxygen economiser into the cupola roof to get it out of the way of the gunner's feet. At some point this modification has been embodied, as the upper support bracket is present. The lower bracket has been subsequently lost (probably during a perspex change) but was easily reproduced as all mods have reasonable drawings. Seen below is the economiser in the post mod position. The economiser is from my FN5.

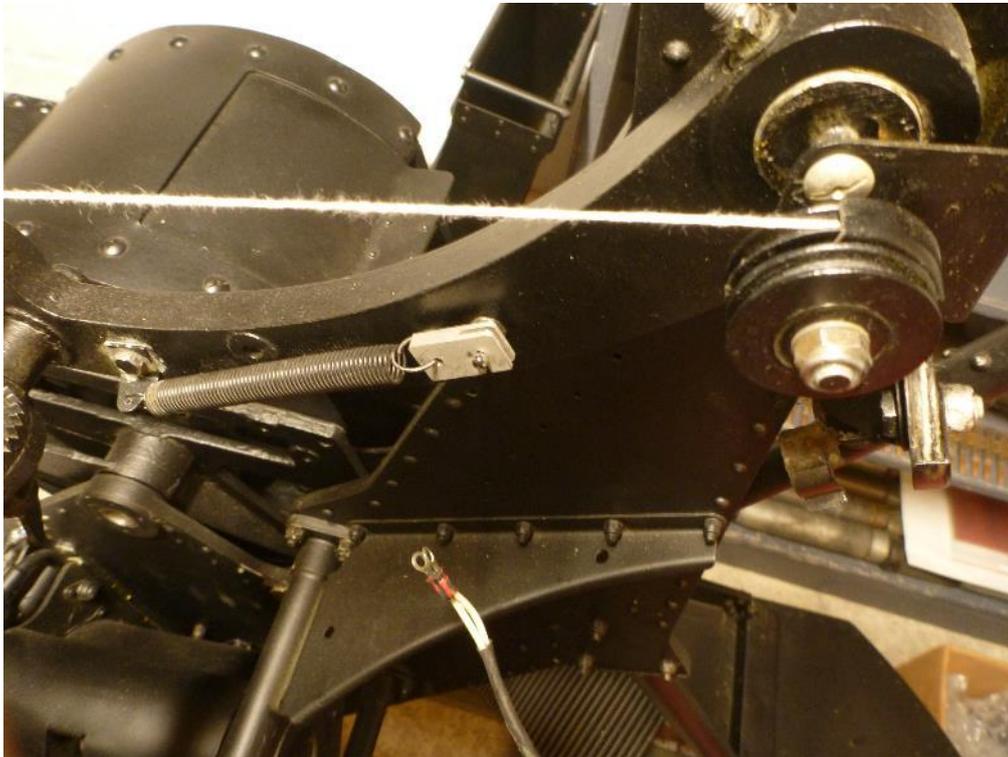
Another partially embodied modification is MOD ARM 896. This mod introduced a spring loaded anchorage for the range control cable when the gun sight is removed. Again the missing parts could be made from the drawings in the mod and the complete mod can be seen below. When used, the cable to the sight (a string at the moment) comes back around the spare pulley and attaches to the spring loaded adaptor.

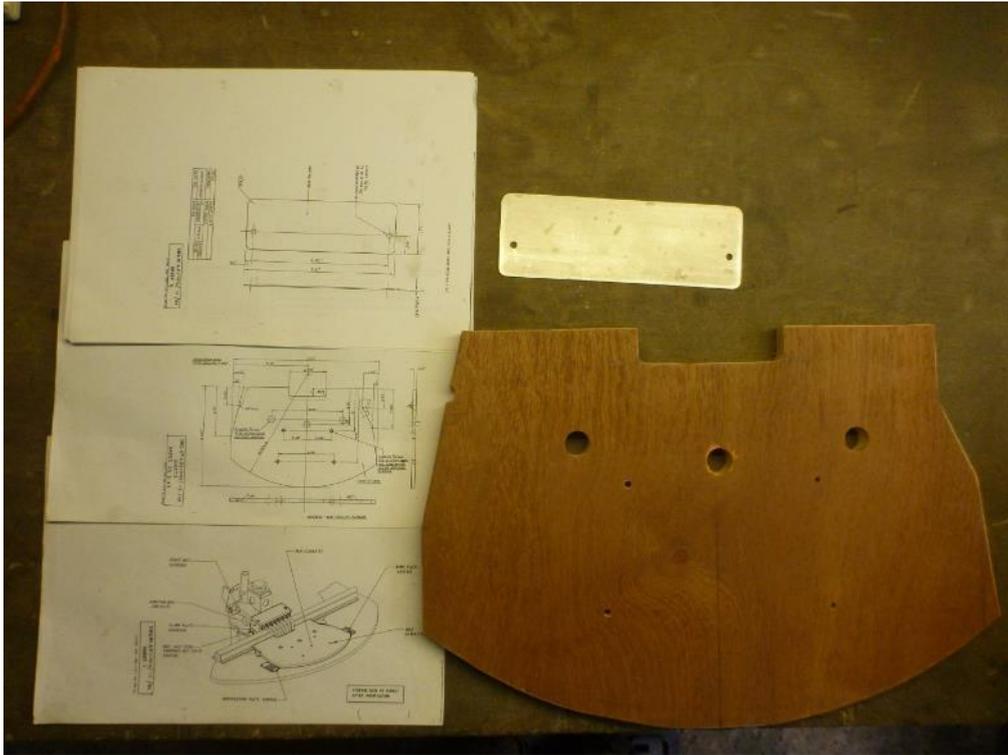
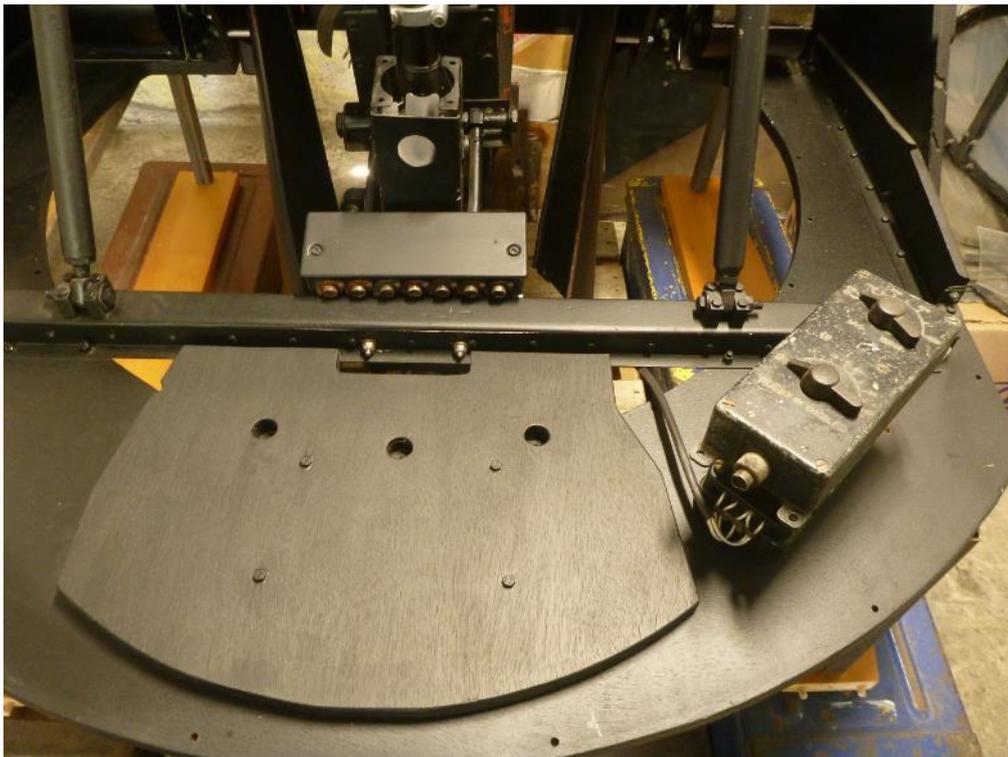
Another modification that may well be of use to us is MOD ARM 969 and may explain the lack of a seat in the aircraft turret. This mod removed the complex, adjustable seat, moved the GGS junction box and fitted a simple plywood seat. The idea behind this was to allow the gunner to sit on a pilot's type parachute which (in my view) is a very good idea.

I decided to embody this mod first on the display turret and, armed with the mod leaflet drawings, soon produced the clamp plate and seat that are needed. The GGS junction box and seat could then be bolted into place, as seen below.

The mod also requires that the turret data plate and modification plate are re-positioned, however, they are both missing.

Also visible in the image above is the height and airspeed controller. This should sit on a pair of post MOD ARM 1035 brackets, which are missing. Hopefully, these are currently being re-manufactured at East Kirkby.

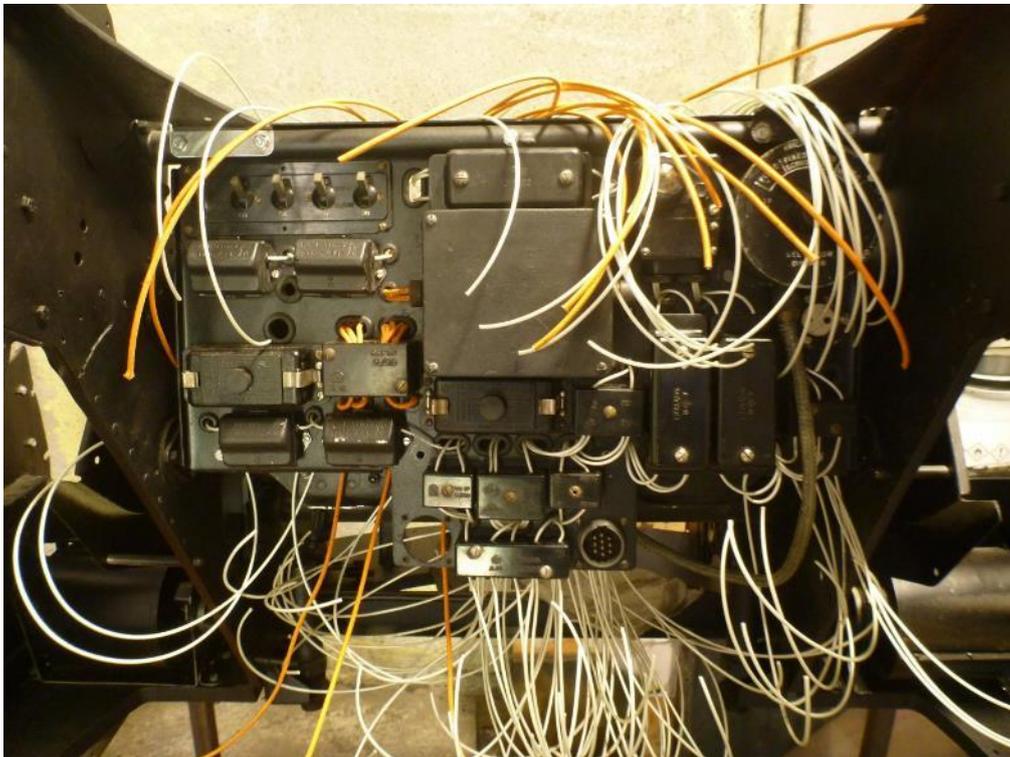
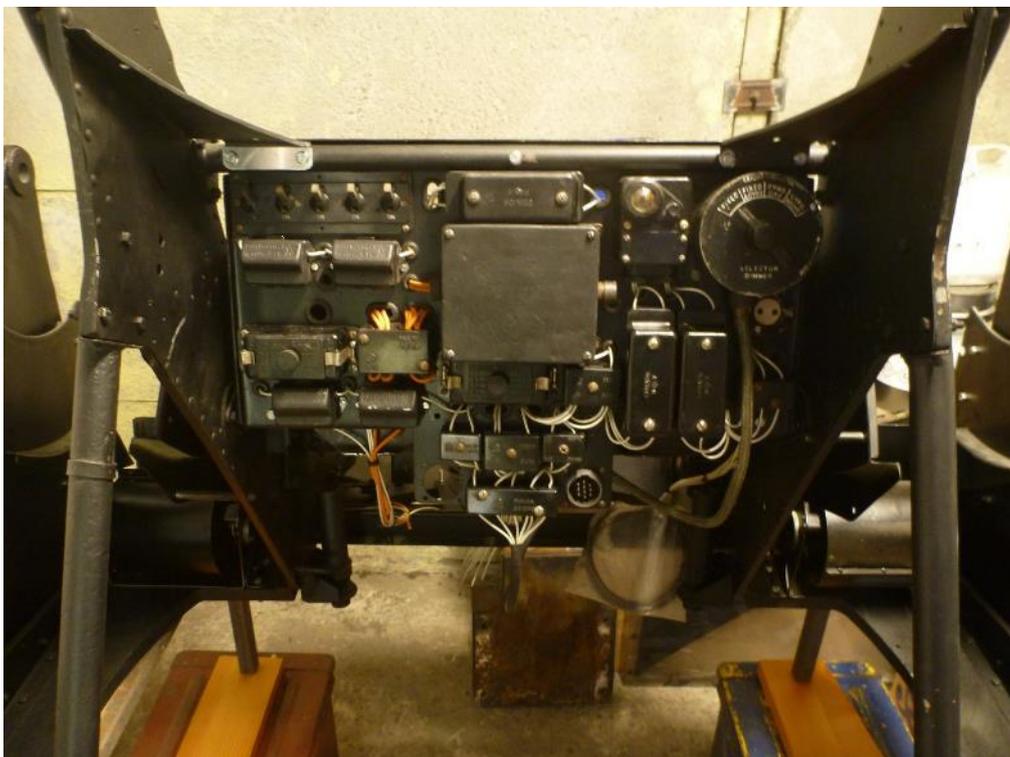
With '611's turret awaiting spares, attention shifted to the display FN82 Series 2. The control panel was re-sprayed and rebuilt using just the components indicated in the Air Publications. As can be seen, the panel on the series 2 is a great deal more complex than on the series 1. Wires were only attached where they would be visible from the front (about 1/3 of the total), but it still looked very busy until they were all tucked away, as seen below.

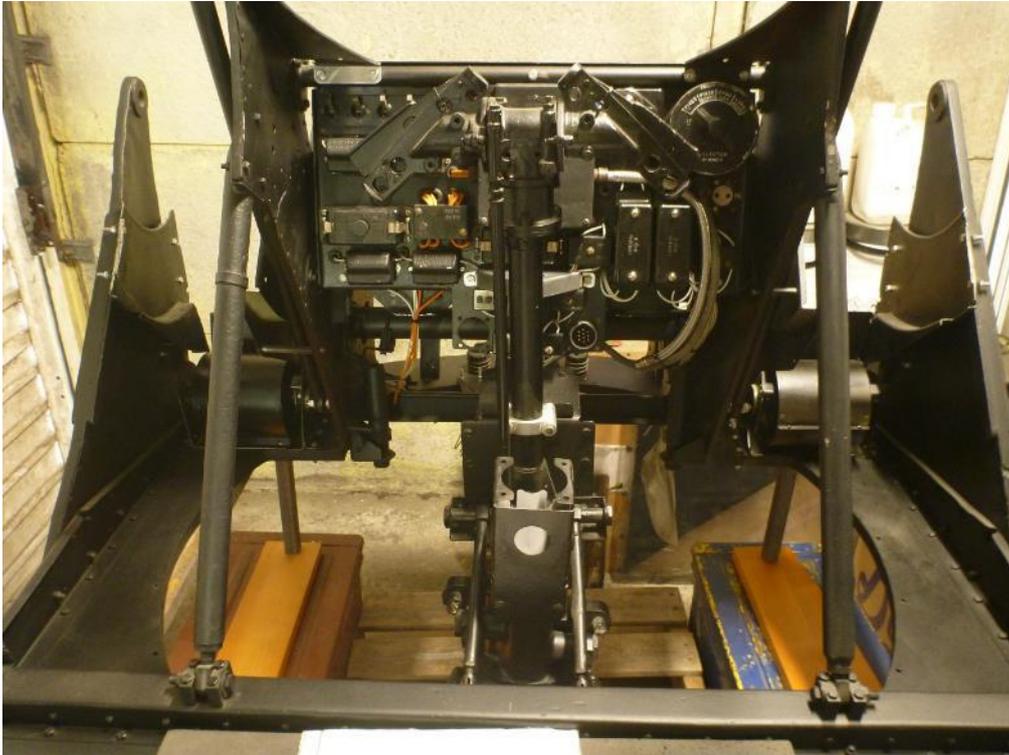
With the panel done, it was all too tempting to position the turret control unit and produce the missing and damaged attachment brackets.

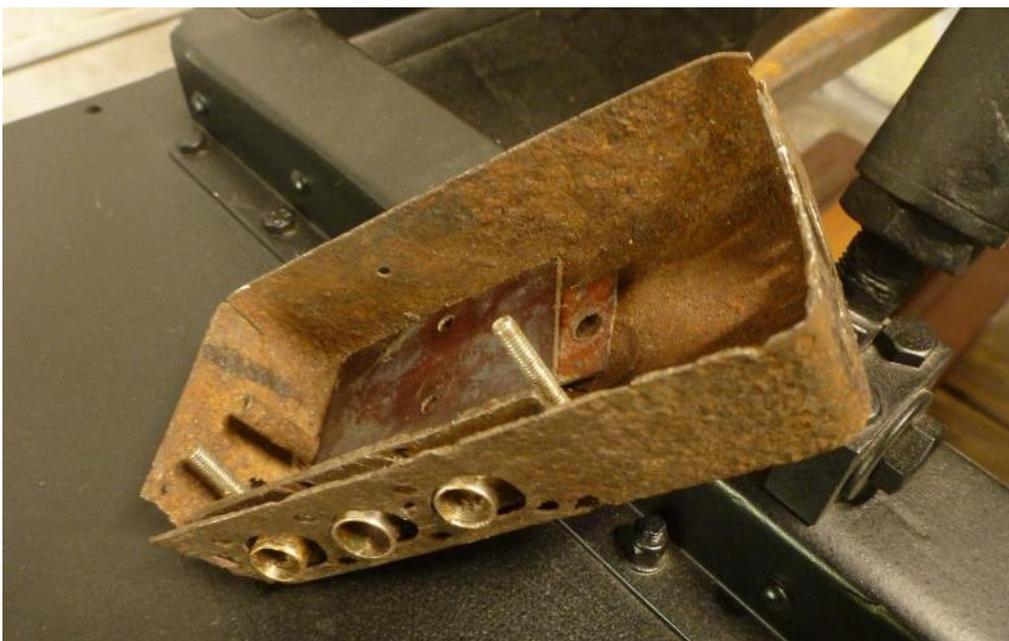
The final component of the control system is the junction box (special) which, in reality, is little more than a junction box with a switch. Seen below is the better of the two that we have and obviously needed some work.

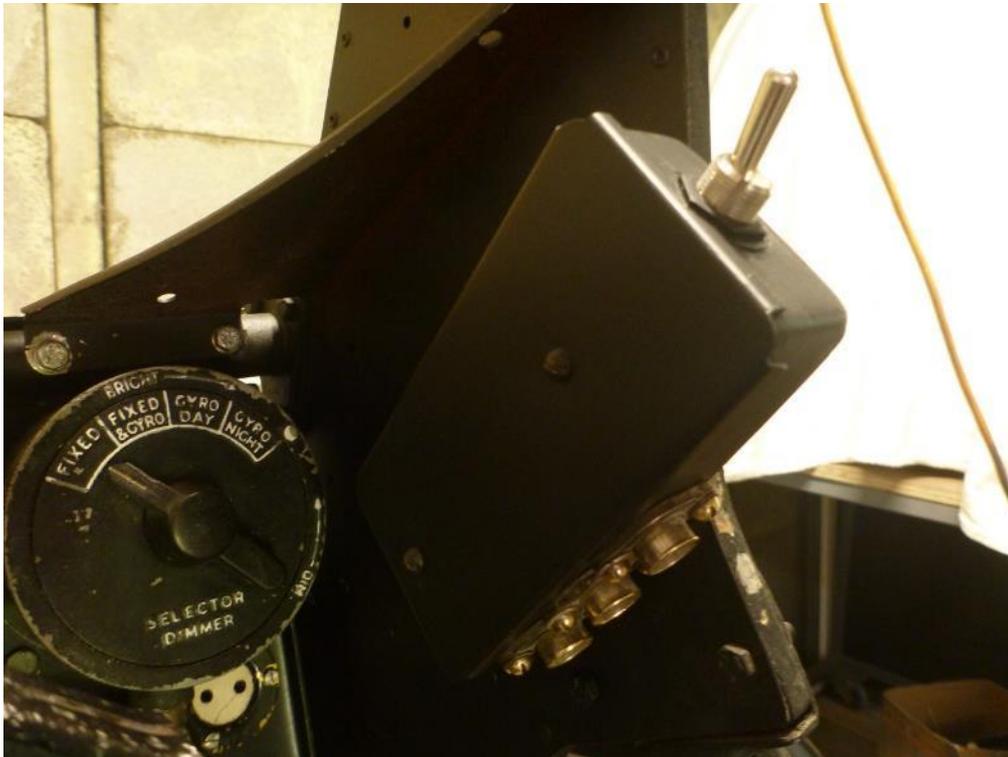
The end result looks reasonable, but there is a fair amount of filler in this one. We currently don't have one of these units that is good enough for '611's turret, but it will be simple enough to fit at any time in the future.

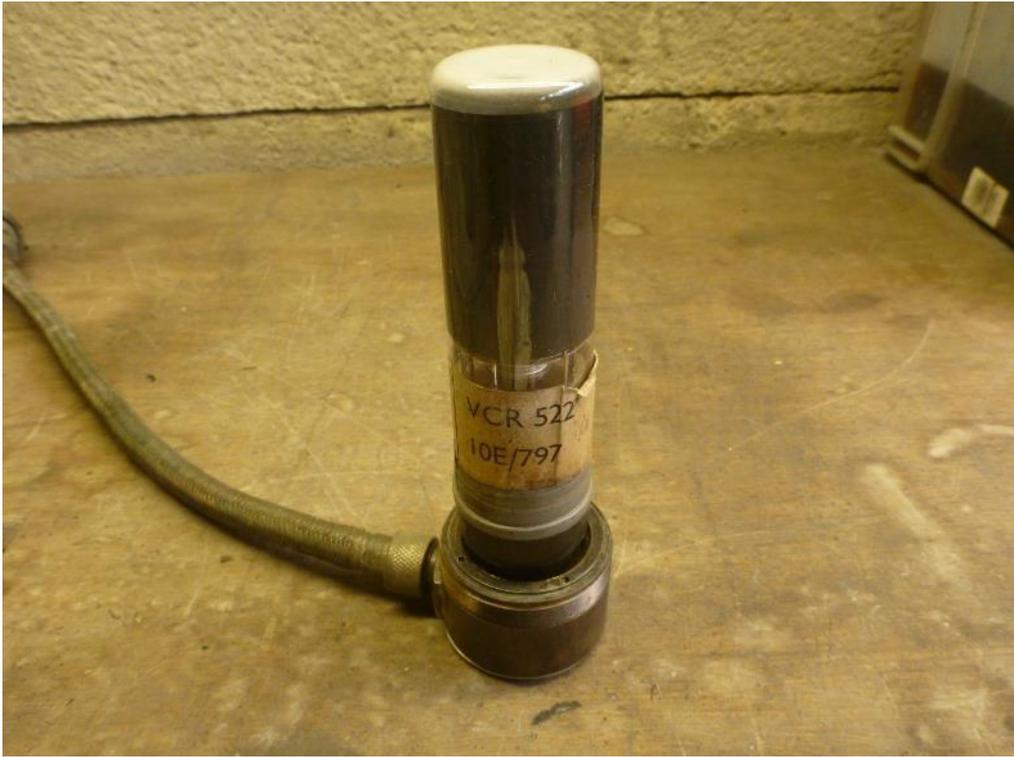
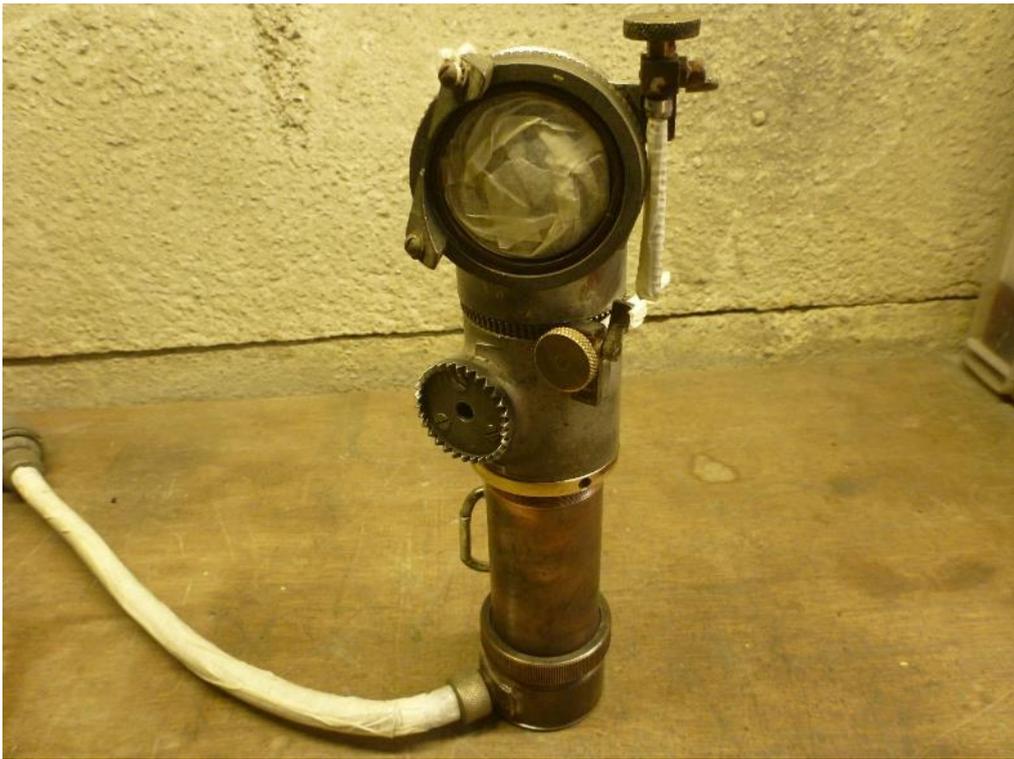
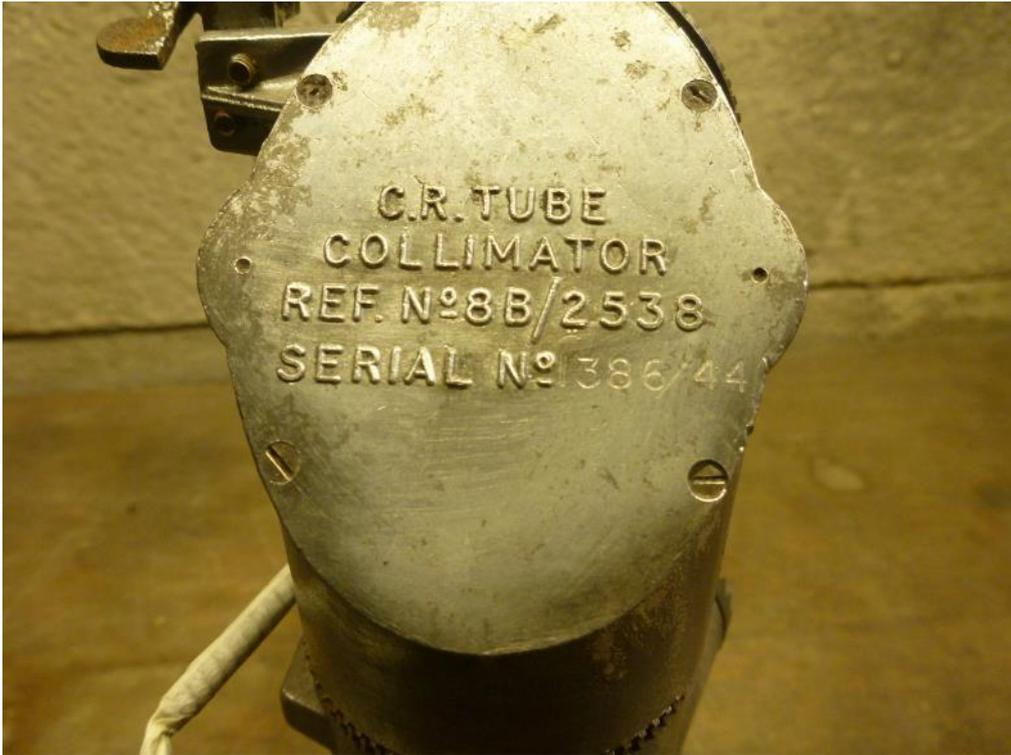
That done, interest moved on to the CRT collimator which I believe to be exclusive to the radar controlled rear turrets. I was quite surprised to see that the cathode ray tube was still in it and appeared to be in perfect condition.

The outside of the collimator was not so good and this seemed a good time to take it back to bare metal and start again. It now just needs priming and painting before going onto the sight rail. The collimator sits beside the usual gyro gun sight which, at the moment, we do not have for this turret.

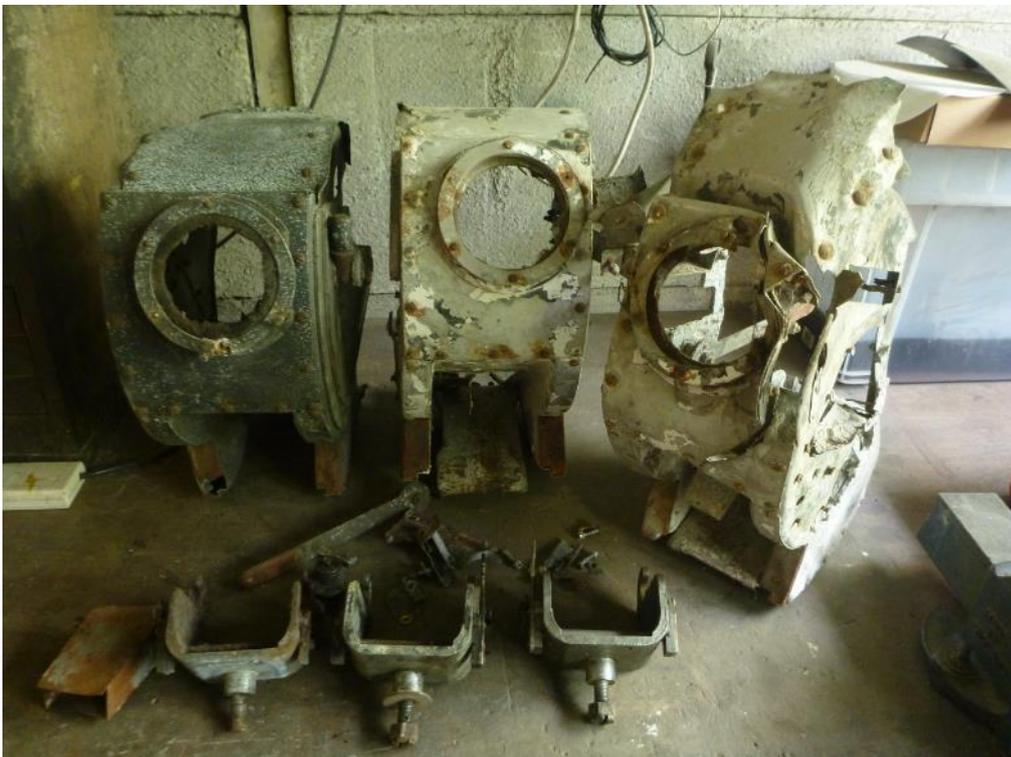
Amongst the jobs for June are the gun cradles for the display turret. As can be seen, these are in relic condition and of the three available the best two are the same (right hand) side – shame that.
