FN82 update September 2022

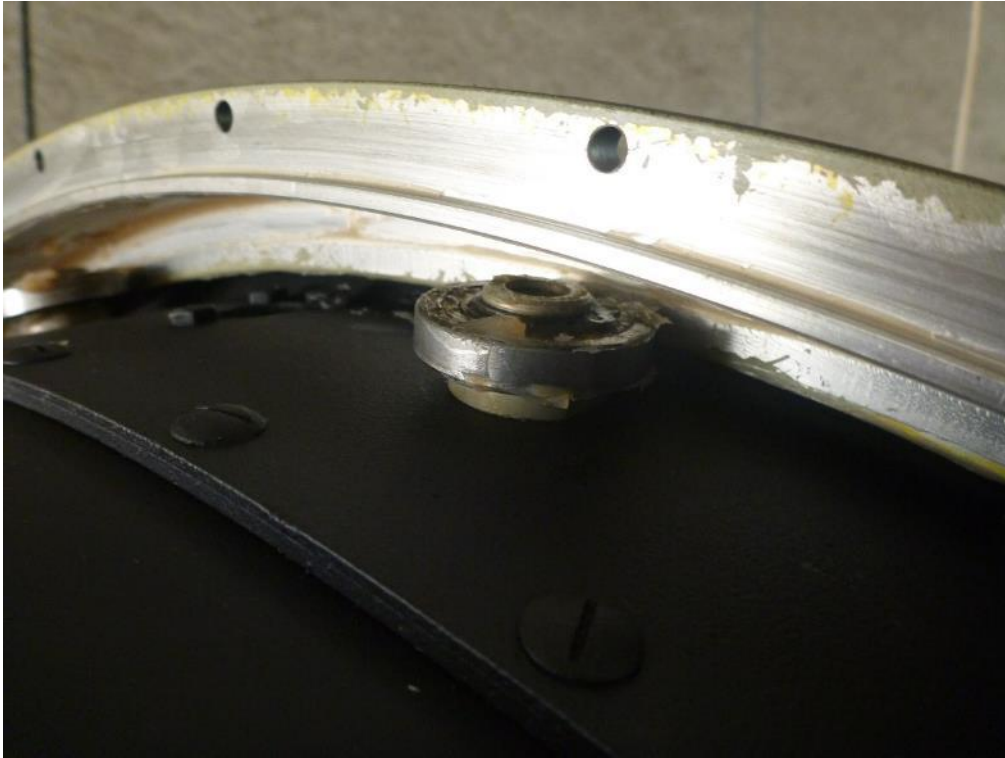
With the arrival of the replacement upper, fixed turret ring it became possible to begin the build of the turret rings. Firstly, the outer surfaces were sprayed with wash, primer and matt black and then the bearing surfaces coated with grease. The remaining surface, seen below with the holes in it, was left untreated in preparation for being bolted up with jointing compound. Given the problems encountered in obtaining this part every effort was made to reduce the risk of corrosion on this one.

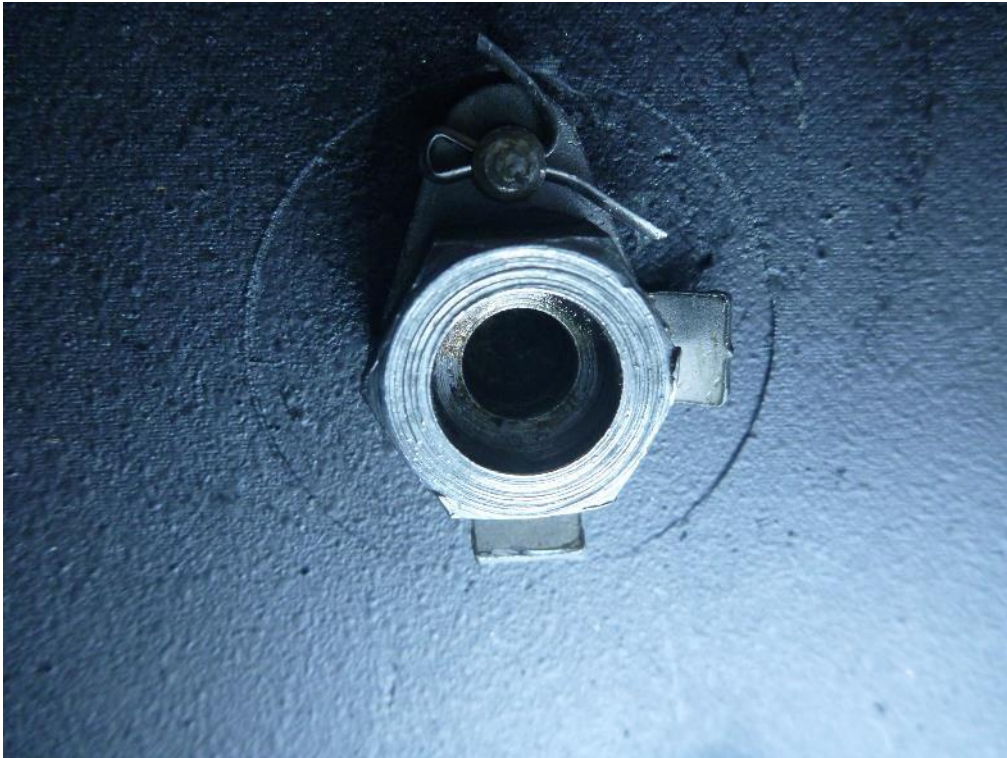
The vertical rollers, pictured above, are held in position with a special nut. This nut is locked with a tab washer that is held in place by a small pin and split pin. The small pin also serves to stop the bearing mount rotating whilst the special nut is tightened. Actually, quite cunning. The set-up is shown below, but with the tab washer not fully locked at this point.

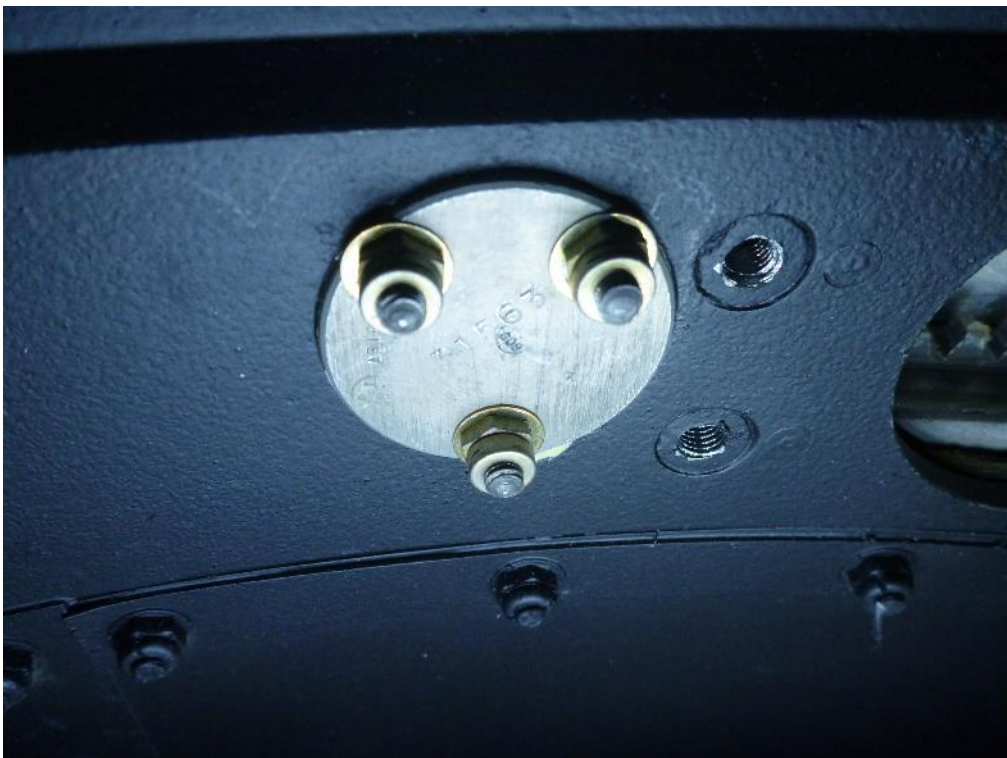
The horizontal rollers are then fitted onto their studs and secured. This removes any lateral movement within the rings.

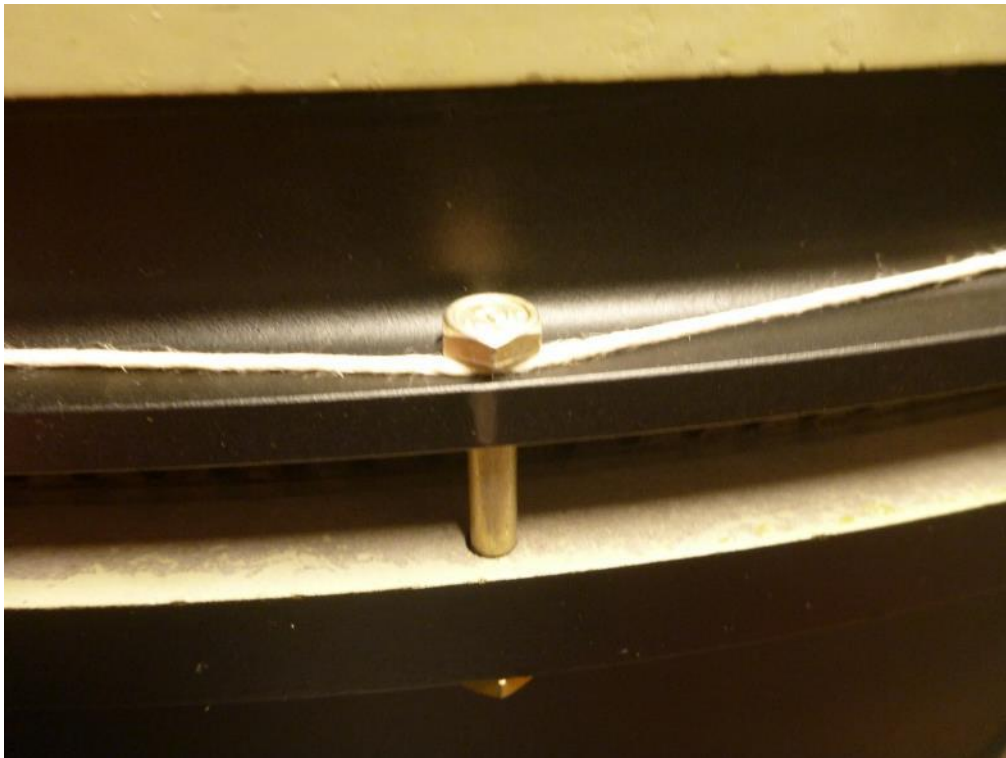
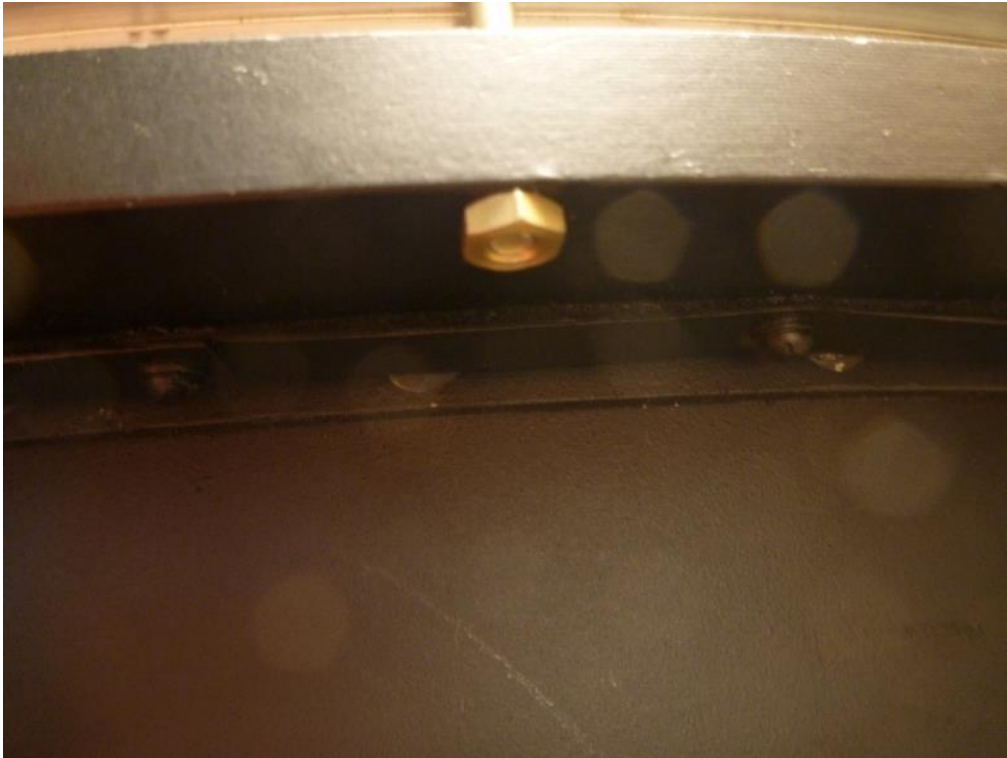
Before continuing, it's a good idea to fit the bolts that will secure the turret to the airframe. Although the AP2799Q says there should be fifteen of these there are actually fourteen and, to complicate matters further, there are sixteen holes in the airframe mount. The extra two holes are actually alignment holes that engage with two special bolts on the turret stops.

A tight string serves to keep these in place until they can be temporarily secured using a plain nut. With the rings wedged apart, jointing compound can be applied into the gap and the process of bolting together the rings can begin.

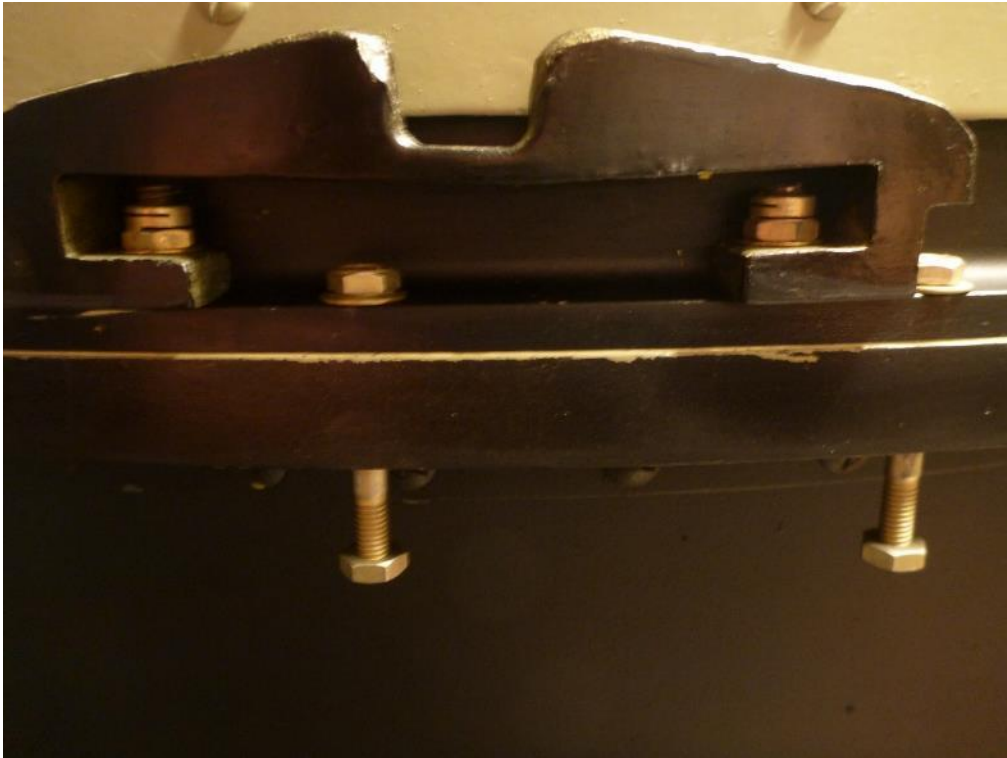
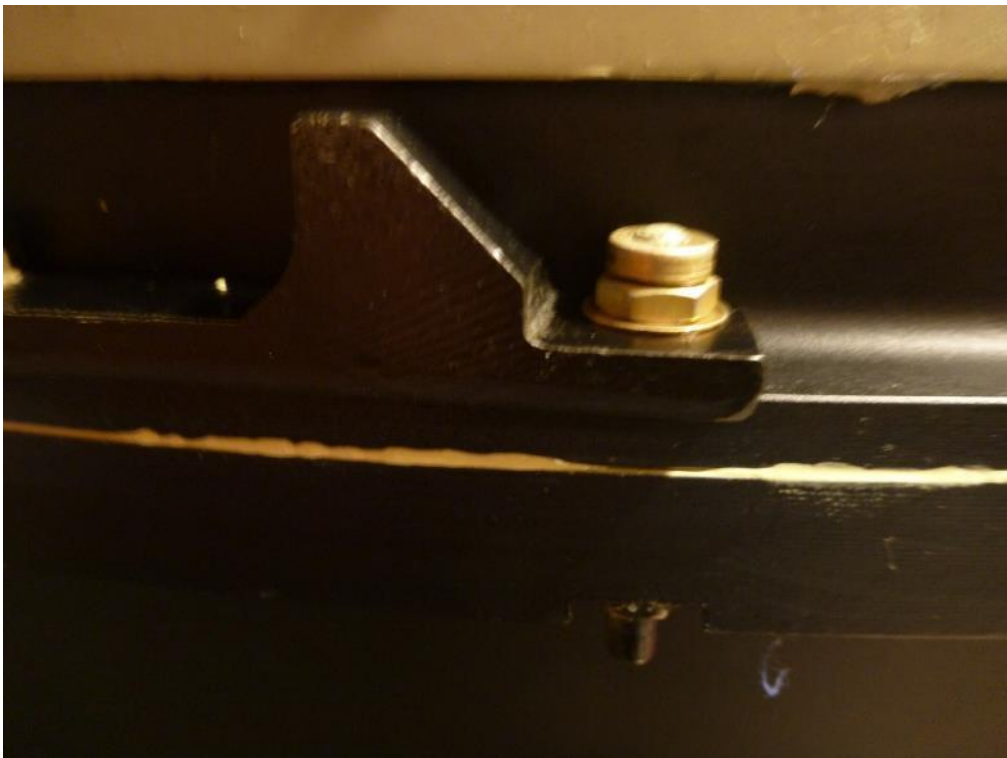
This particular turret has five fittings that also go in at this point, although the AP2799Q only mentions three of them. In general, the rings are held together with countersunk head bolts, with the heads at the bottom – some of these bolts also secure fittings. The fittings include the turret lock and traversing stops (below).

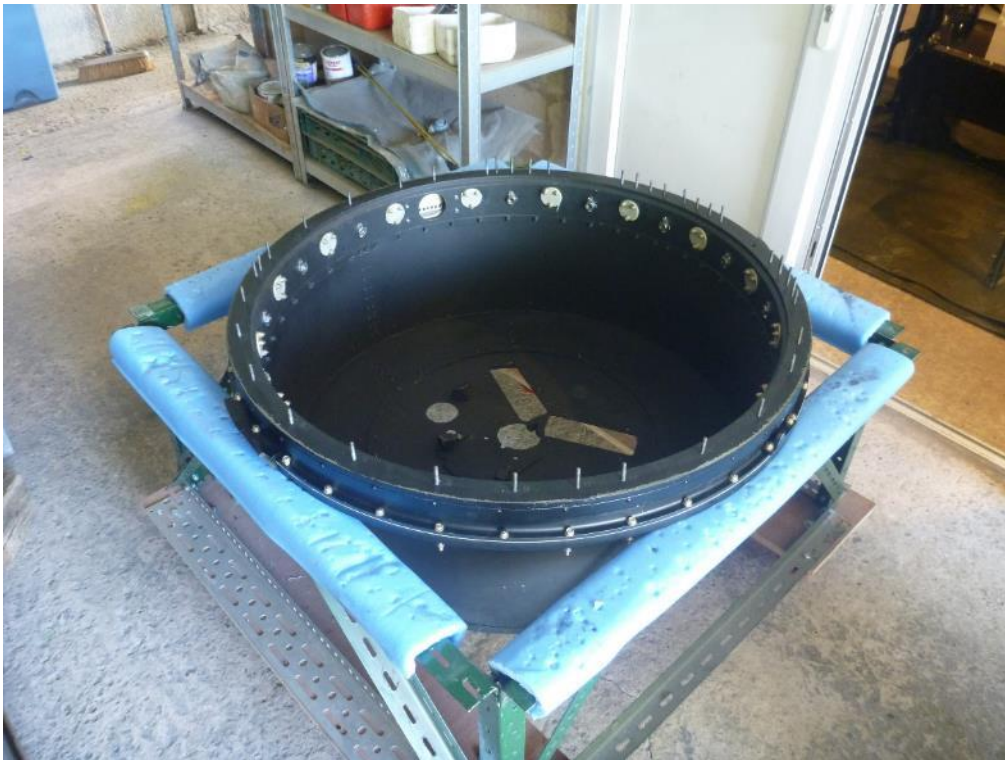
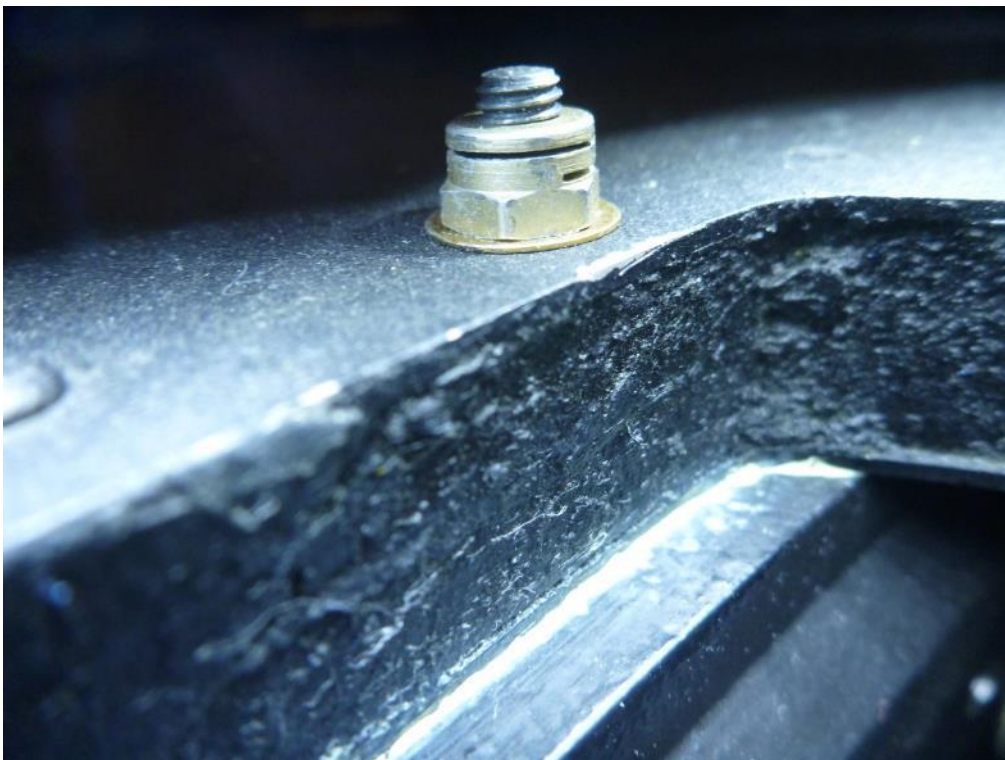
Once bolted up the turret rings, drum and floor assembly could be re-fitted to the stand. It is now possible to fit the accommodation plate to the rotating ring and find out if the three lengths of bolt went into the correct places. Pictured below is the assembly so far with the special bolts protruding and how a correctly positioned bolt should look.

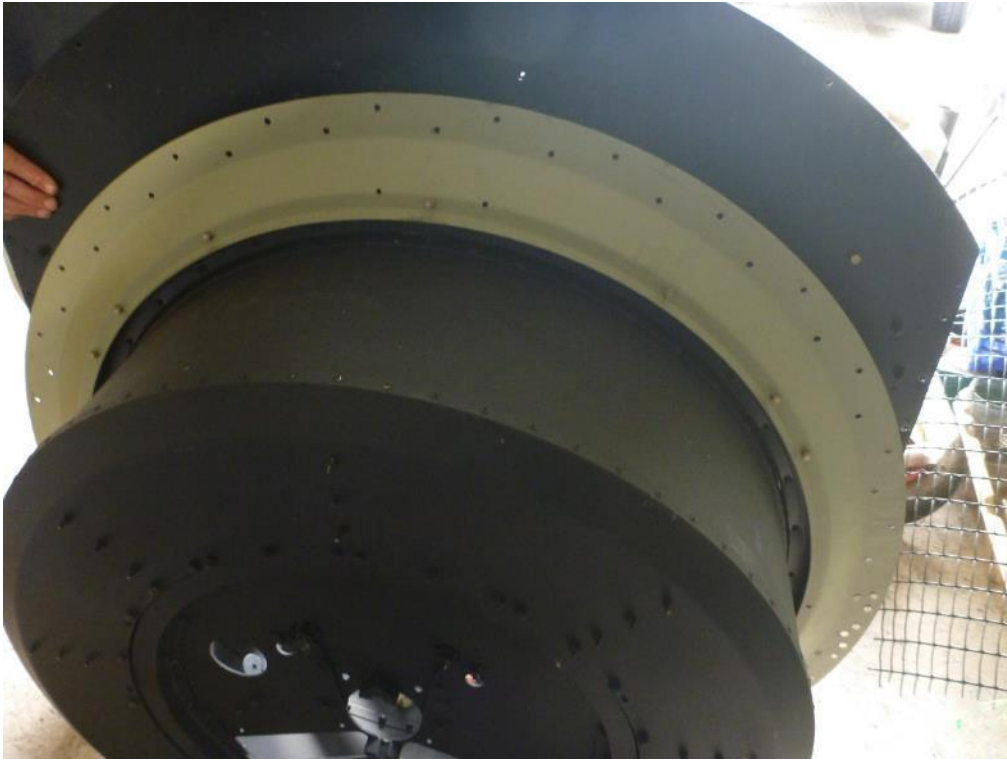
With this done it was possible to try the fit of the turret rings, drum and floor to an original Lancaster rear turret mounting plate. All was in order and assuming the mounting plate fitted to 'Jane is the same there should be no problems fitting the turret.

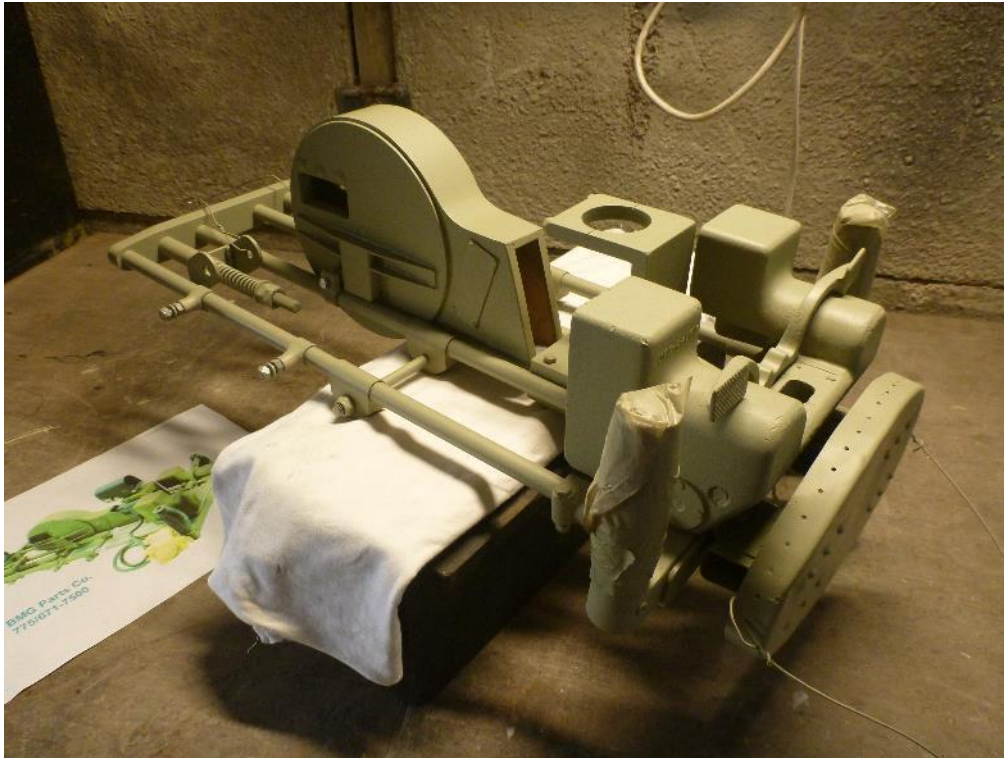
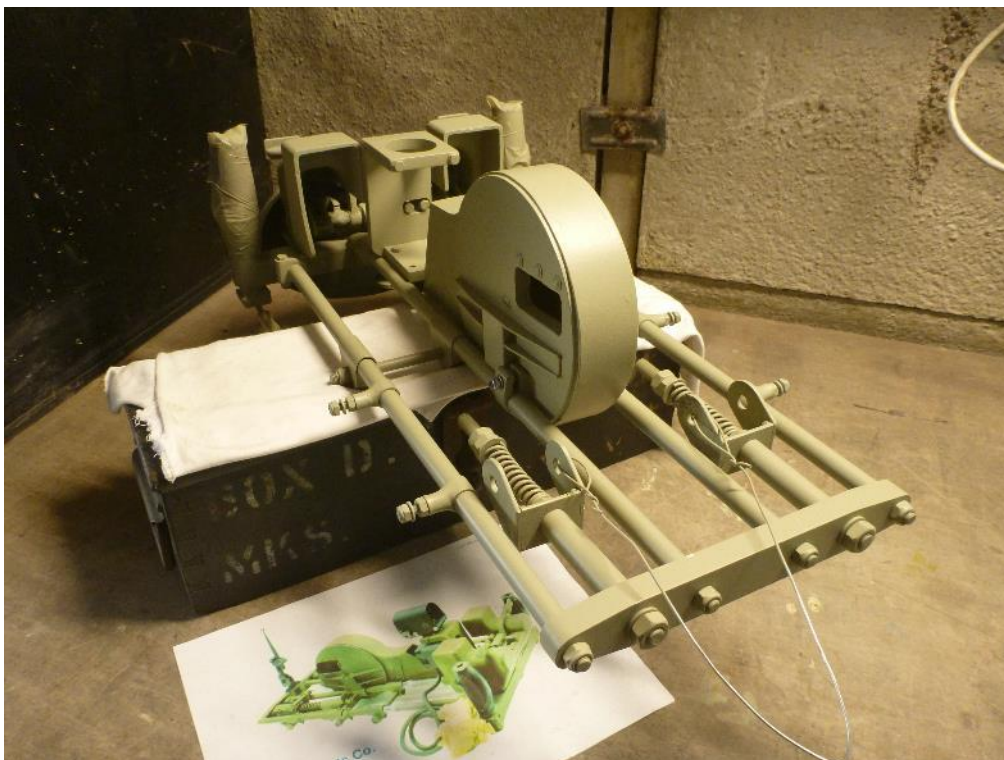
Meanwhile, for a bit of light entertainment, the Dauntless rear gunner's mount was progressed. There was a fair bit of re-manufacturing required here and then the whole thing was sprayed with some left-over primer. The next job for this is to apply the grey finish and bolt the two guns in, after that it just needs to find a display home.
