### FN82 update January 2023

The last update ended with just a couple of modifications to embody and the cupola to go on. Most of this work got done in a final push to complete the turret by Christmas.

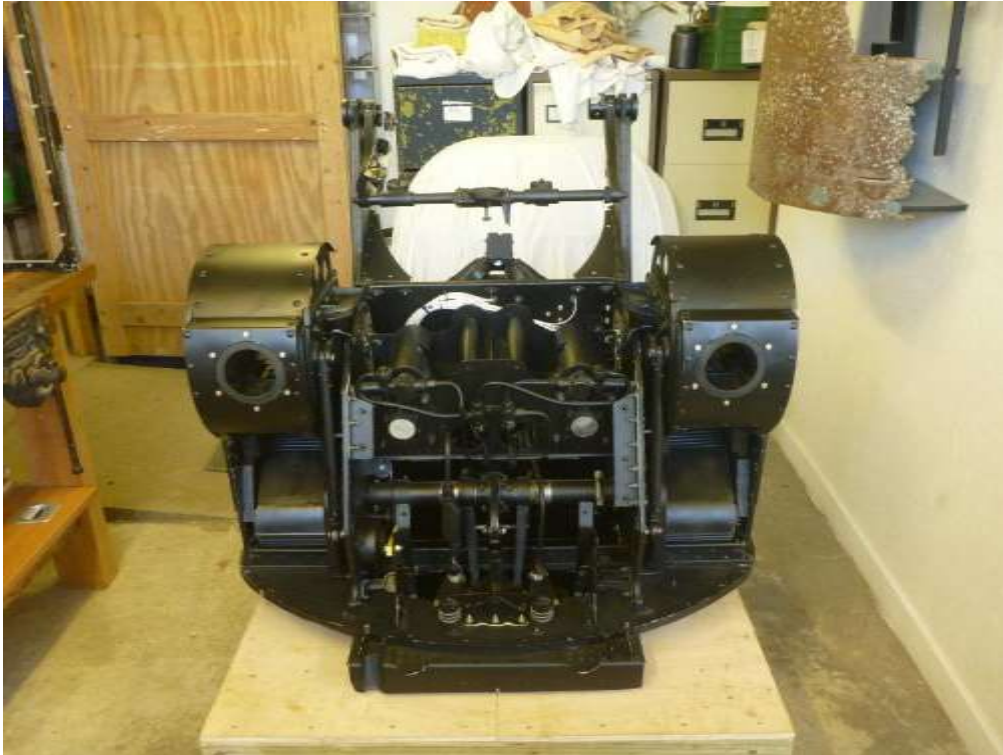
Seen below is the completed turret before the cupola is fitted. This was a good, and probably final, chance to give it a good clean out and dusting.

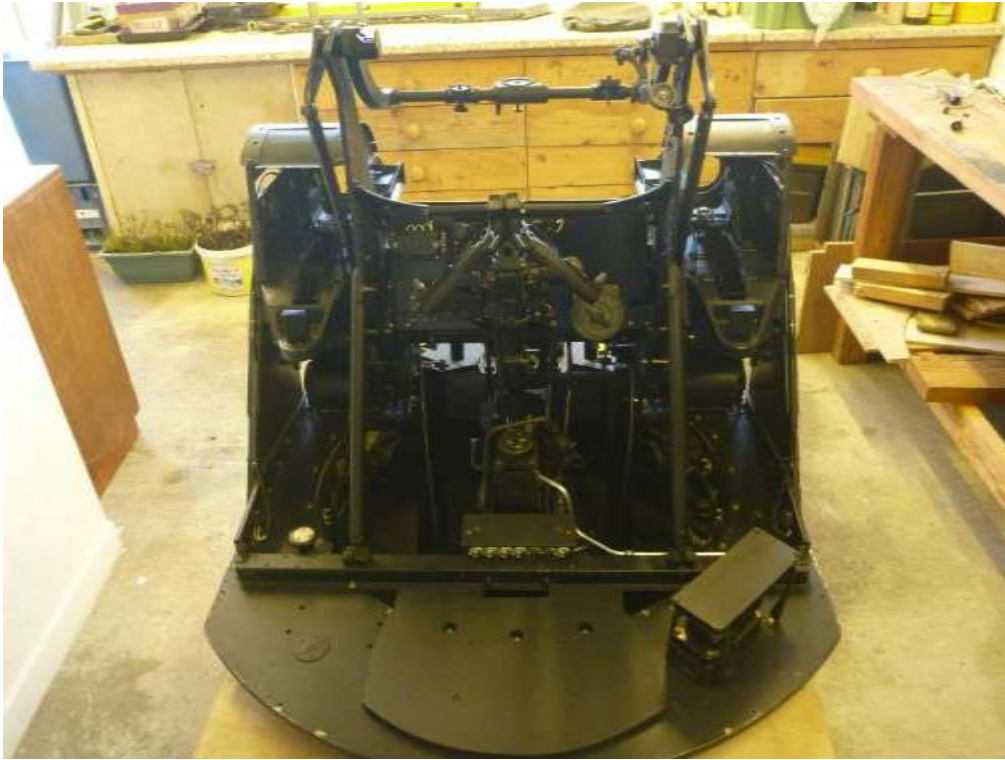
The view from the rear shows the oxygen pipe heading off towards the economiser which is now located in the top rear of the cupola, behind the gunner's head. Also visible is the later standard of seat which allows the gunner to sit on a 'pilot's type' parachute. This seems like a very good idea as it removes the need to reach into the aircraft to retrieve your parachute before bailing out. This modification also moves the Gyro Gun Sight (GGS) junction box to just in front of the seat.

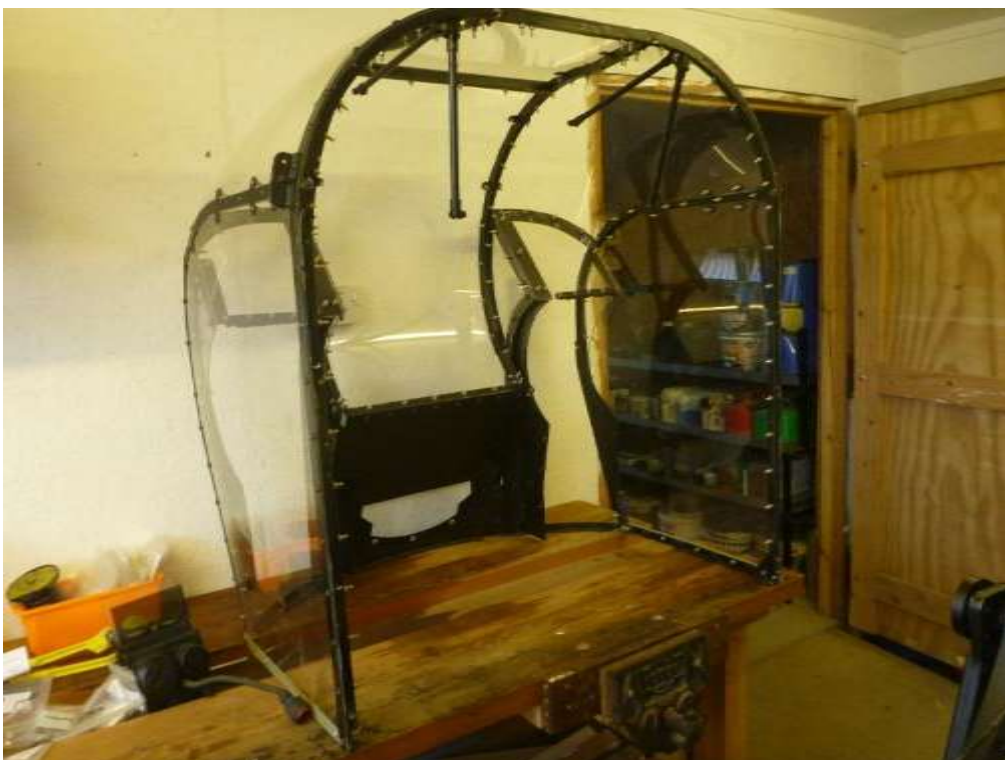
Below is the cupola front half, waiting to be wrestled back onto the turret. Always a nerve wracking moment as it doesn't take a great deal of effort to crack these Perspex panels.

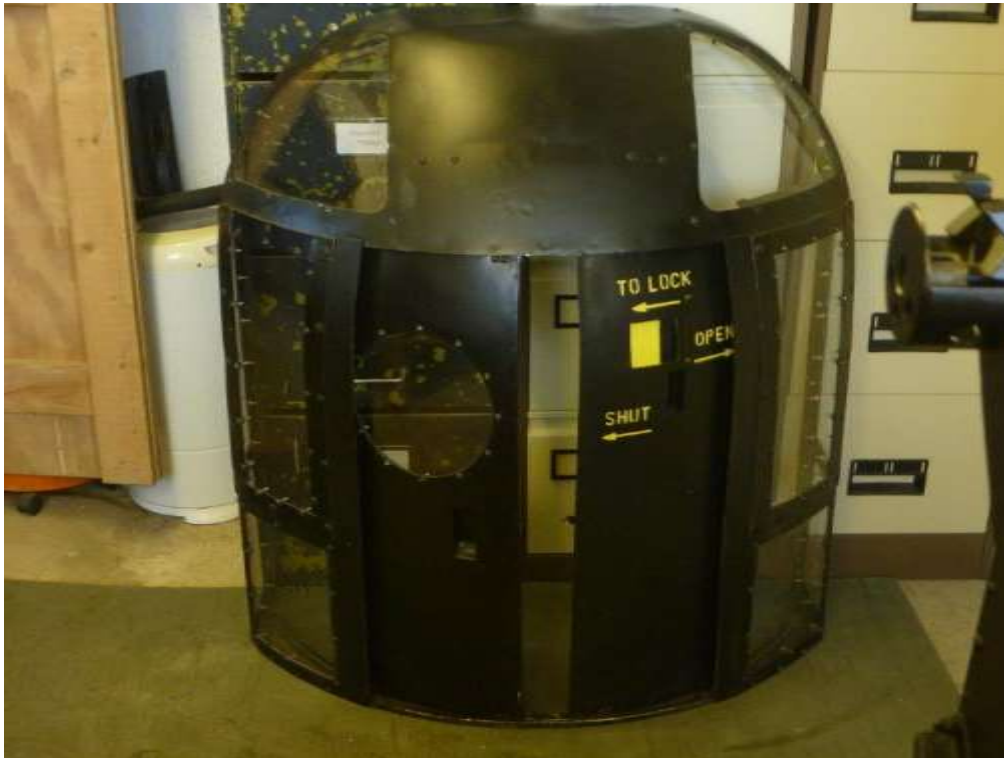
The cupola rear half goes on last. This has now had the door markings applied.

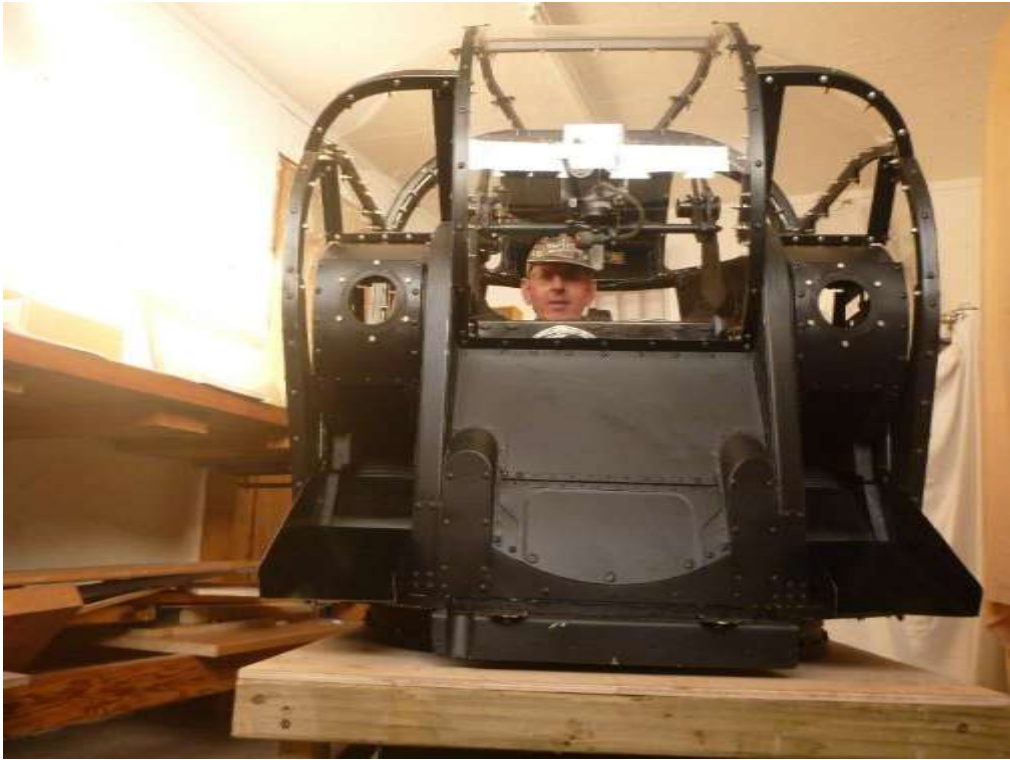
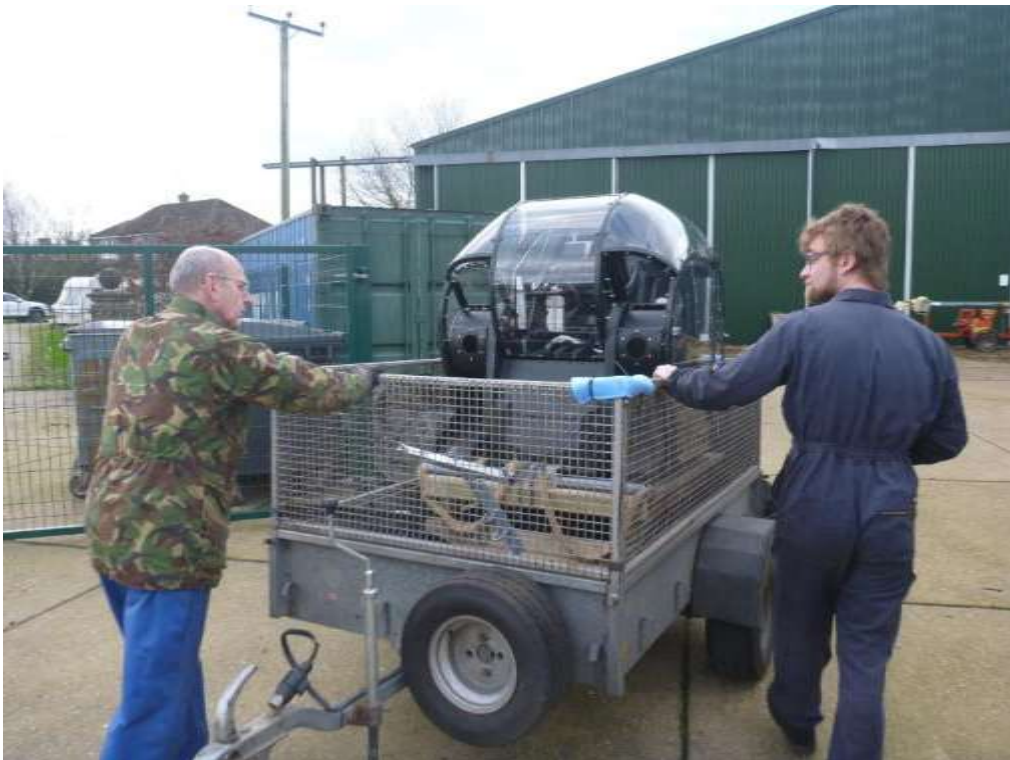
The completed turret cleaned and polished and ready to go back to East Kirkby. From start to finish this turret took 1119 hours to restore, with the vast majority having been done during various Covid lock-downs.

All that was now needed was a still, dry day to trail it back to the hangar and so it was that in January it finally got back.

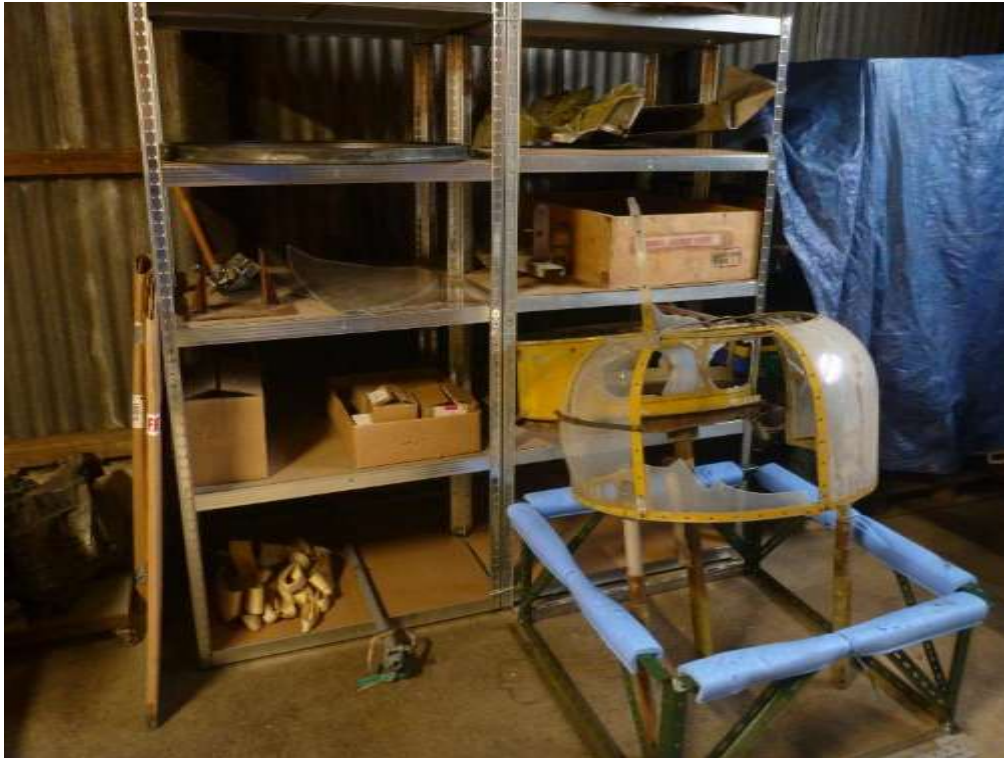
Already lined up in the workshop are some of the Blenheim turret parts. There are parts of three turrets available and (I think) the plan is to build one for display and one for the Blenheim project. There is also the small matter of a very tired looking FN20 in the display hall that could use some work. Maybe watch this space?
