FN-150 Turret update January 2020

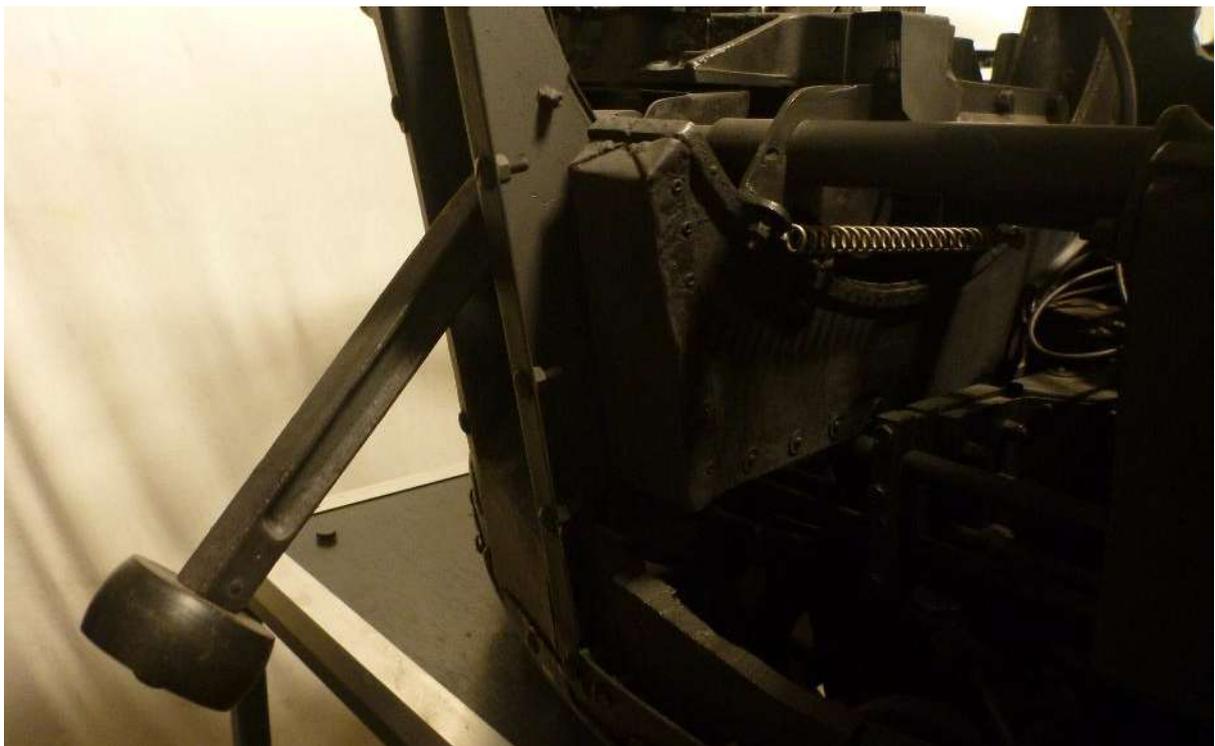
With these in place it was possible to build up the transverse shaft. This shaft carries the two levers with the rollers as well as another with a return spring and a fourth with return spring and Bowden cable mounting. After a fair bit of trial and error, the relative positions of these four levers was worked out and they could all be secured.

I managed to obtain sketches and patterns from the ever helpful Colin Waterworth and then started creating the missing parts. Firstly, two brackets were produced to do the job of the missing castings on the gun cradles. These were secured using the gun mount bolts to avoid drilling any further holes in the cradles.

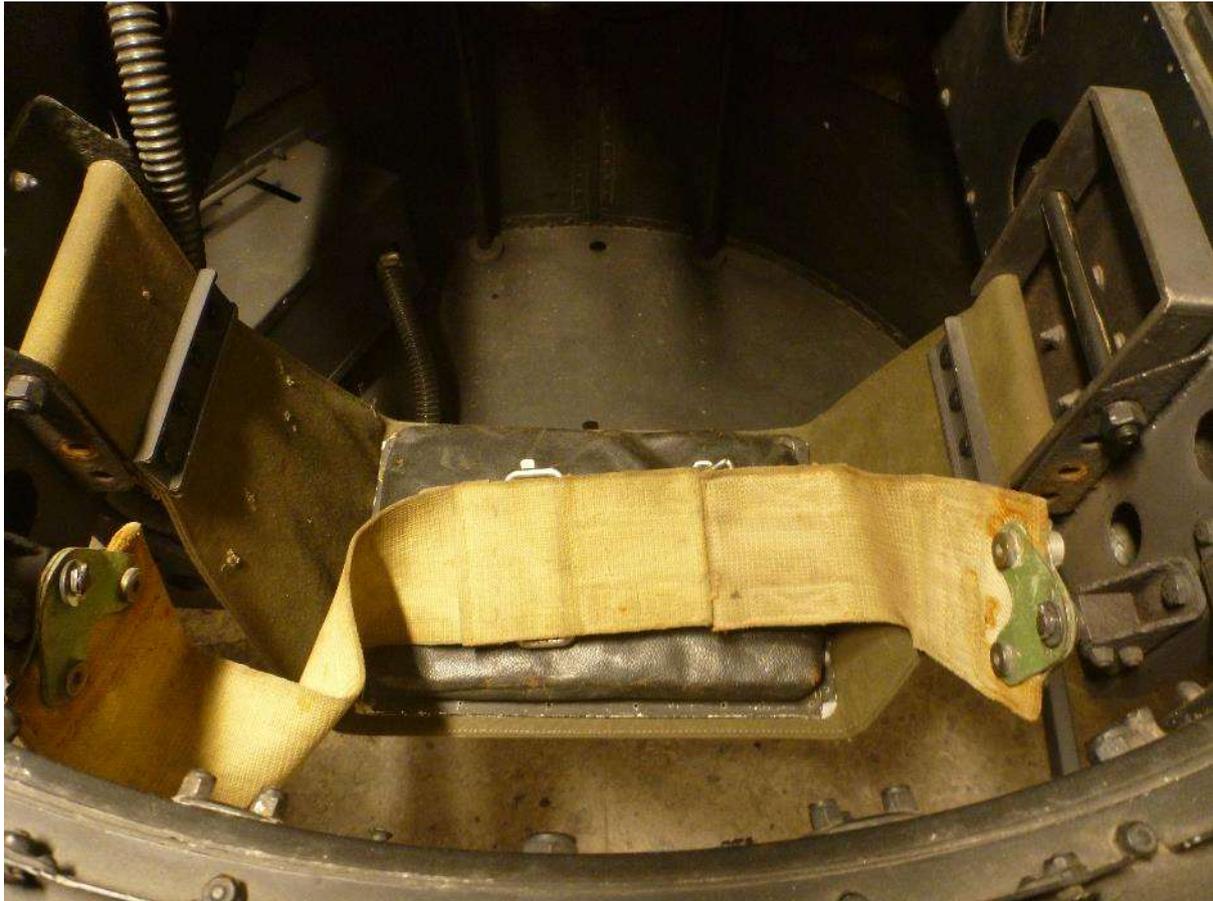
There was little to go on for the seat assembly either, but in this case I went to the schematic drawing in the various Air Publications. The right side detachable mount was fabricated from steel, whilst the seat "sling" was sewn up from an old RAF sausage bag. With the whole seat bolted in it was tried for size, adjusted a bit and then finally fitted.

Then in went the seat belt mountings and, after a good scrub down, the actual seat belt. I have to admit at this point that only now do I realise why all vintage flying jackets are so badly torn. It is virtually impossible to enter or leave the turret without getting caught on something – and that's with it firmly on the ground.

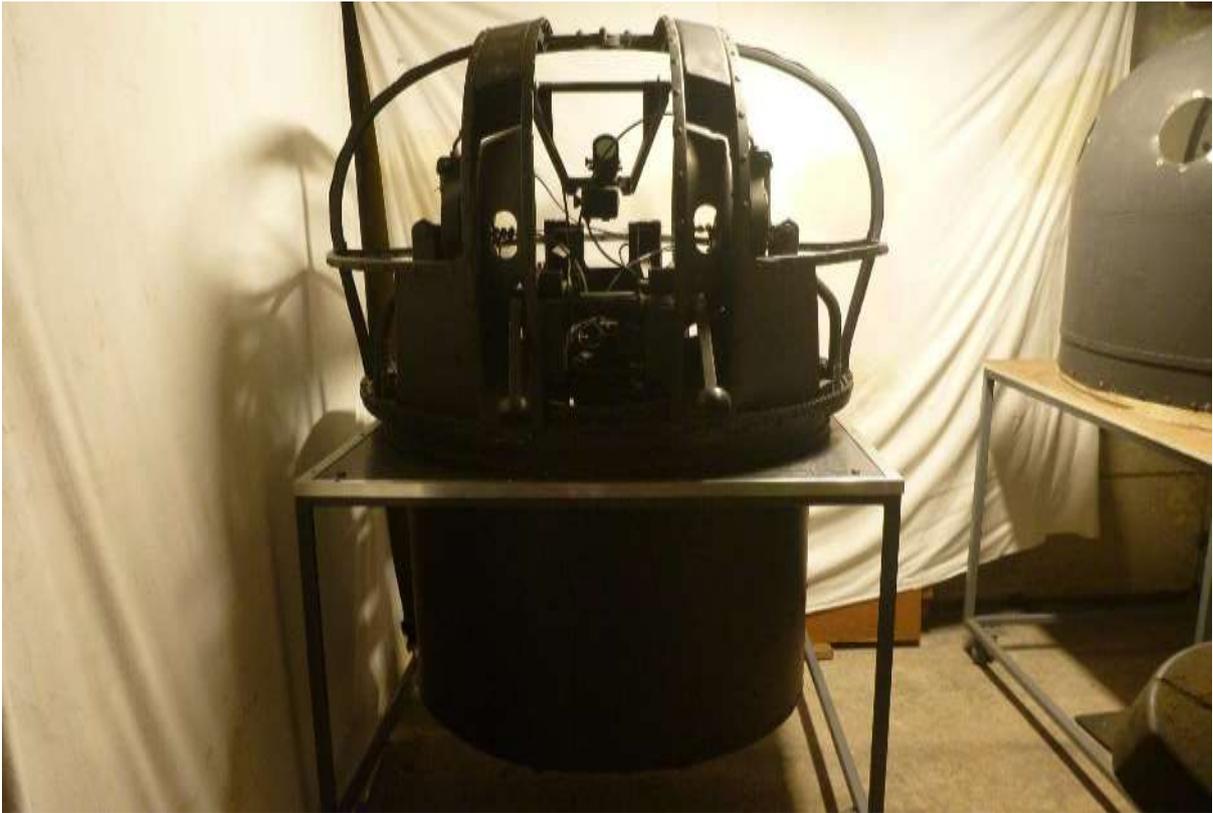
Above; a more or less complete FN-150 turret, which looks a fair bit different from the start of the project (below). 648 hours of work separate these two images.

Finally, it was time to lower the height of the stand. I had built this deliberately high to make access easier whilst the restoration was going on. With virtually all the work now done, it was time to get it to a better height for viewing by the average person. Taking 30cm off the legs left the turret at a point where it is now easier to look inside and, with care, spot the mistakes!
