FN-150 Turret update June-July 2019

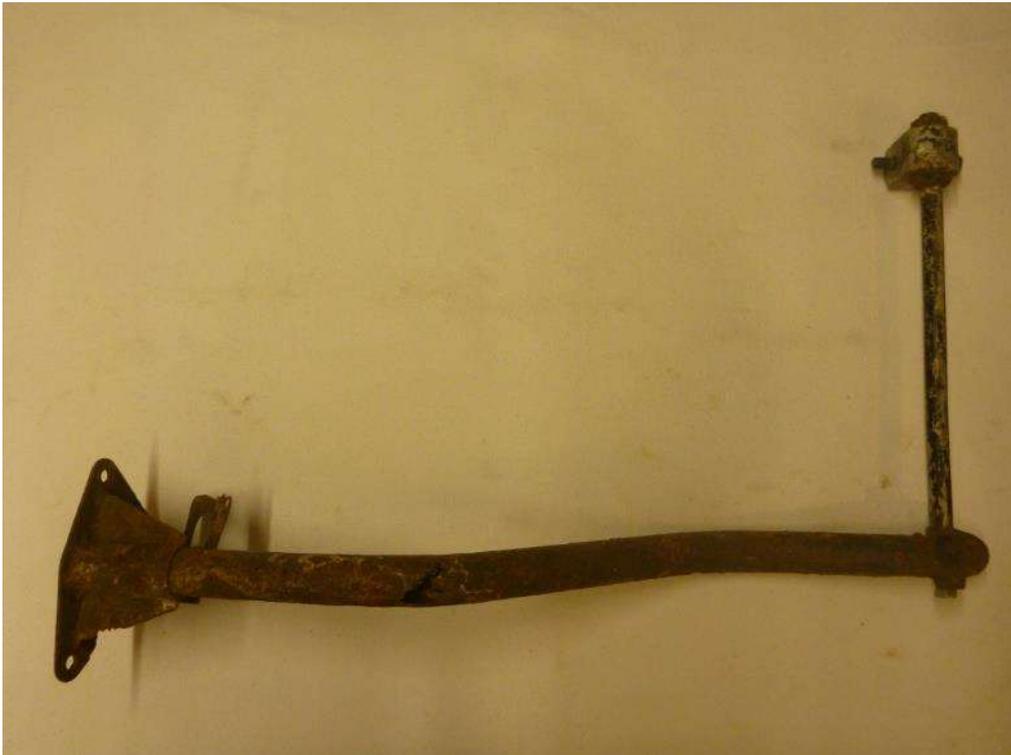
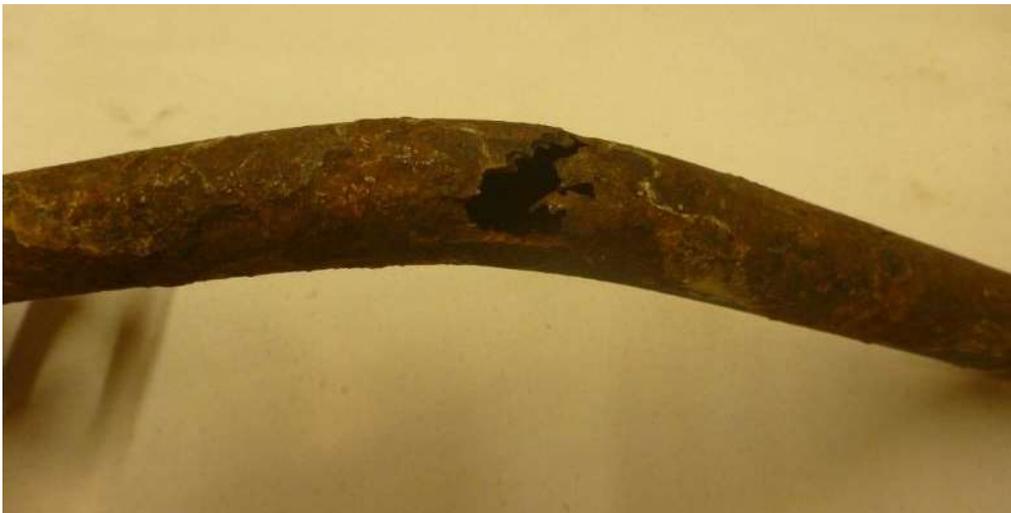
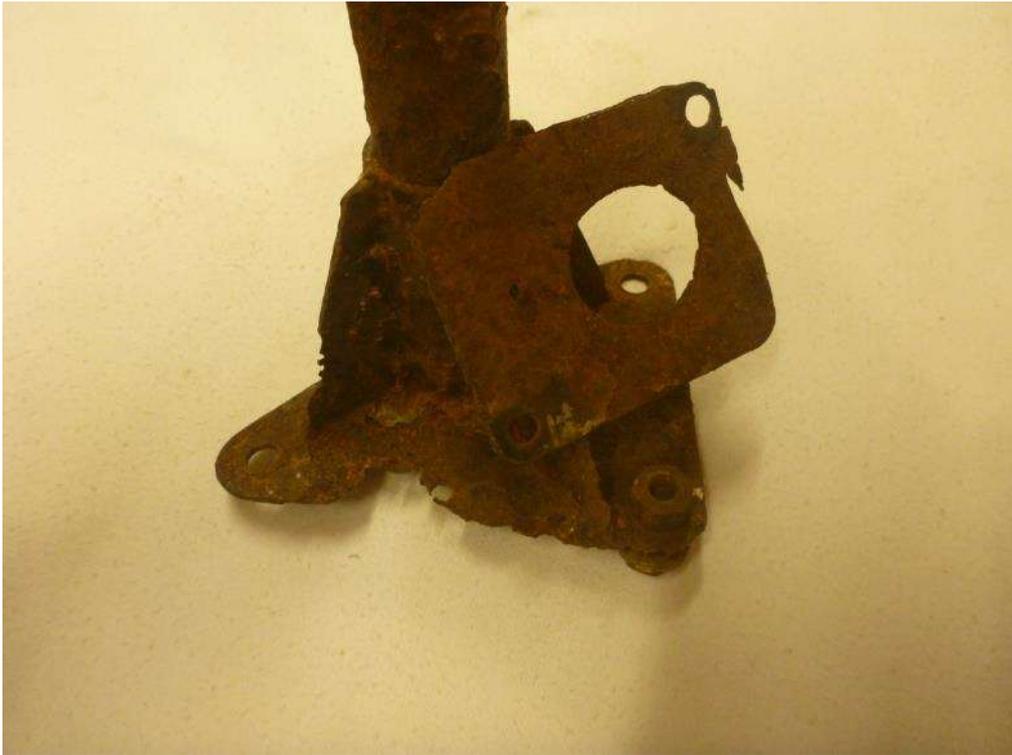
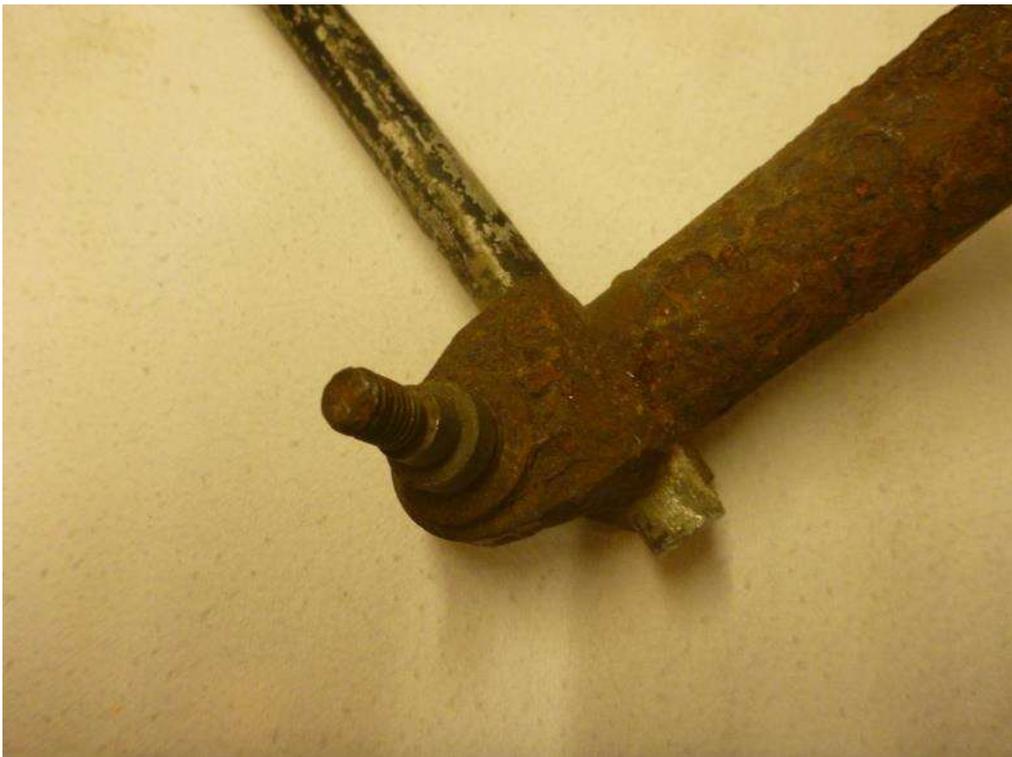
These were not in the best condition to put it mildly, but there is a lot you can do with a MIG welder and abrasive wheel. These support tubes are an important part of the FN-150 as they not only support the side frames, but also provide the mounting points for the gun sight radius arm, the oxygen indicator and a two pin power socket.

The rust soon gave up the fight and there was a small amount of welding to do to get these supports back into action. Once done it was a relatively simple task to bolt them to the turret ring and side frames.

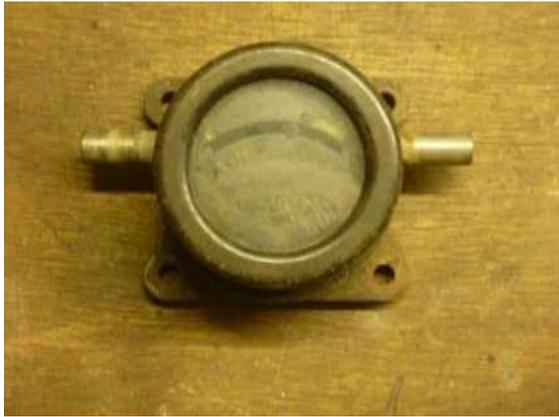
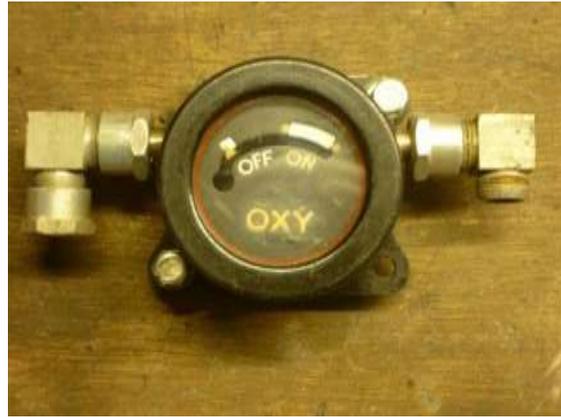
The oxygen indicator that was in the box of bits was distinctly worse for wear and, being an old luminous instrument, I opted not to dismantle it. I managed to obtain an example in better condition with the added bonus that it had most of the pipe connections still fitted.

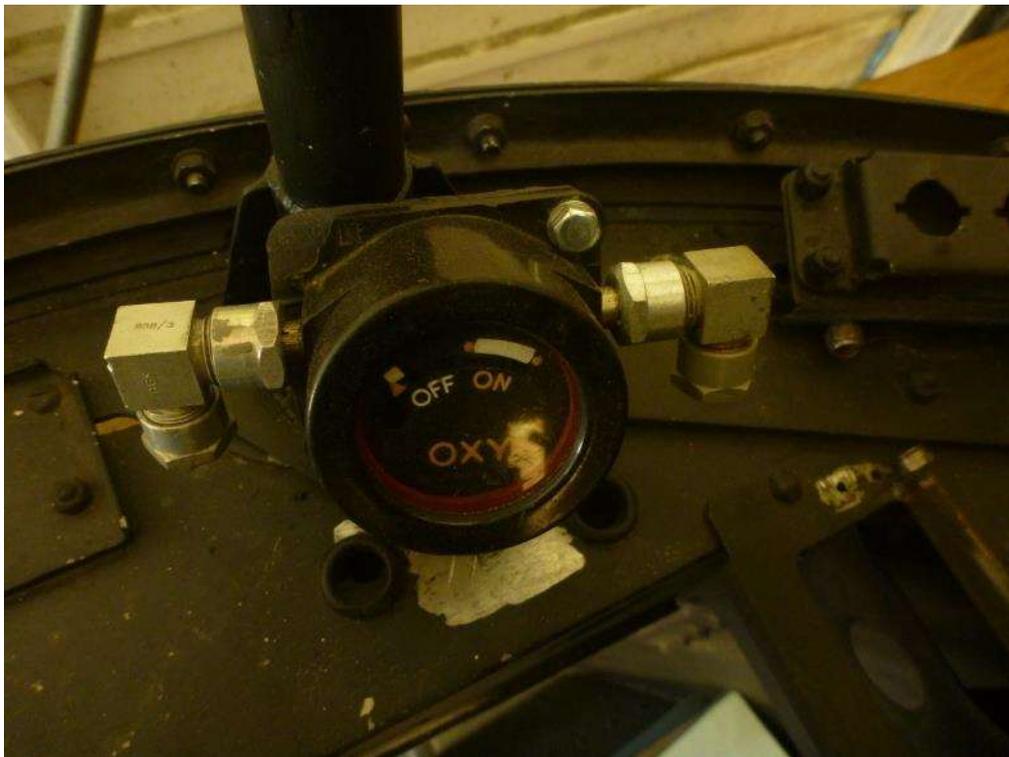
The indicator fits onto the left support tube, with oxygen pipes going through the two holes visible below it. There was damage to the turret ring where the bare aluminium can be seen which appears to be from a support tube suffering impact.

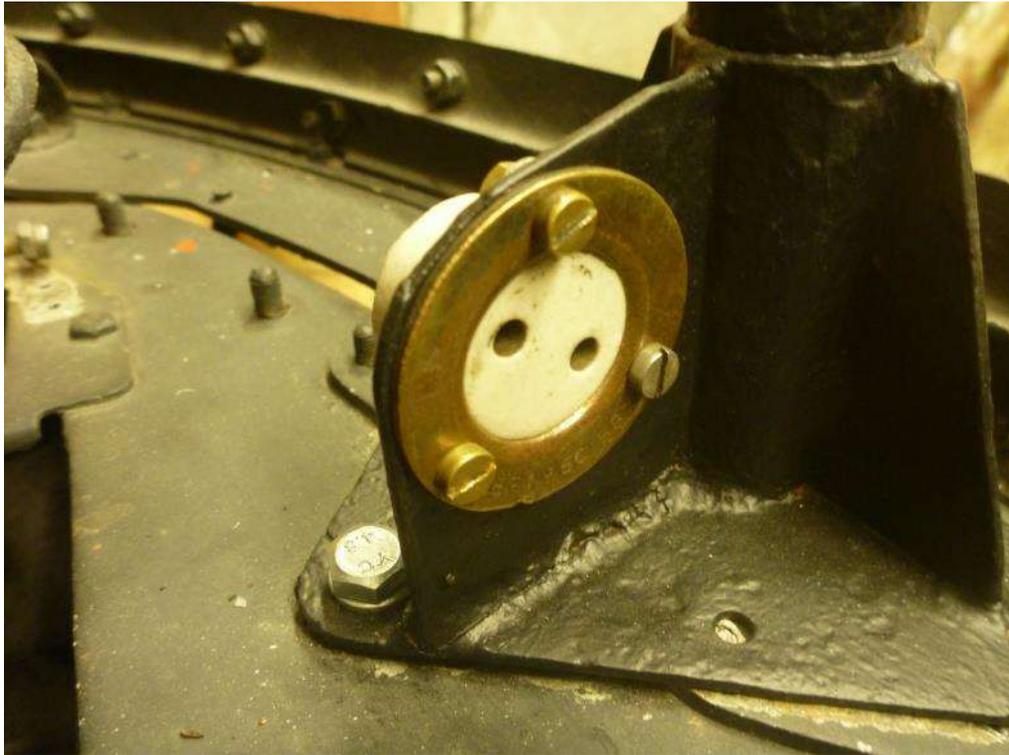
The right side support tube mounts a second two pin power point (The first being on the control panel). I understand that these are for heated flying clothing and camera.

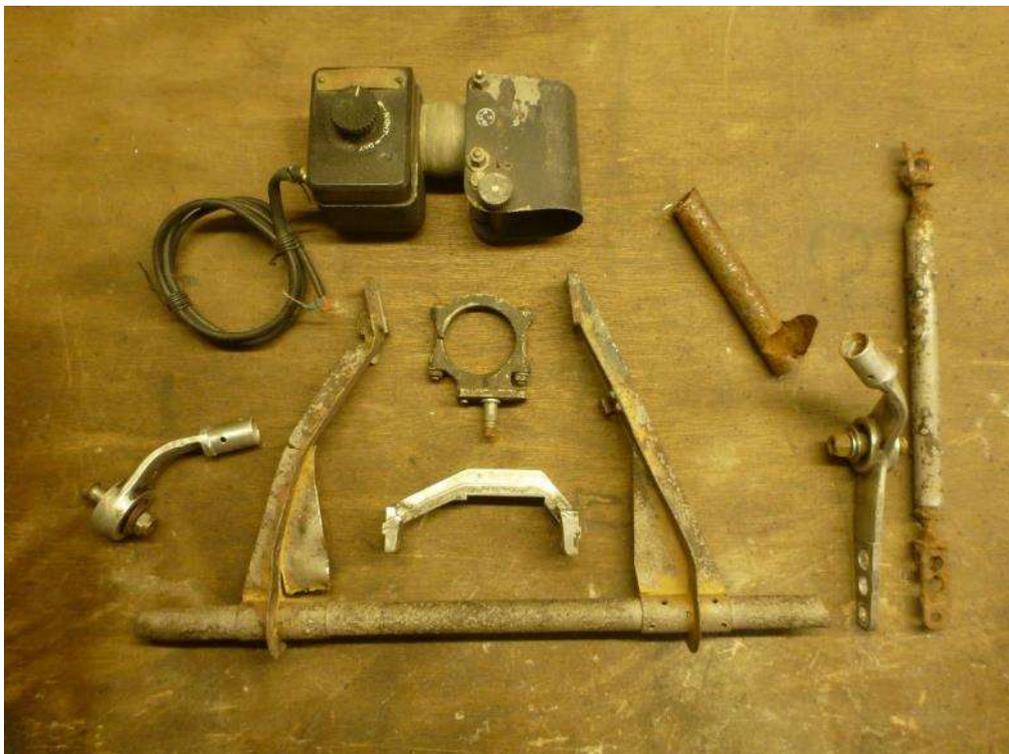
As mentioned earlier, the support tubes also provide the mounting points for the gun sight radius arm and, therefore, the gun sight. This assembly made the obvious choice for the next project but there was a lot of work to get this into a reasonable state.

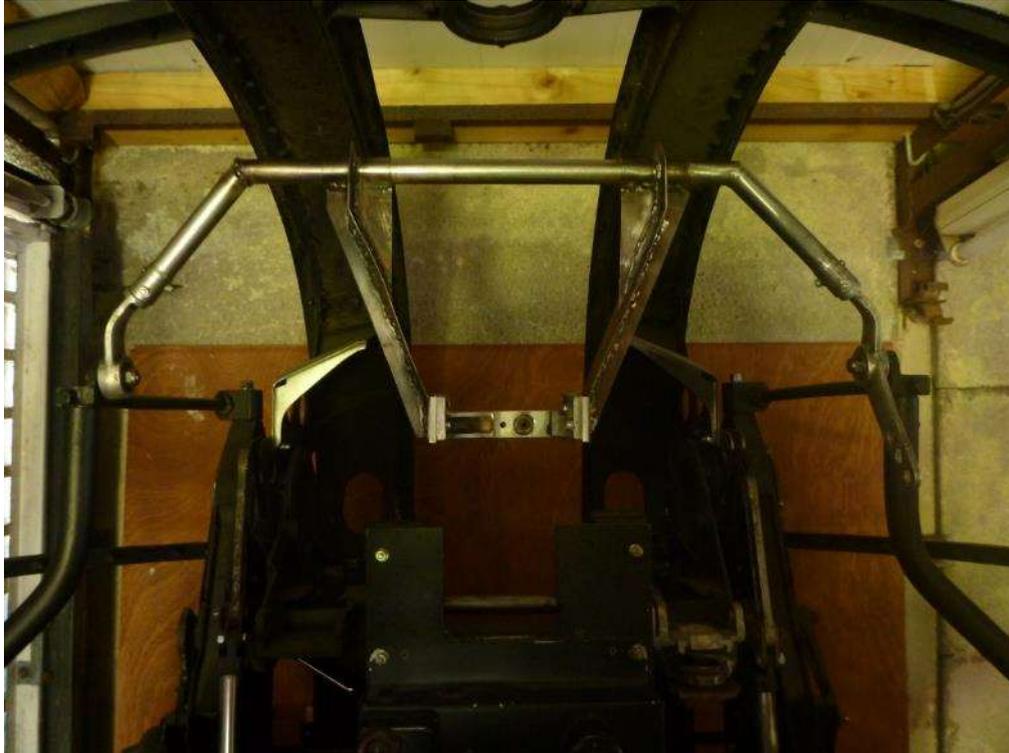
Although the original alloy castings were in very good condition, the actual radius arm which is made of steel was only really suitable to use for a pattern. The MkIIIA reflector gunsight came from a well known on-line auction site. A day or two of light hearted tin bashing produced a passable radius arm, which was bolted in to check it for size, angles and the like.

Being made of steel, it was treated to a zinc primer before being fitted with a gunsight and then re-fitted. A reproduction sight connecting link was then produced and tried for size and can be seen on the right side of the sight radius arm. It was only at this point that I realised that I had managed to get the geometry slightly wrong such that the sight would not align with the guns. Although this turret is unlikely to need sight/gun alignment to be exact, the error was too great to simply ignore.

So, it all came out again for the two top corner welds to be cut and re-welded. This in turn removed most of the primer and so it was another day before the whole lot could go back in again. It will come out again for spraying at some point soon.

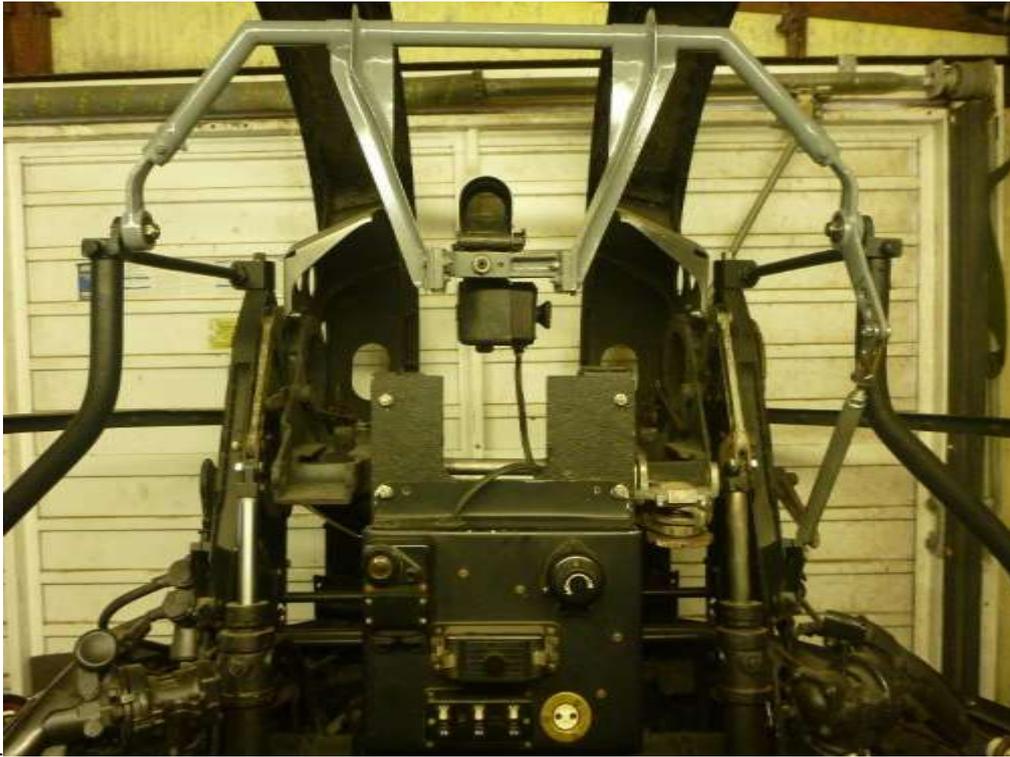
With this assembly largely finished, the turret is starting to take shape and the gunner's eye view is beginning to look much busier.

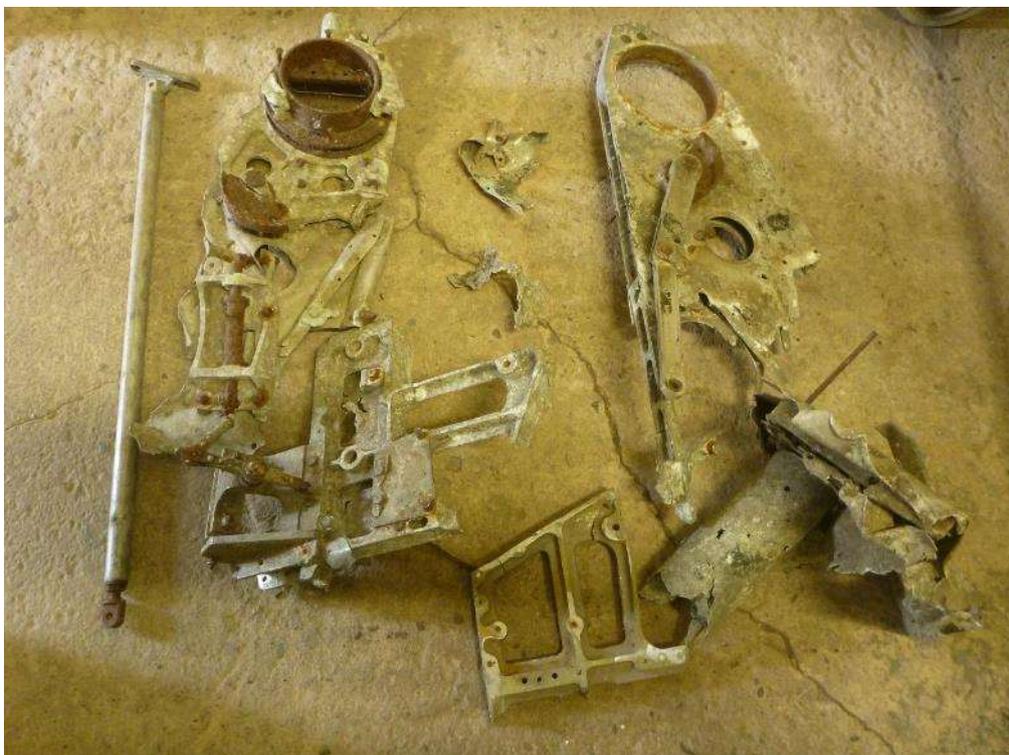
Also in June I picked up another FN turret. Admittedly it is going to need a lot of work, but my main interest was that it had that missing interrupter gear bracket.

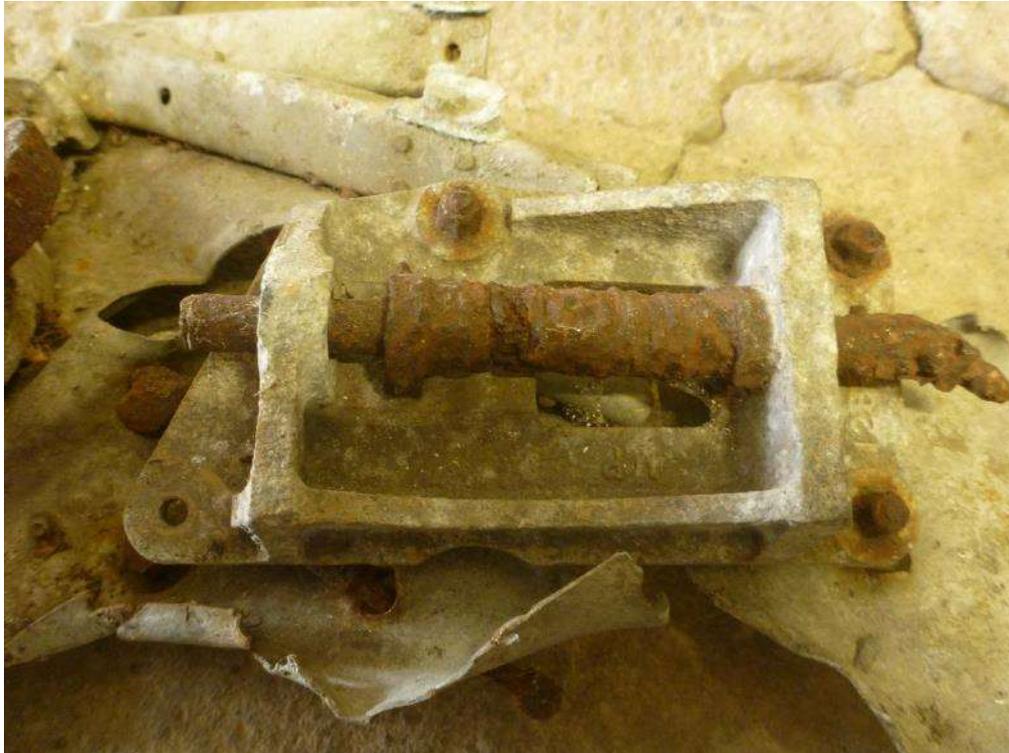
Although very badly corroded, the alloy casting is perfectly good enough to use and the steel plunger can either be restored or used as a pattern. All ways round getting this bracket provides the last major missing item (except x2 Browning 303s). Fitting it at this point might be considerably harder than I had previously predicted, however.
