FN-150 Turret update November 2019

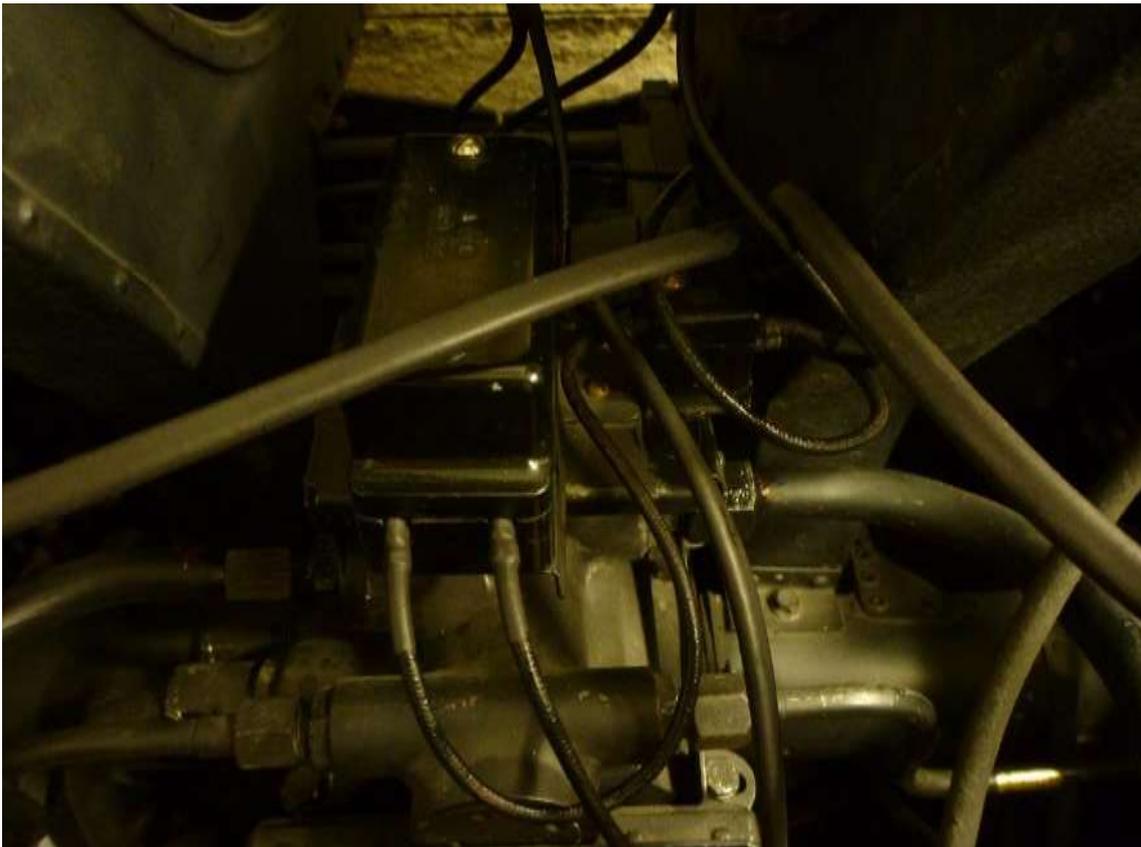
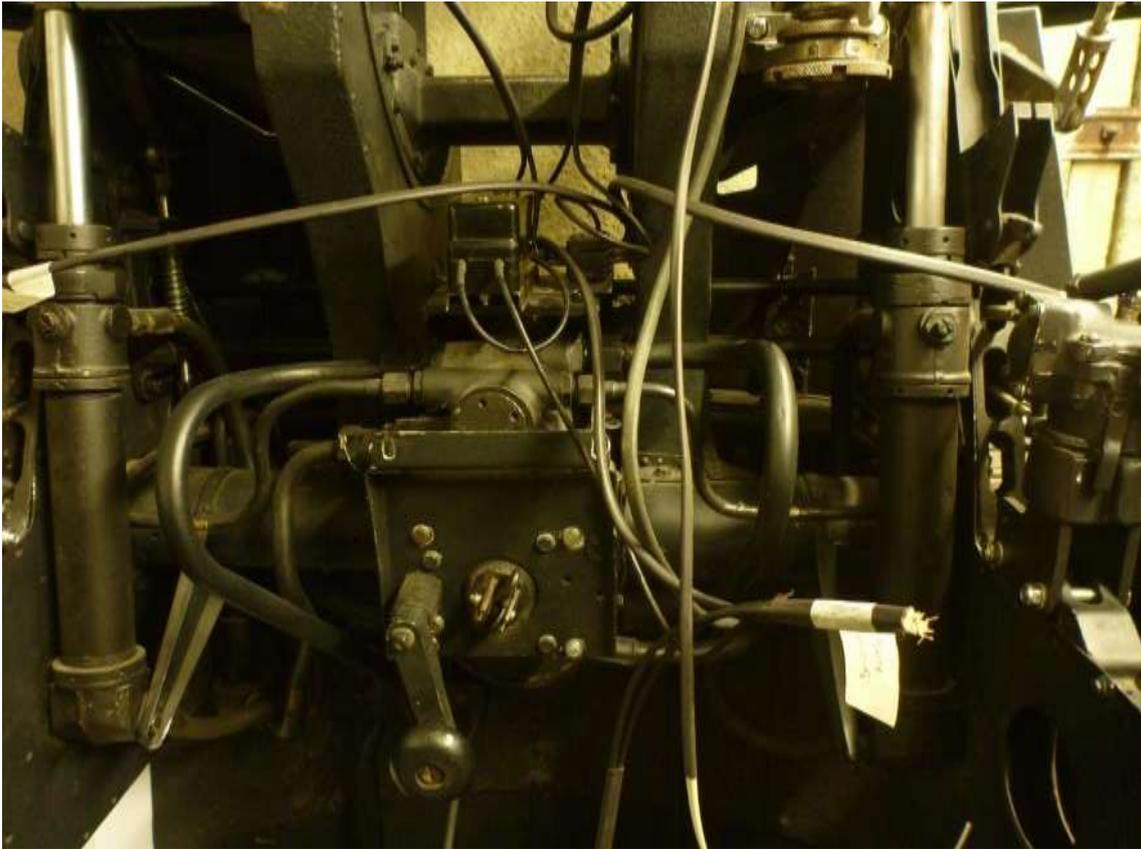
So, I busied myself with the electrical system, all of which was missing. It was agreed to make this a cosmetically reasonable reproduction and I made no attempt to make this function. The closest cable I could find to a period original was a mini co-ax cable that, once painted black, looked quite convincing. Also, black heat shrink sleeving looks very similar to the vintage rubber sleeving that is fitted, for example, to the gun sight cable.

Cables were produced and laid in to go to the gun fire micro-switches and solenoids although at this time I have not been able to find either.

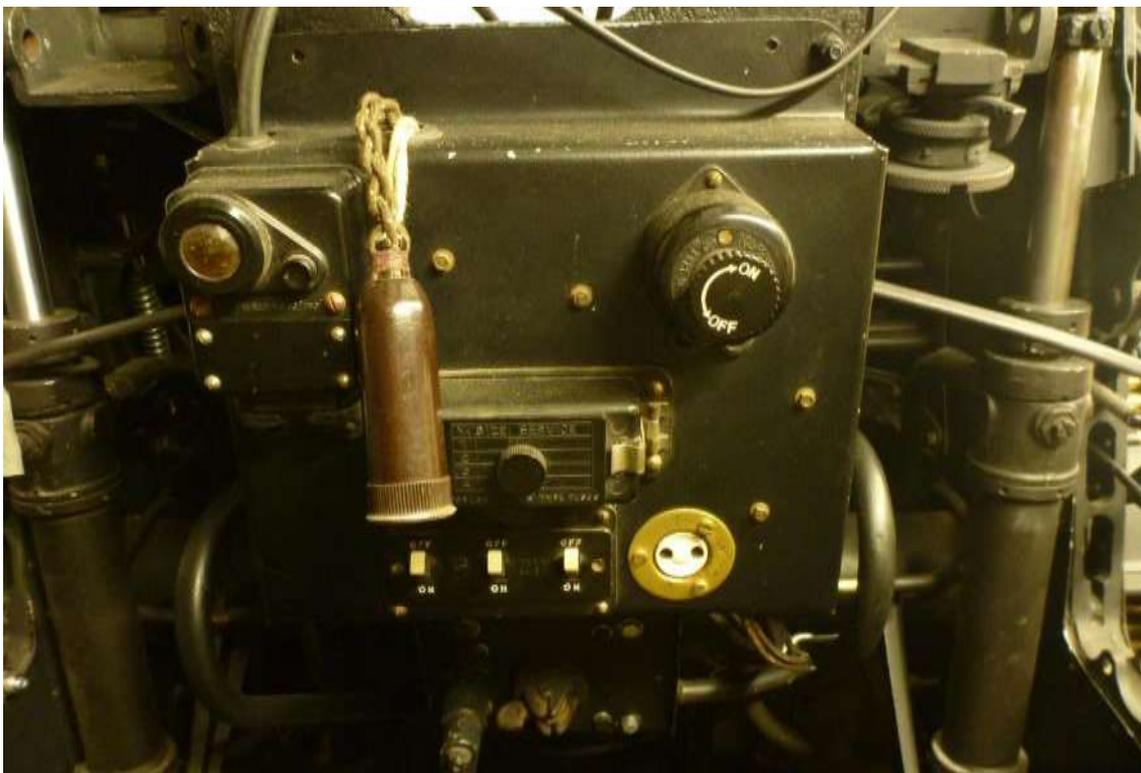
With the cables in and labelled as required, the face armour and control panel could go in and the cable ends were tucked up inside it. At this point, the intercom jack plug was fitted and the cables from the interrupter were added to the harness. This leaves just the cables from the bottom of the turret to be added in once I can work out where they go.

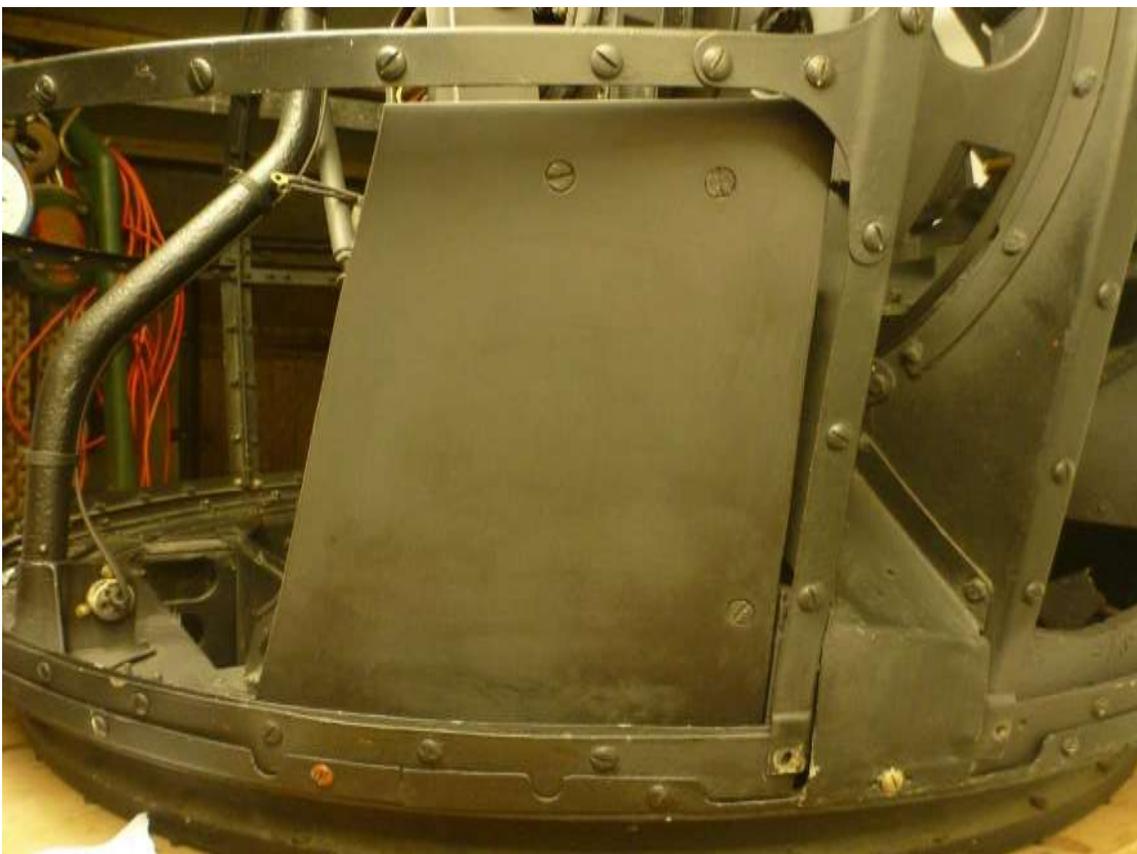
Next on the agenda were the missing armour plate panels. Both big panels were absent and for weight saving I had considered using either plywood or aluminium for these. In the end I opted for mild steel – not much use for stopping a bullet but certainly looking the part. We had enough of the original machine screws to use in the visible positions.

Getting the lowest two bolts into these panels proved an interesting challenge. The cupola had to come off and, even without the perspex fitted, this required a home made long reach spanner. This got me to wonder how on earth the cupola could be fitted after the perspex is installed as appears impossible despite being described in the Air Publications.

The answer is that there should be anchor nuts fitted all round the cupola lower rim, but these have been carefully drilled off. So there's another job for the list – anyone got a box of 2 BA anchor nuts?

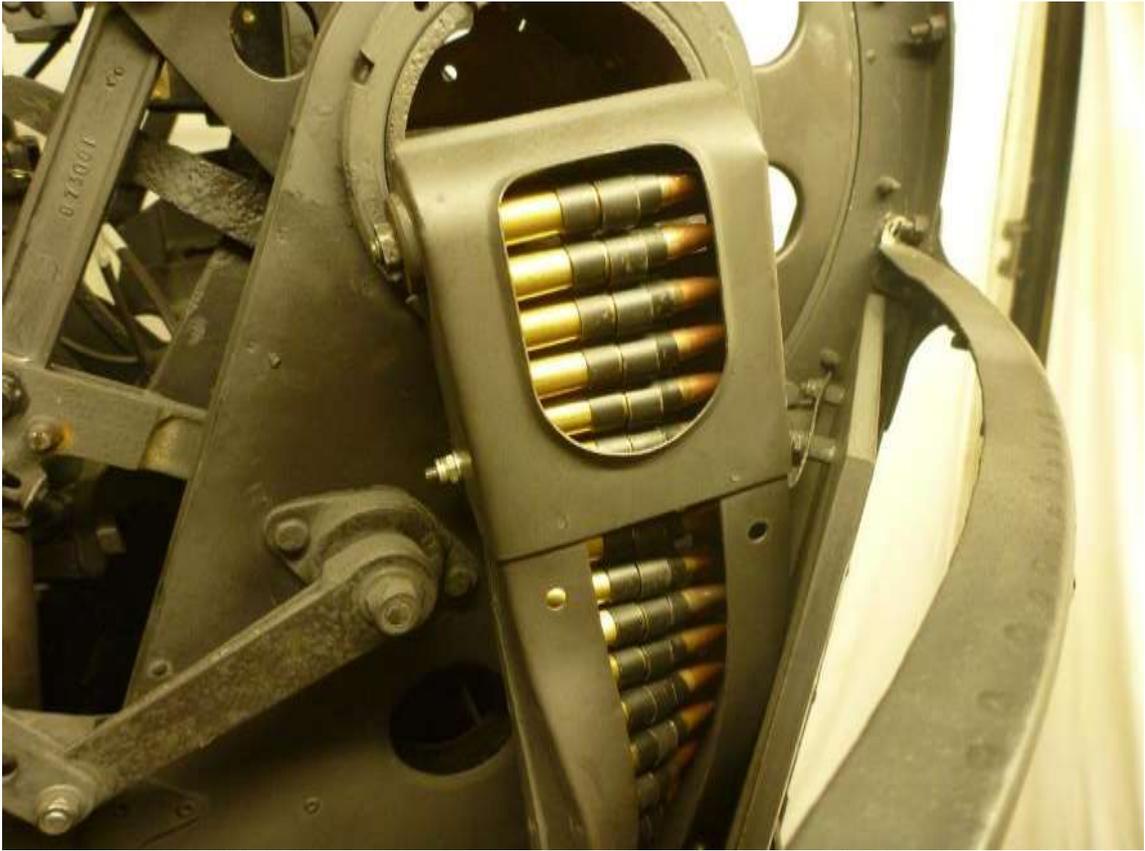
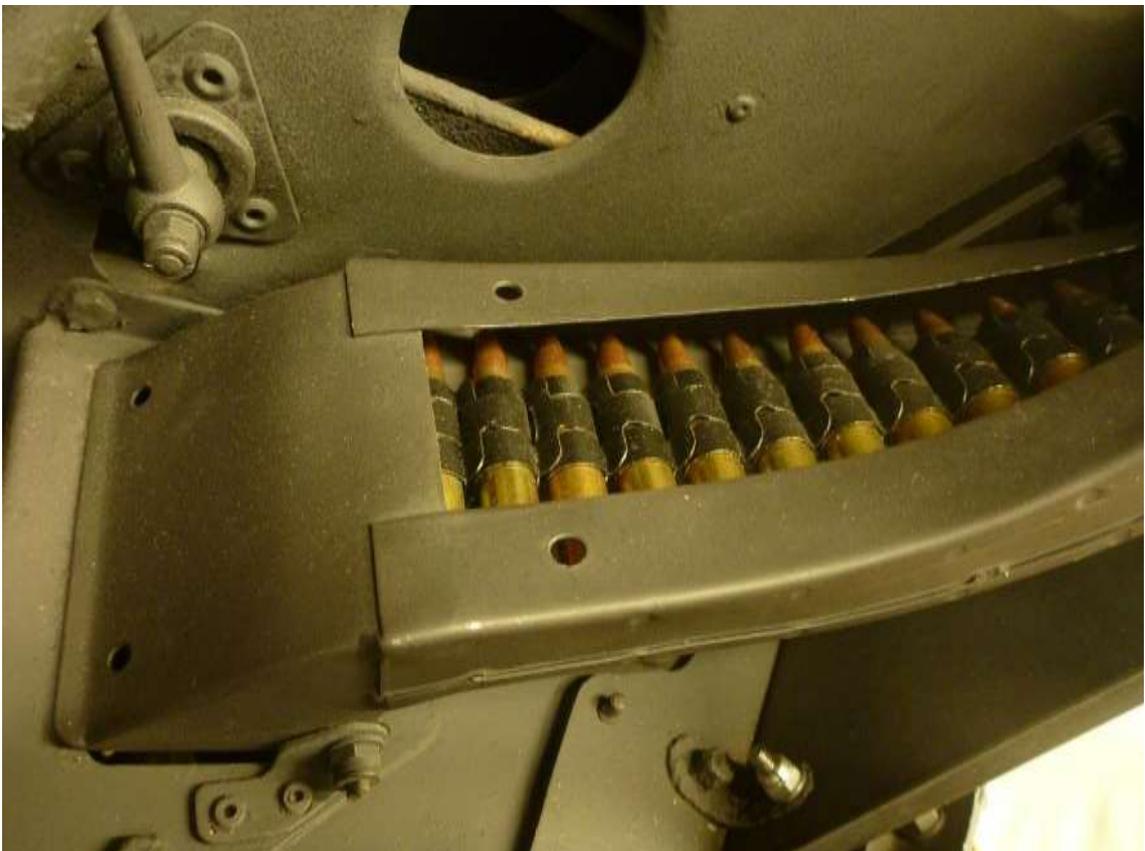
Next, the armour came out again for the ammunition chutes to go in. These needed just very slight adjustment to get them to sit correctly and then each was loaded with 50 rounds on inert .303 inch ammunition just for effect.

At this point I realised why the Air Publications show a spacer at the top of the armour, this being to stop them fouling the chutes.

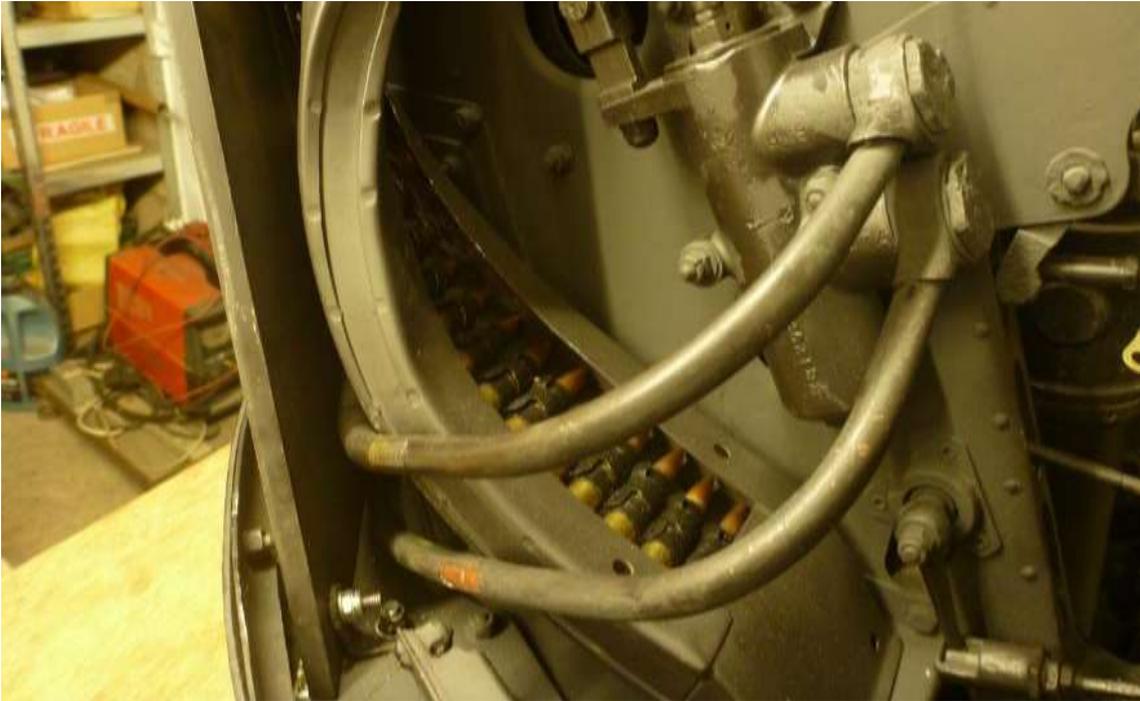
If the right side is tight for space, then the left is really tight as it also has a couple of hydraulic pipes to squeeze in. Unsurprisingly, these needed to be removed and adjusted a few times to get everything to fit, but we got there.

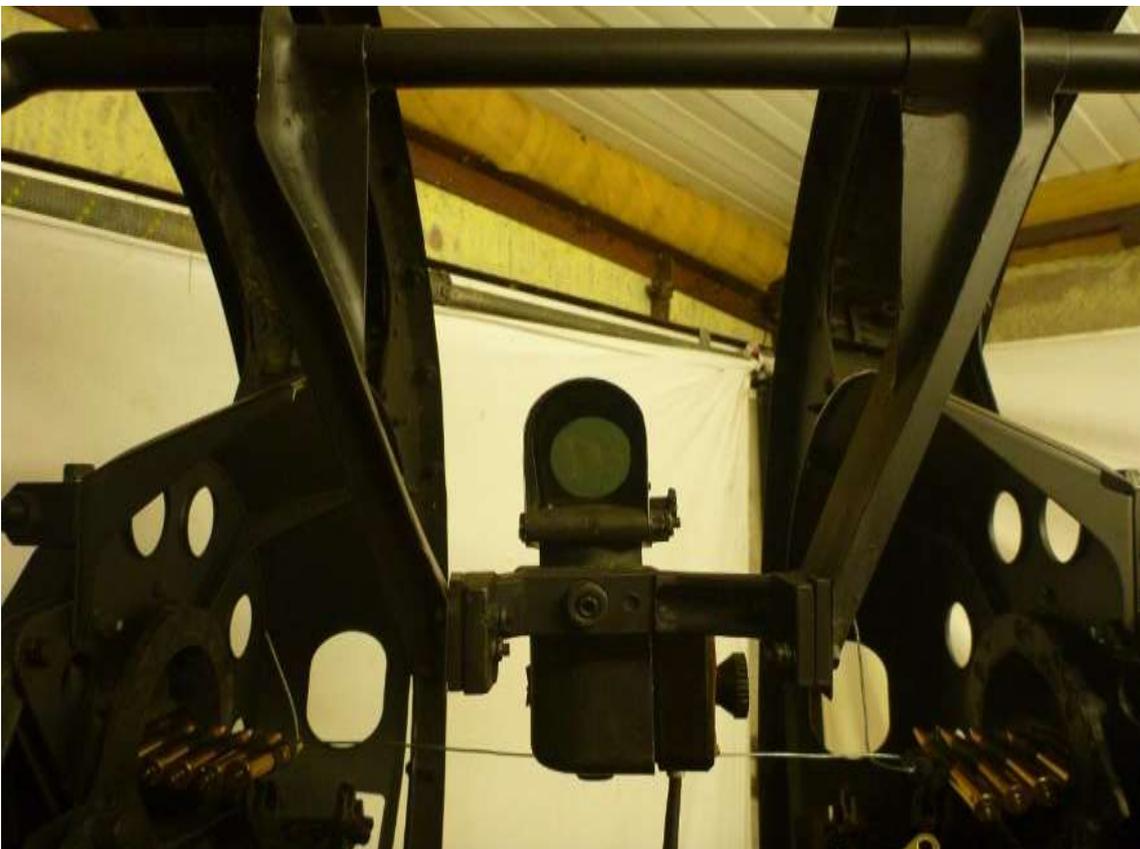
Next job was to get painting some of the many parts that had been installed over the last couple of months. With this done, the turret was really beginning to look complete.
