## FN-150 Turret update September 2019

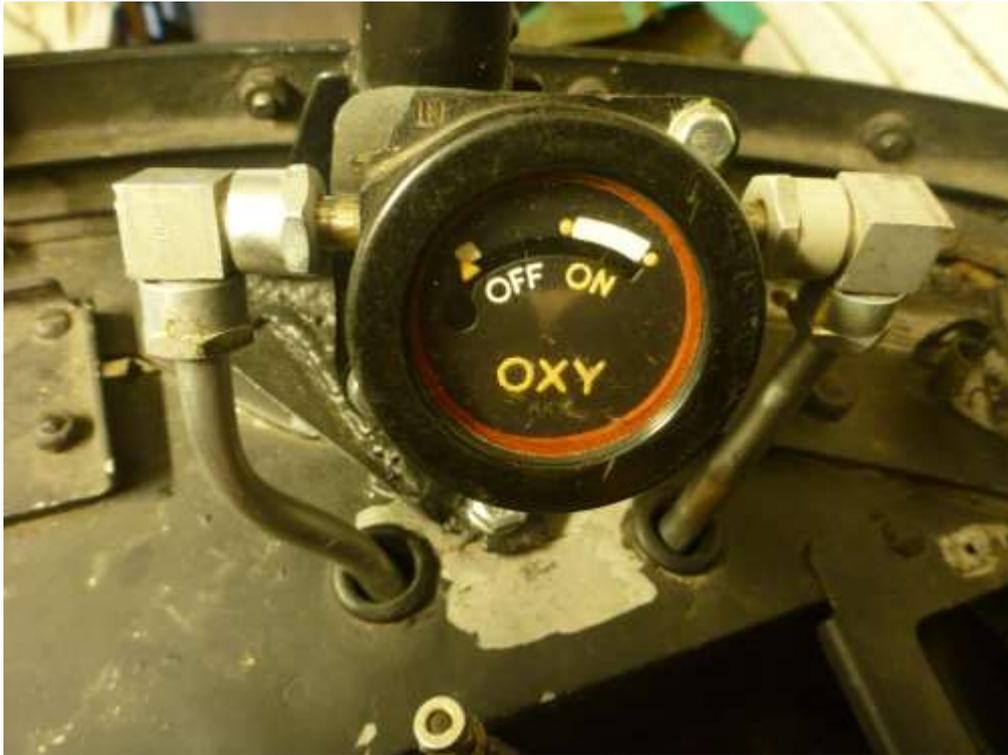
The indicator was fitted to the mounting on the left side support tube and then the 90 degree alloy adaptors from the FN-5 were fitted. The alloy pipe refused to behave and so a rudimentary mini pipe bender was made to form the tight complex bends that were required to align them with the original holes in the turret ring. I have no idea why FN decided to put these holes out of line with the indicator inlet and outlet positions, but the hole are original and so I concluded that they should be used as they are.

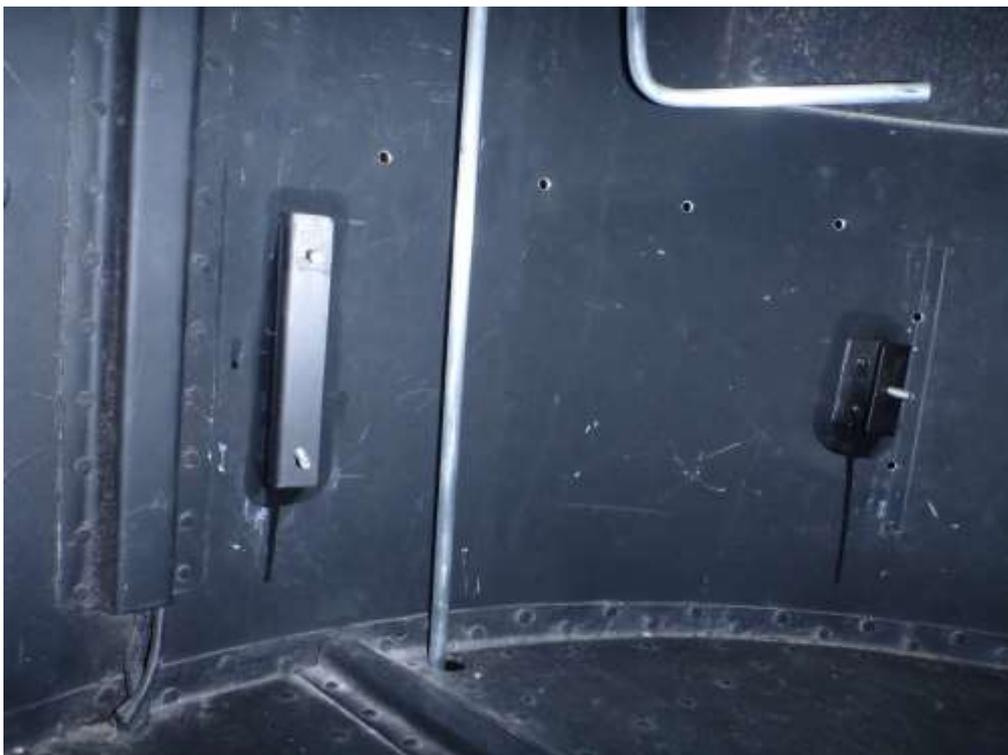
The left hand pipe comes up through the turret floor from the (missing) Rotating Services Joint whilst the right hand pipe heads down to the Economiser. There were no fixtures or fittings in the Economiser position which is near the floor by the gunner's left foot. The mountings were produced following inspection of similar installations and reference to the turret manuals. Once done they were riveted to the turret skirt.

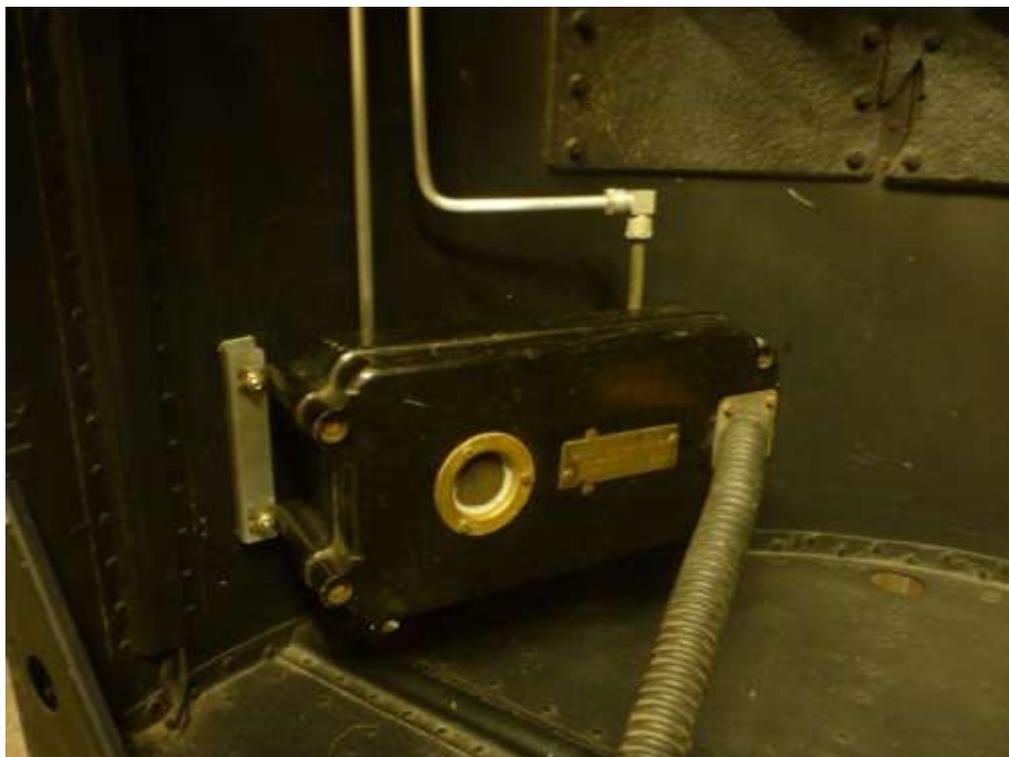
The Economiser is then simple to bolt in and the right hand pipe can be connected. The 90 degree alloy adaptor seen here is borrowed from the oxygen indicator to get the correct fit. The turret actually needs three of these adaptors if anyone has any. The flexible oxygen hose then runs off up to the gunner.

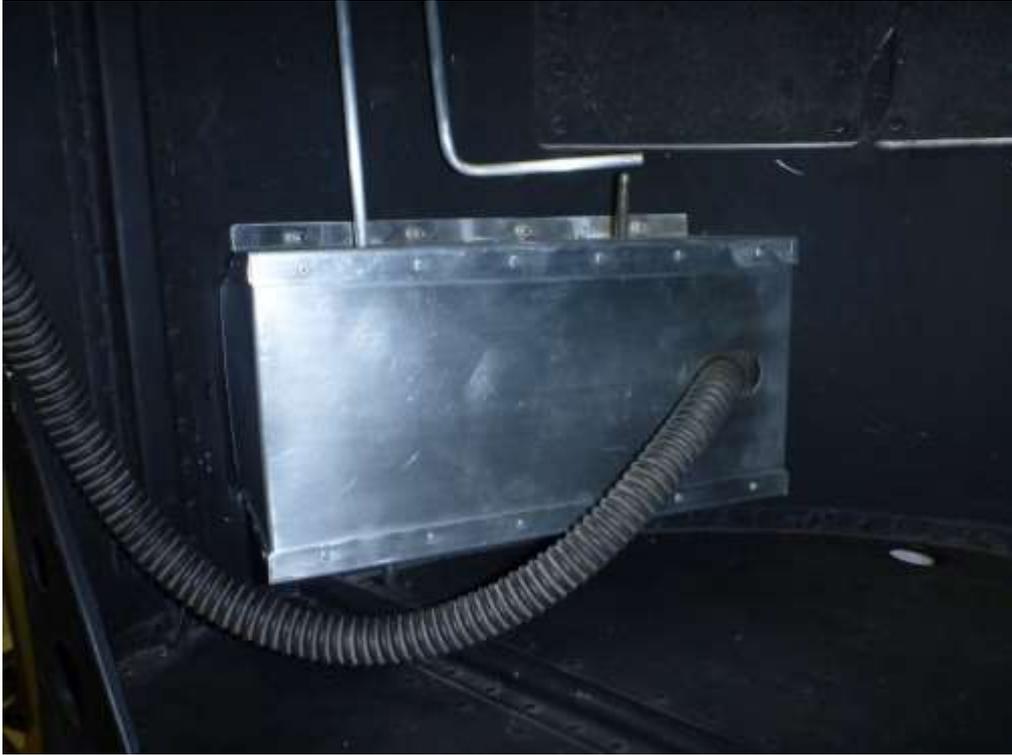
Next comes the protective cover – not a bad idea given the position of the Economiser. This is a large alloy box that I made using the schematic drawing in the manual – the box is then bolted to the turret skirt.

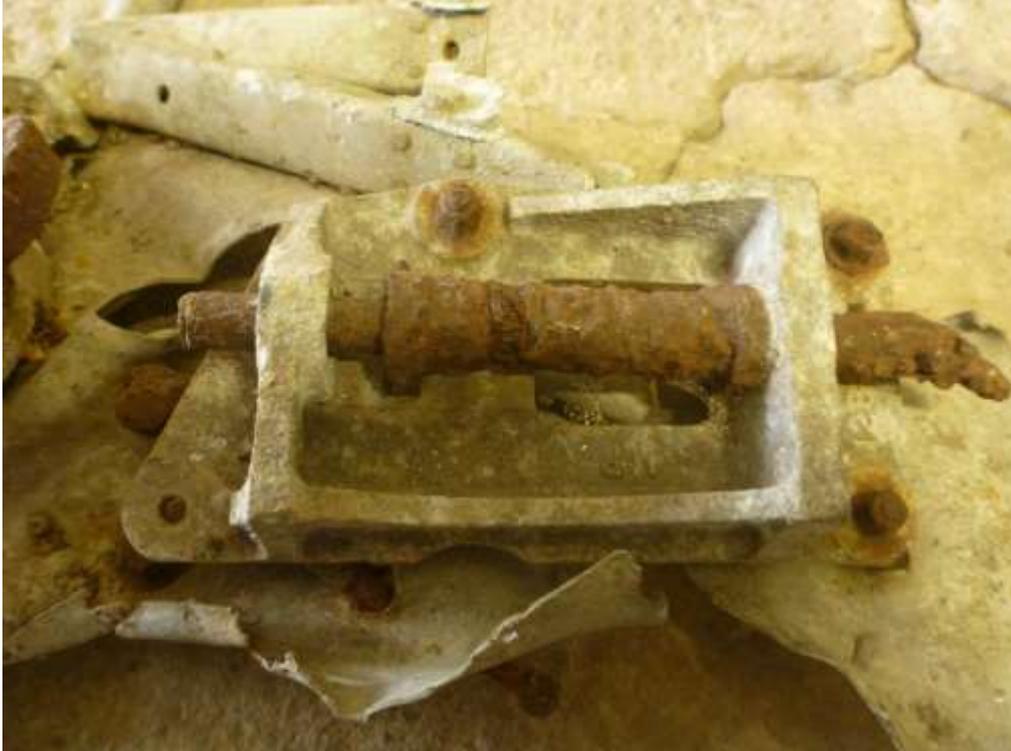
That done, I went back to the interrupter cam follower that I had tracked down in June. Following a good soak this was relatively simple to dismantle with the alloy casting, in particular, being in pretty good condition. The cam follower, actuating rod and spring all had to be replaced resulting in a tidy, fully functional item.

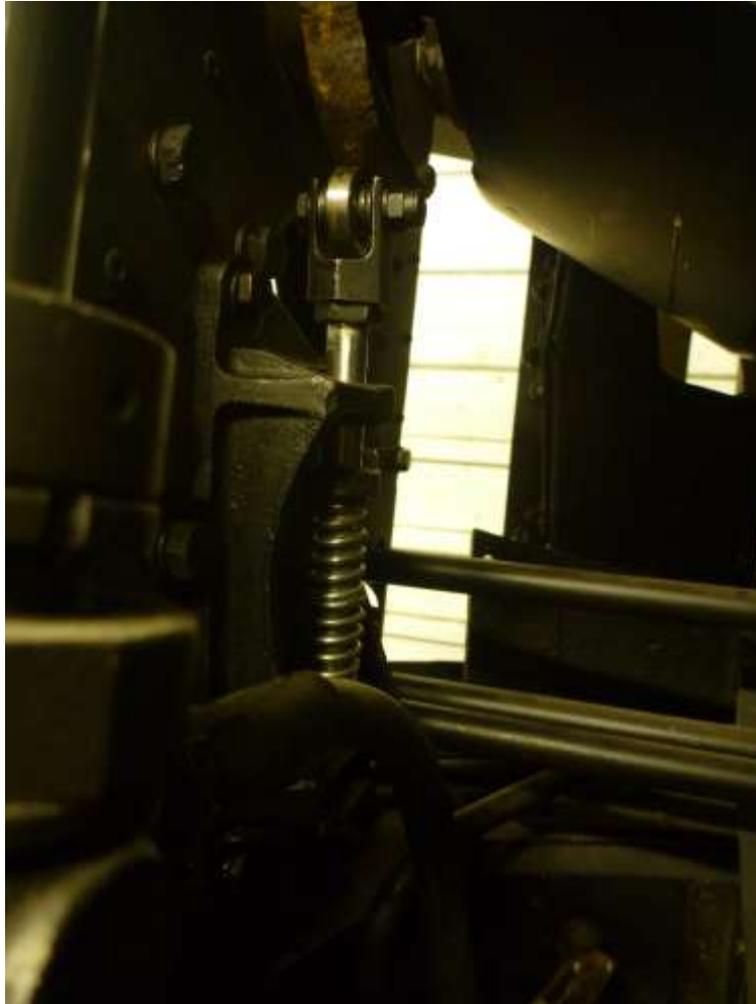
Fitting this actually proved slightly harder than had been predicted with access being one of the main problems. Also, two of the four bolt holes were occupied by siezed, sheared bolts which had to be carefully drilled out.
