FN-150 Turret Update, August 2018

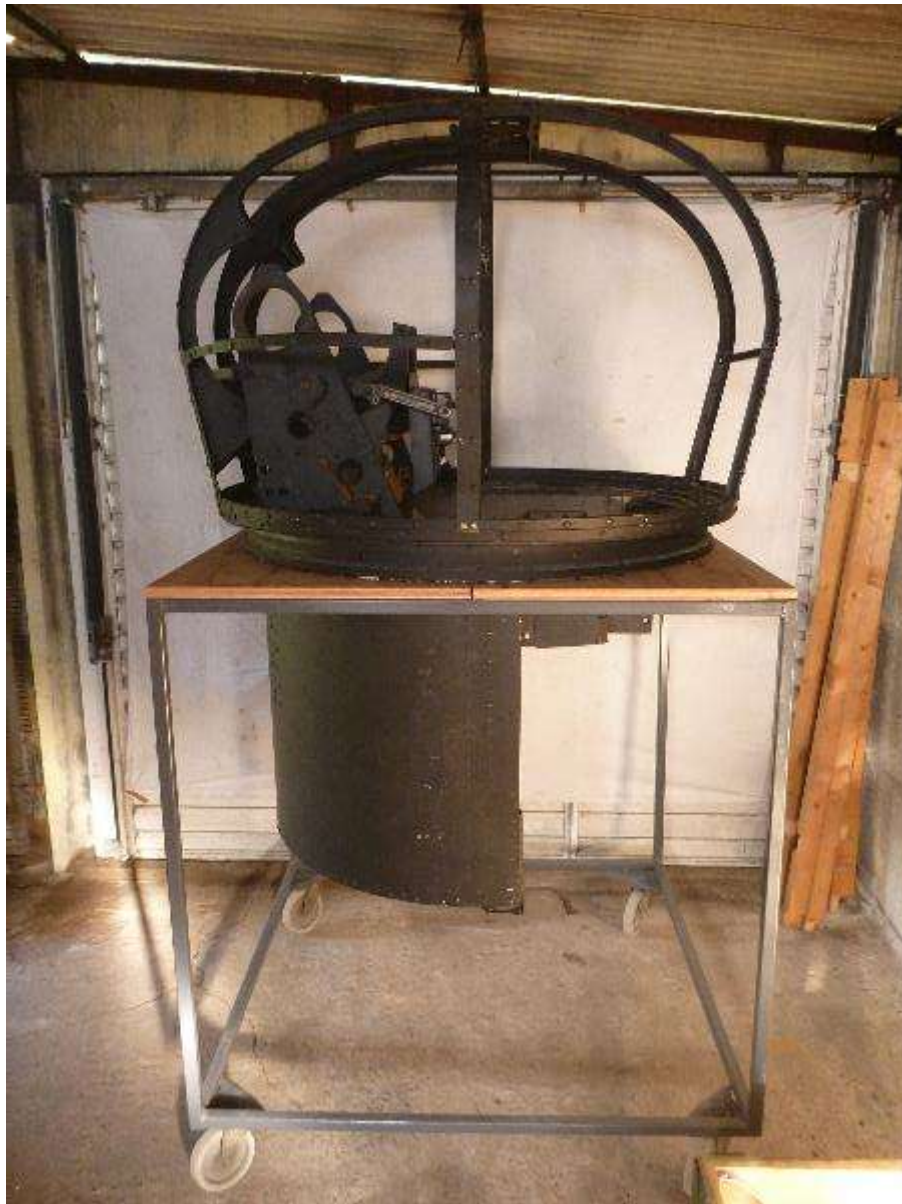
The first task for this turret was to build a suitable maintenance stand. The idea was that the extra height and accessibility would make the whole process of inspecting and then restoring and rebuilding the turret considerably easier. A design similar to that used for my FN-5 was employed, although slightly higher. The same material has been used for all three of the turrets currently in the

workshop, this being 25x25x3mm box section steel. This provides enough strength without being so bulky as to detract from the turrets. FN-5 and Briggs Sperry A13-A below.

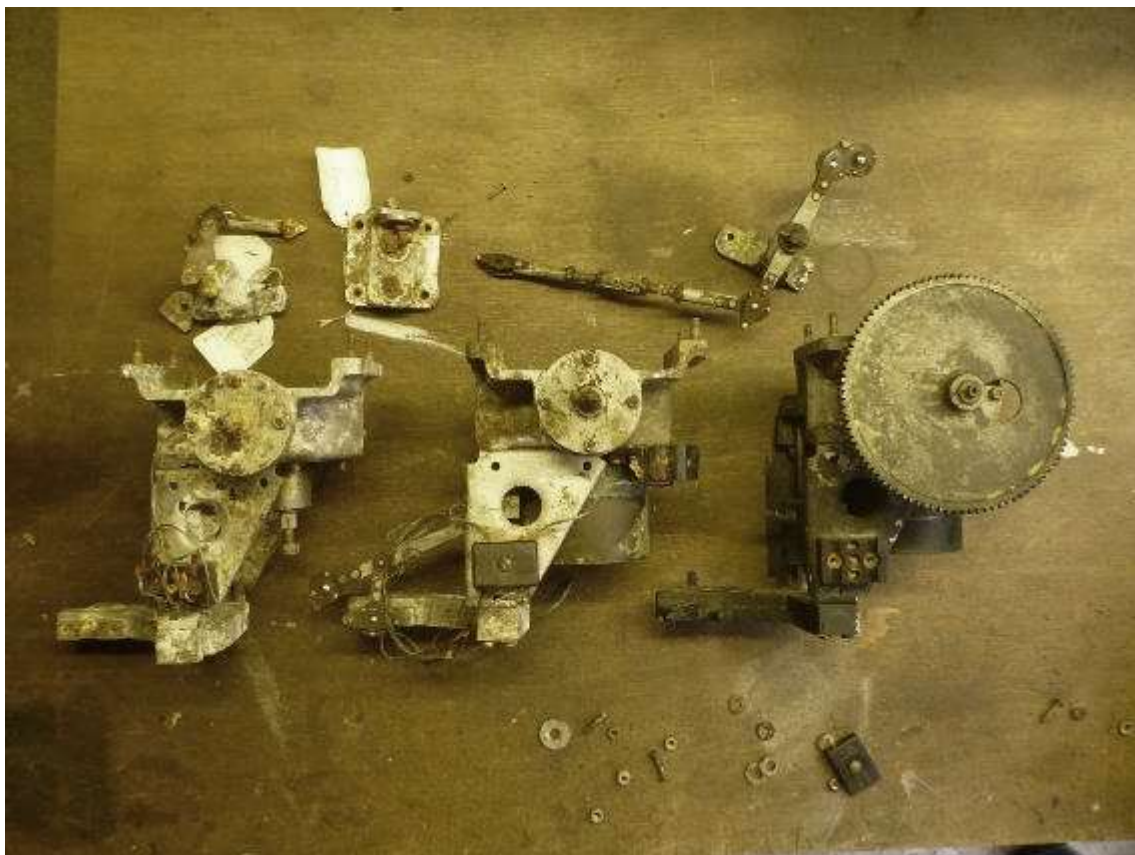
After several hours of checking through the boxes of components it was discovered that, amongst other things, there were three Gun Fire Interrupter Mechanisms each with different parts available. It seemed wise to start by working down the turret from the turret ring as access will become more restricted once the gun mounts go in. The Interrupter, therefore, seemed a good place to start and so one good interrupter was built from the best parts of each.

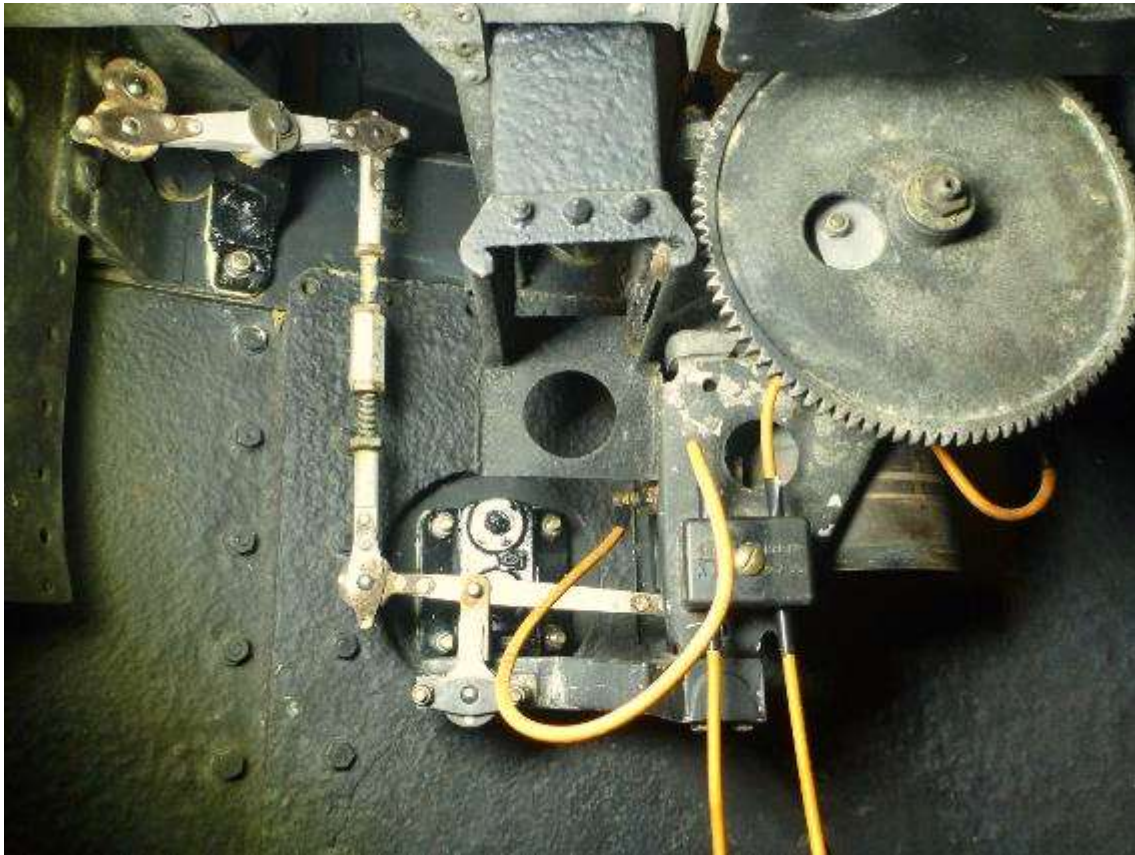
Once cleaned, rebuilt and re-wired the Interrupter was refitted to its place below the Hydraulic Rotation Motor and behind the gunner's armour.
