FN-150 Turret Update, September 2018

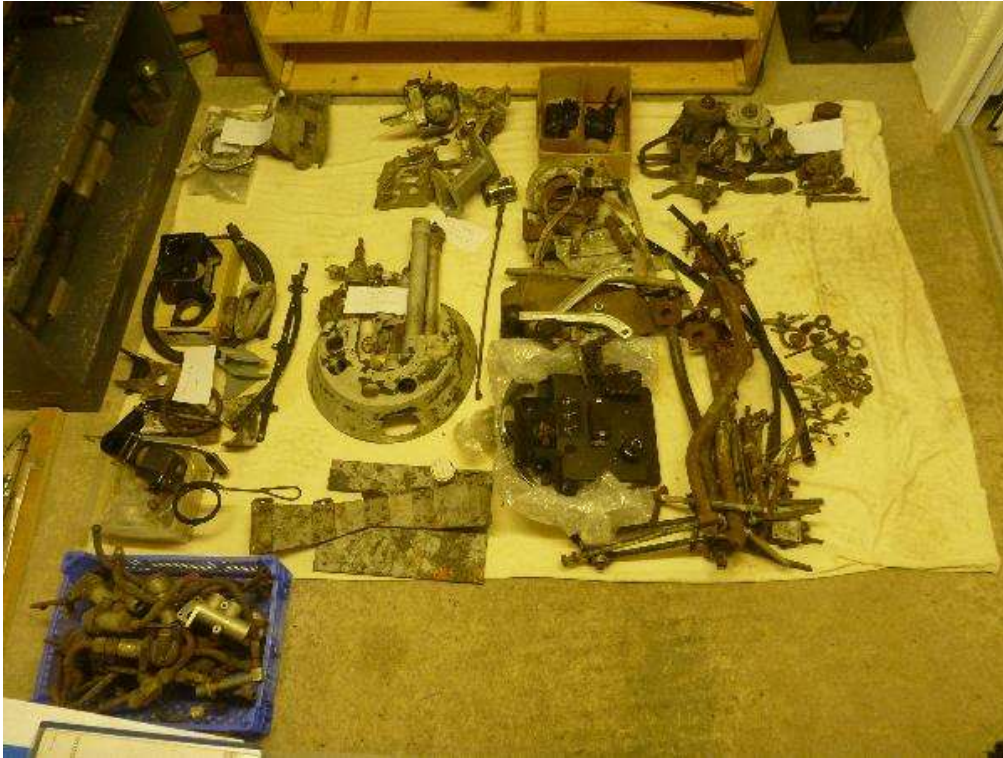
September's project was the Rotation Restrictor Valve and associated pipework. When the guns are depressed this valve reduces the oil flow to or from the hydraulic motor, thereby limiting its speed and preventing shock when the gun interrupter mechanism operates.

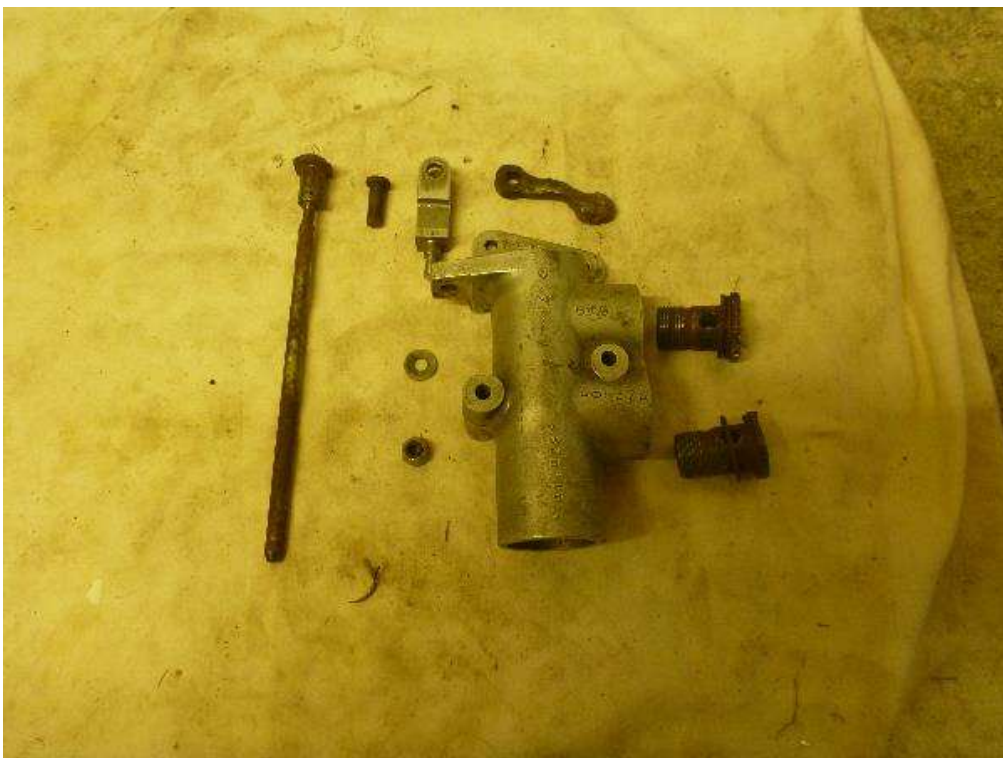
The first job was to find as many parts of the restrictor valve as possible. In fact this collection of FN5 and FN150 parts contains all but two of the components. See if you can spot them.

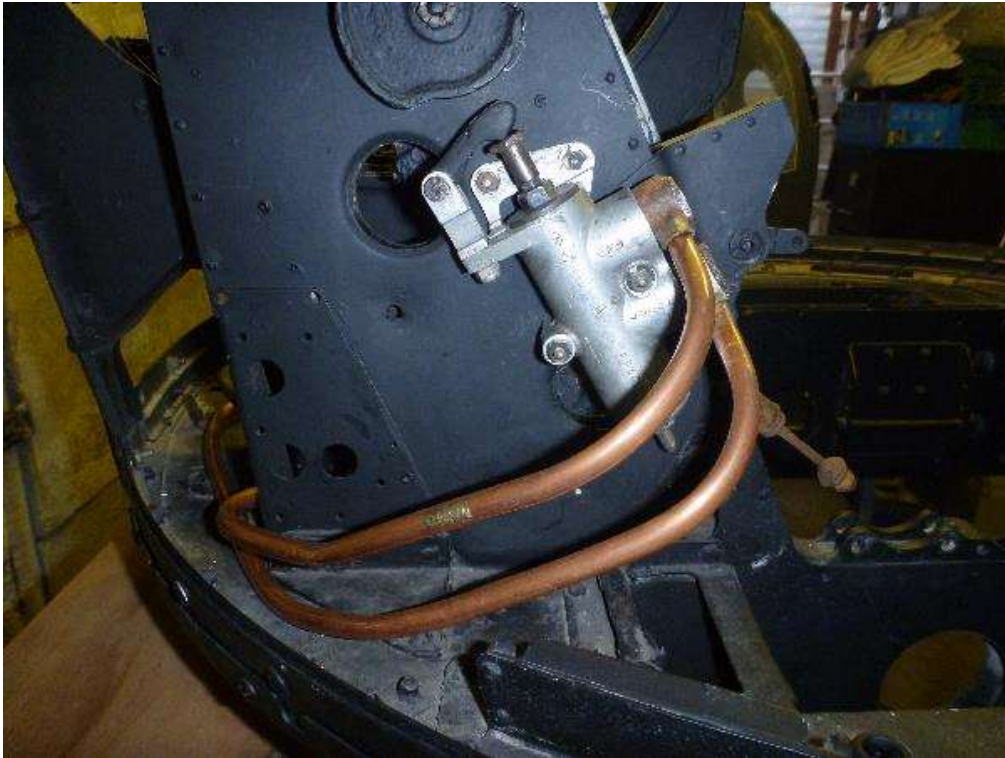
Once re-assembled (minus the seals) the valve is fitted to the left side gun support. That was the easy part, much harder was producing the two pipelines to and from the valve as the originals were damaged beyond repair.

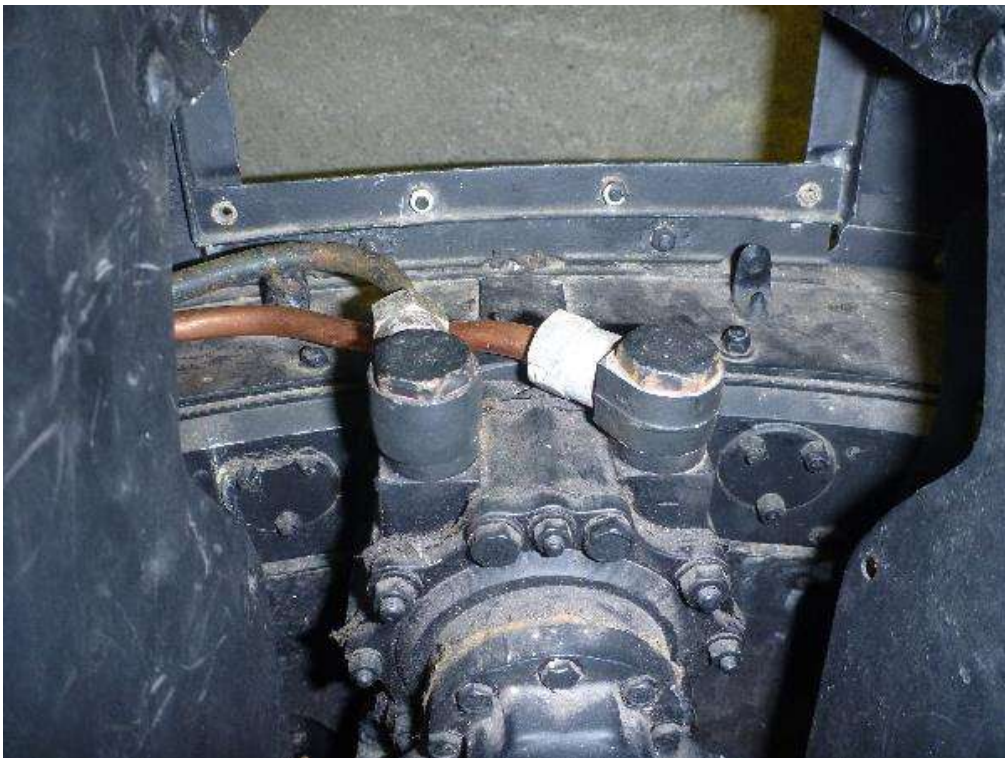
Below, one of the new pipelines goes to the hydraulic motor whilst an original heads off, via one of the two filters, to the control valve.

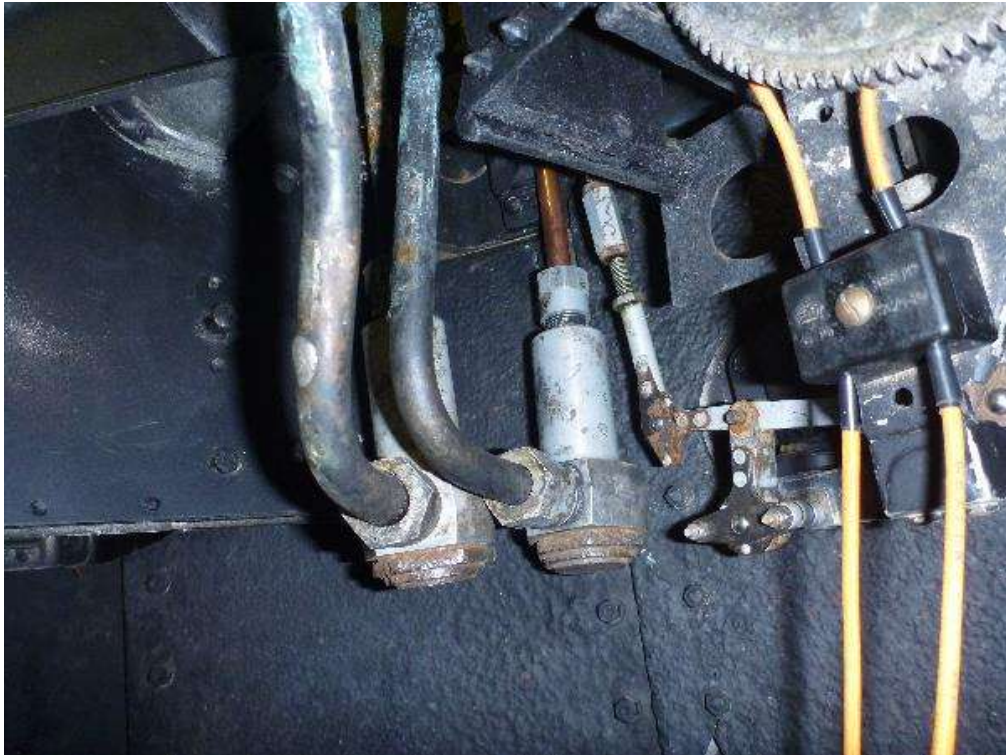
The two filters are squeezed in beside the interrupter gear (see August update). The two larger pipelines connect to the Valve Box. Now it all fits together, the whole lot can come out again for painting.

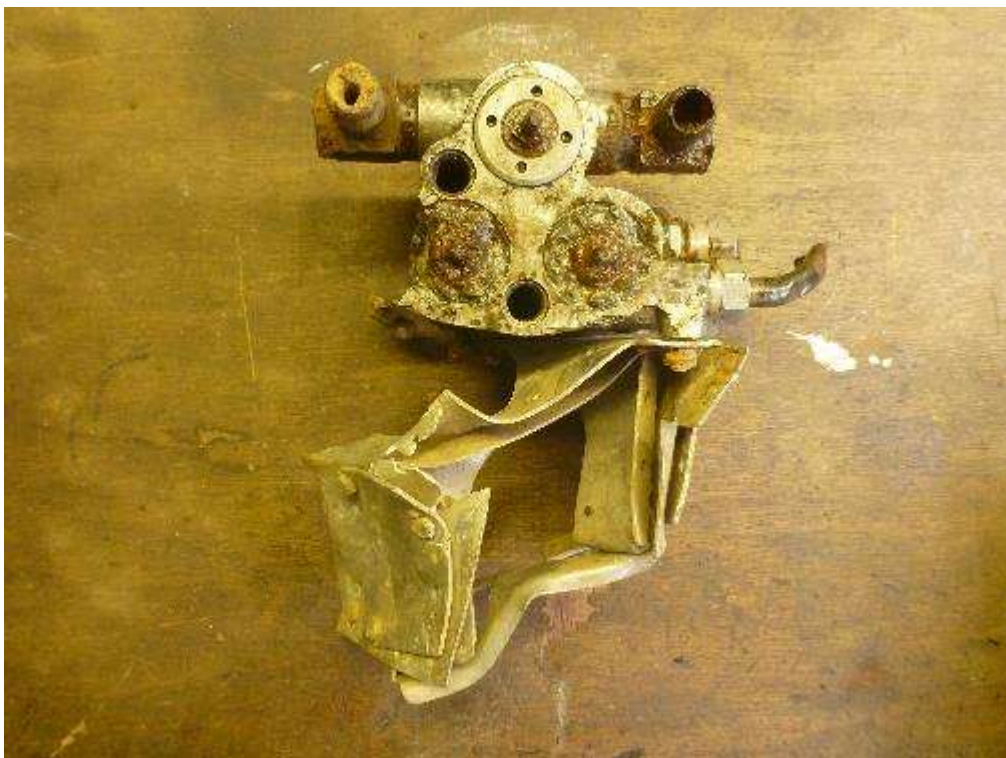
The project for October is the Valve Box – this could be something of a challenge as it has obviously crashed!
