## FN82 Turret update December 2020

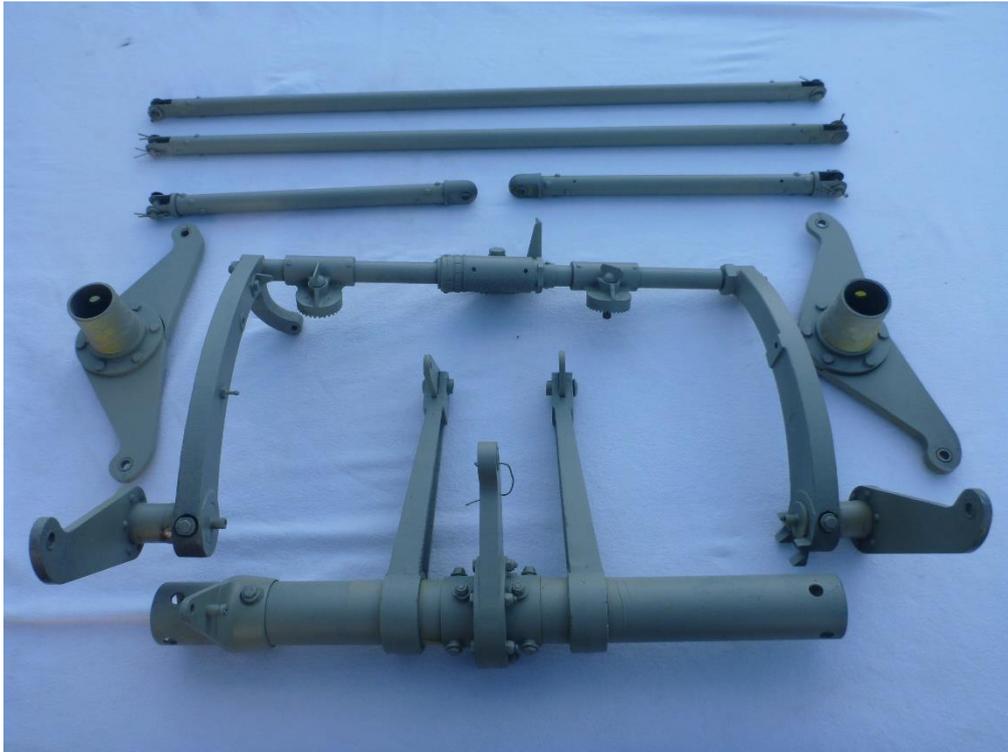
Seen here are the control components that have now been sprayed with wash and primer. They now need a light dusting of black and can then be built back into the support frames of the main superstructure.

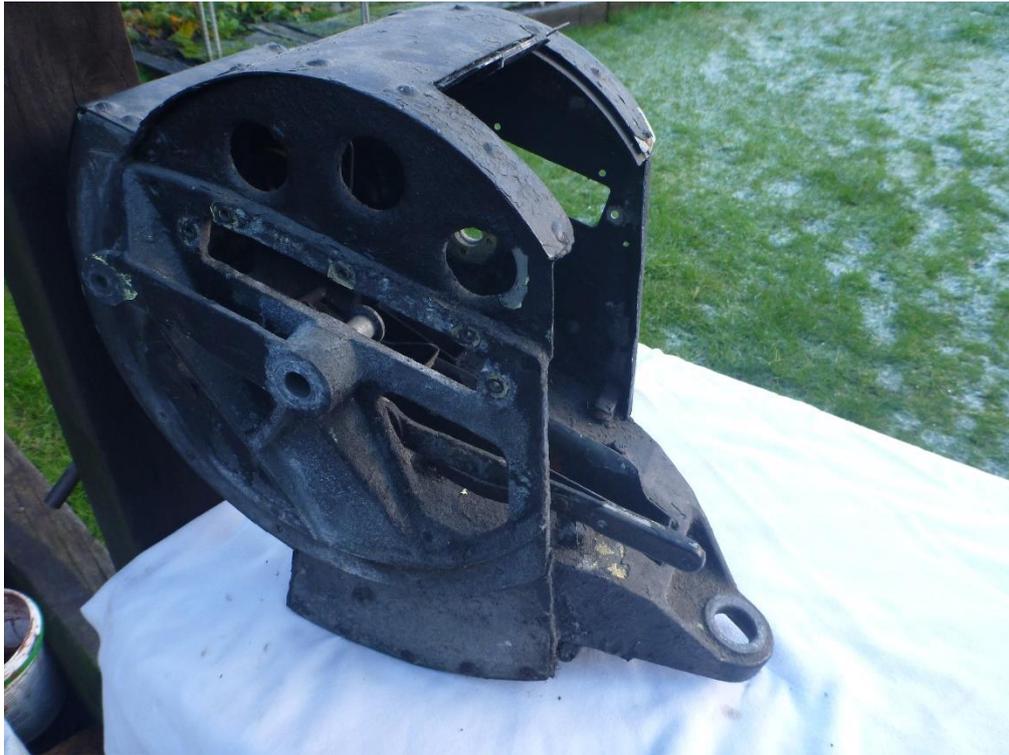
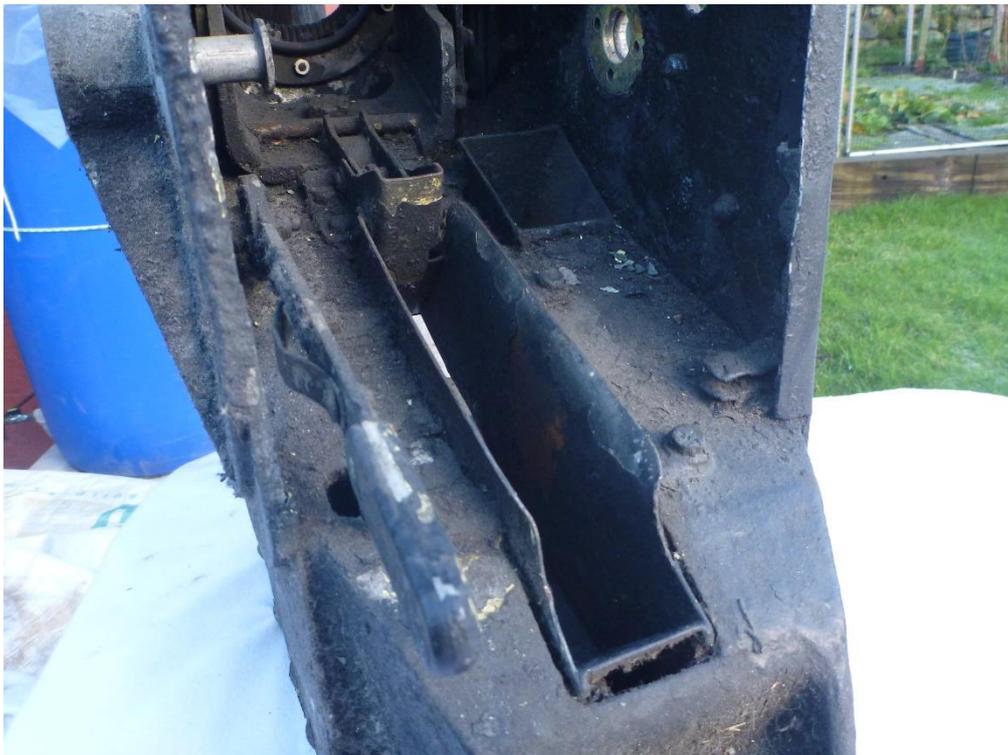
With the controls set to one side for the time being, attention turned to the gun cradles. These are complex assemblies and almost a project in their own right. Each has been subject to many previous layers of paint and, without exaggerating, in some areas the paint was up to  $\frac{1}{4}$  inch thick. It was decided to do these one at a time as, despite having the relevant Air Publications, it is always easier to have a complete example to copy.

Although they looked to be in poor state, they had survived remarkably well and came apart without undue difficulty. Removing the paint took quite a while, but was made slightly easier by the lack of any paint in the void areas.

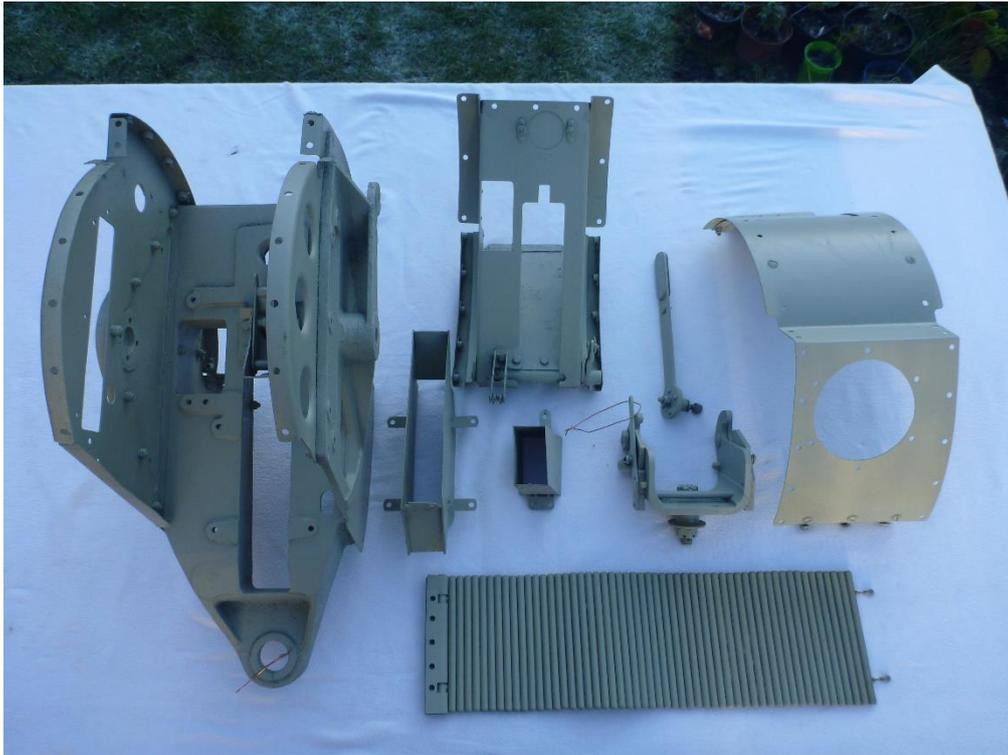
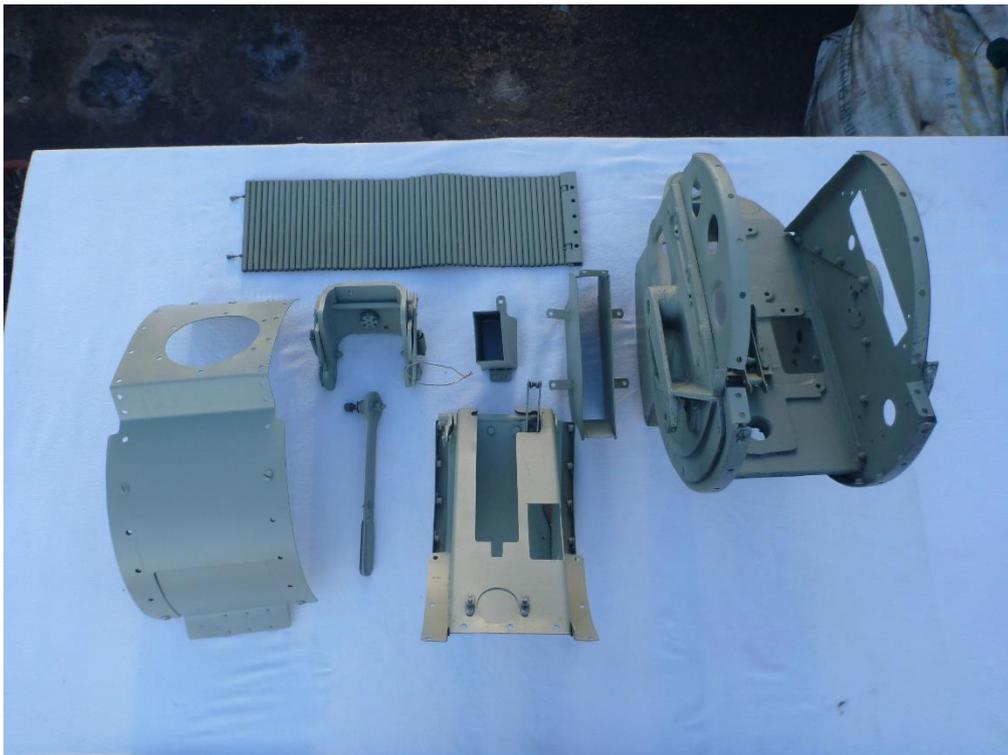
Once dismantled, the parts could be cleaned, inspected and then sprayed in preparation for re-assembly. Again, these will be dusted over in black before re-assembly and then finally sprayed again in their assembled state.

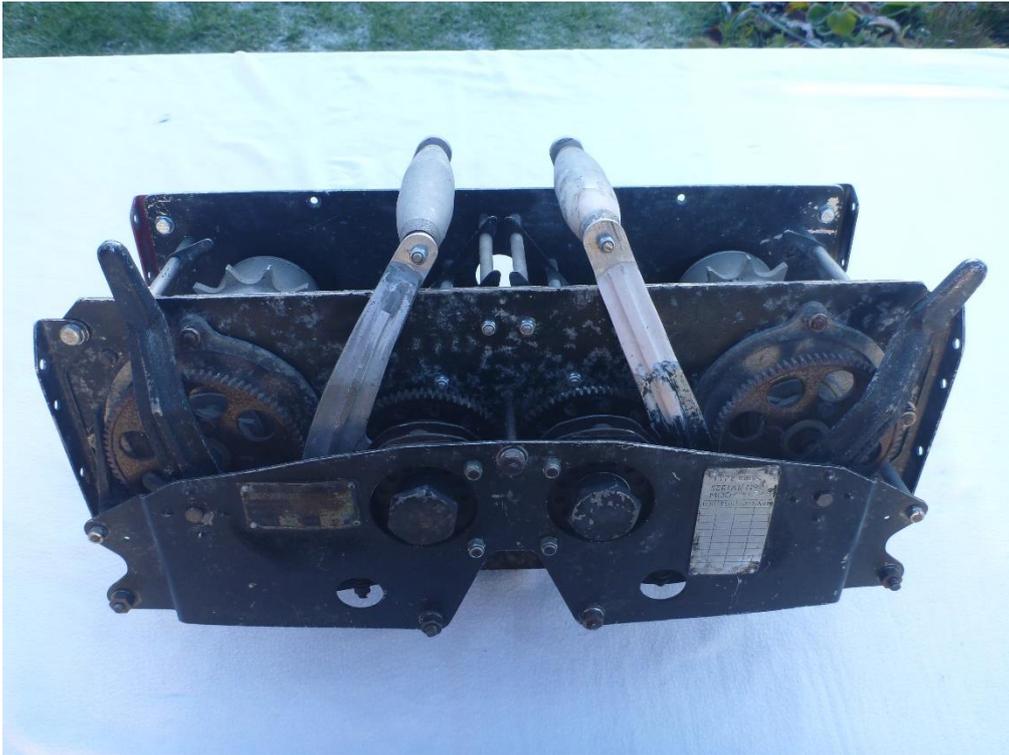
By this point, there are many assemblies awaiting spraying in black, however, the black paint has yet to arrive. Therefore, there was a useful period during which some time could be spent on the display FN82 Series 2 turret. The servo ammunition feed unit was completed and is now ready for painting. On the Series 2 turret the servo feed is an electrically driven unit as opposed to the hydraulic one on the Series 1.

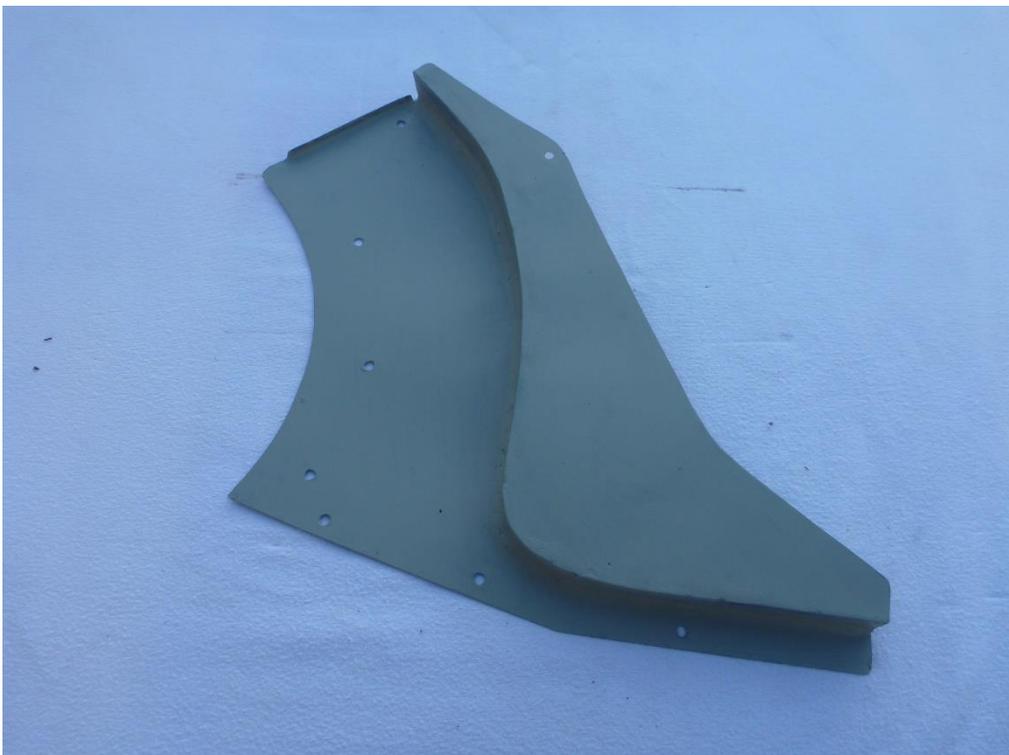
That done there was a chance to re-manufacture the cupola inner arch support brackets. These complex parts were missing from the display turret but need to be made to enable the construction of NX611's cupola on the display turret.

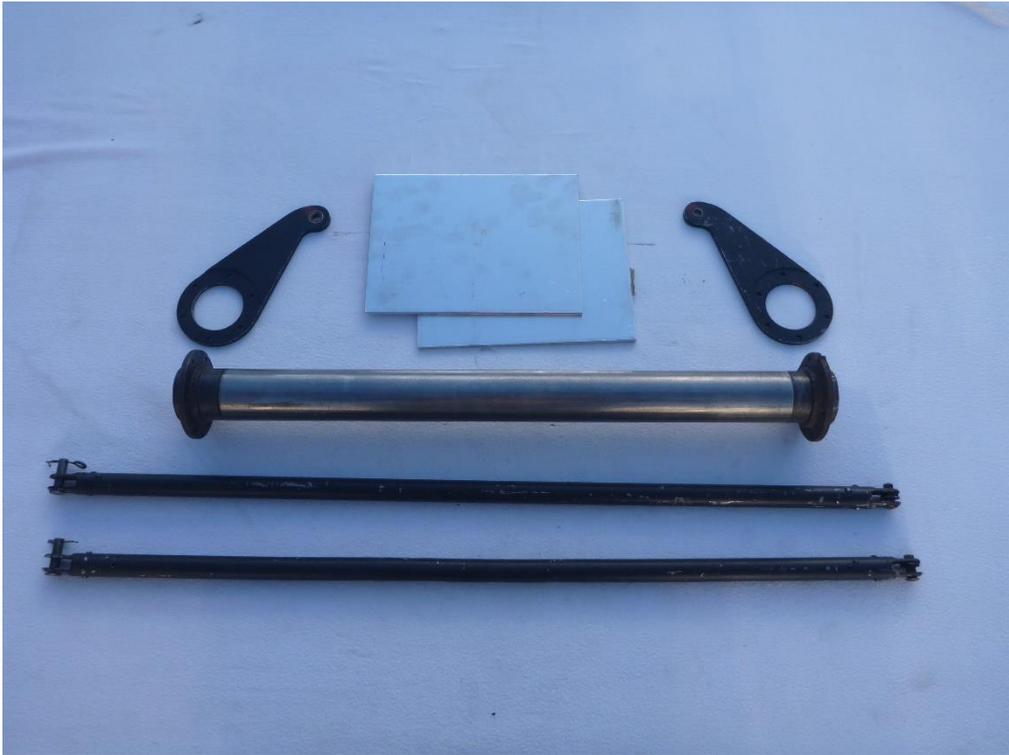
Seen above are some of the components of the display turret control system. The torque tube needs to be bolted onto the bearing ends and then the control levers fitted. The two alloy blanks are for the re-manufacture of the two missing control levers.

So, next month should see a great deal of spraying over with black and then the re-build of several of the sub-assemblies. The control system of the display turret can be progressed and, hopefully, built into the turret along with the servo ammunition feed. The only major problem could be the somewhat cold weather we are experiencing at the moment.
