## FN-150 Turret update January 2019

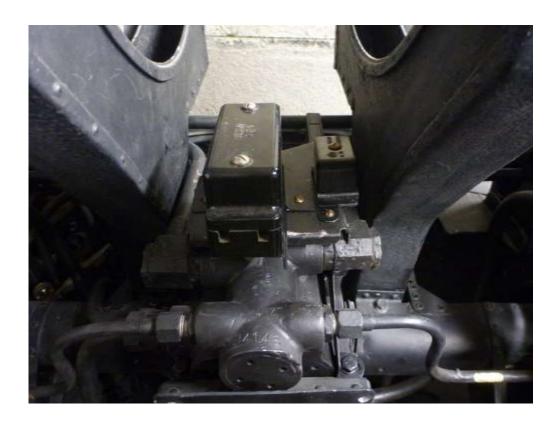
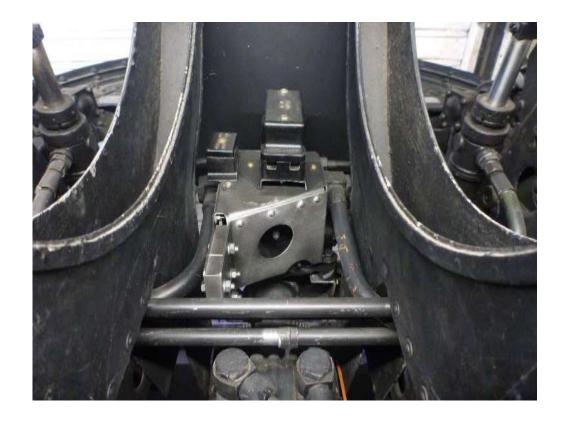
The bracket was then assembled, fitted, removed, tweaked about and then finally fitted onto the Valve Box. This took quite a while as I was keen to make this fit the final one. Once the bracket was in the Firing Relay could be fitted alongside its junction box, both of which have their own brackets. When the triggers are pulled, this relay closes and activates the two firing solenoids, the firing solenoids withdraw, pulling a Bowden cable which in turn fires the guns.

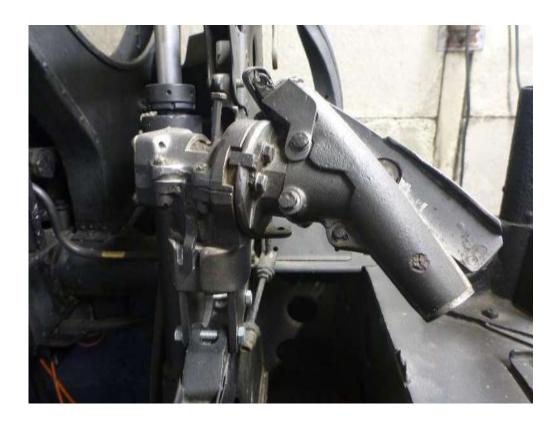
The right side control handle was finished off and then sprayed. In the FN-150 the guns were electrically fired and so both handles will need to have a firing micro switch fitted – I will need to try to find a pair of these and then produce their mounting brackets.

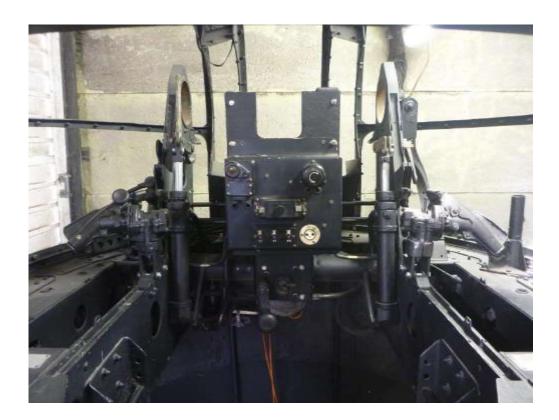
The Face Protection Armour Plate could now go in as all work in the area has been completed. Sadly, most of the above work disappears from view at this point. For completeness the Control Panel was then fitted after having added the missing socket at the bottom right. In time this will need to be removed so that the wiring can go in but that will be way down the line.
