FN-150 Turret update November 2018

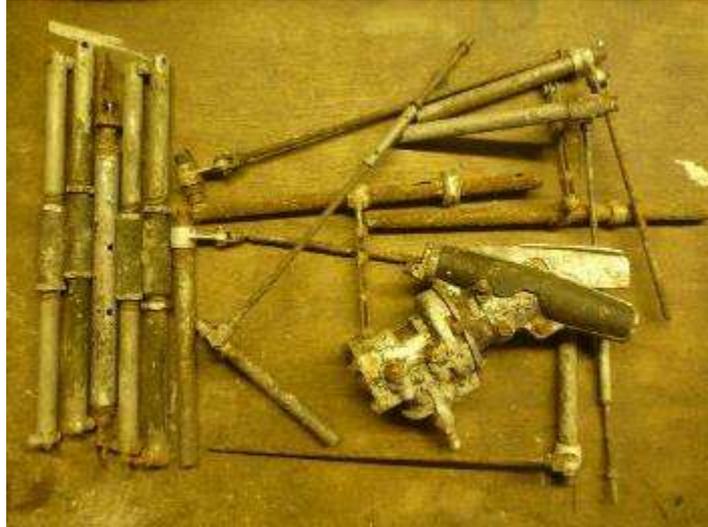
The October update finished with this image of the gunner's control system in kit form. Actually, some of these pieces are not from the control system.

In short, the control system comprises of two control handles each of which can activate the hydraulics, rotate the turret, elevate the guns and fire the guns. All this is achieved with rods and levers in the wonderful, pre-electronic age!

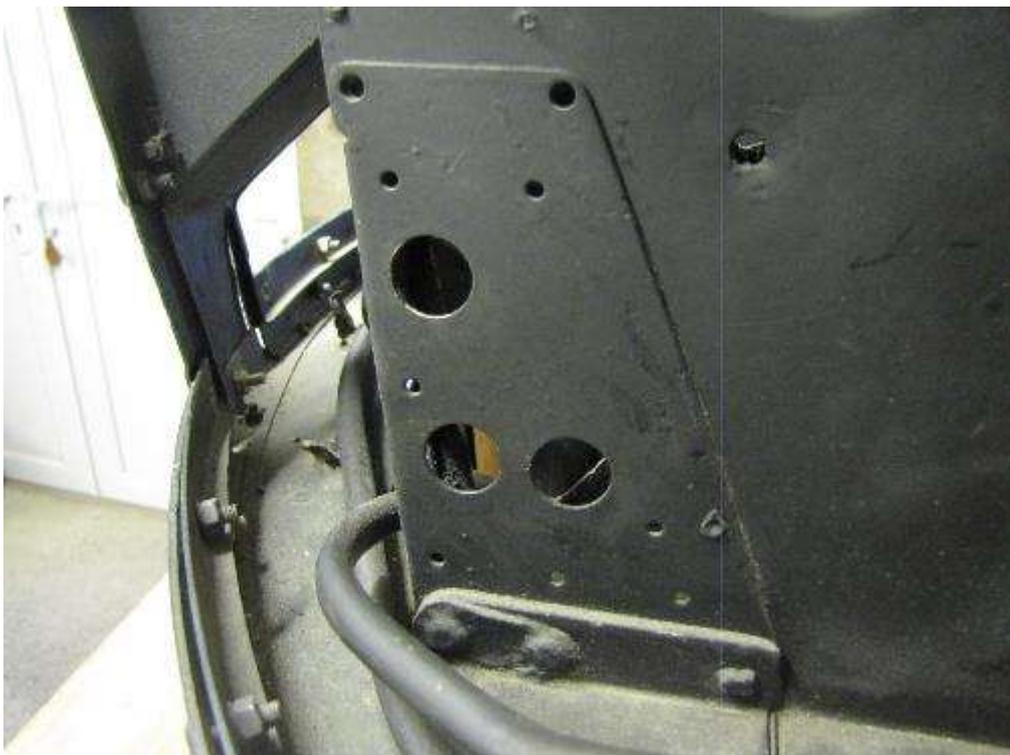
The three control shafts (seen in bits above with the levers attached), are supported on each side of the turret by an alloy wrap round assembly, like the one below.

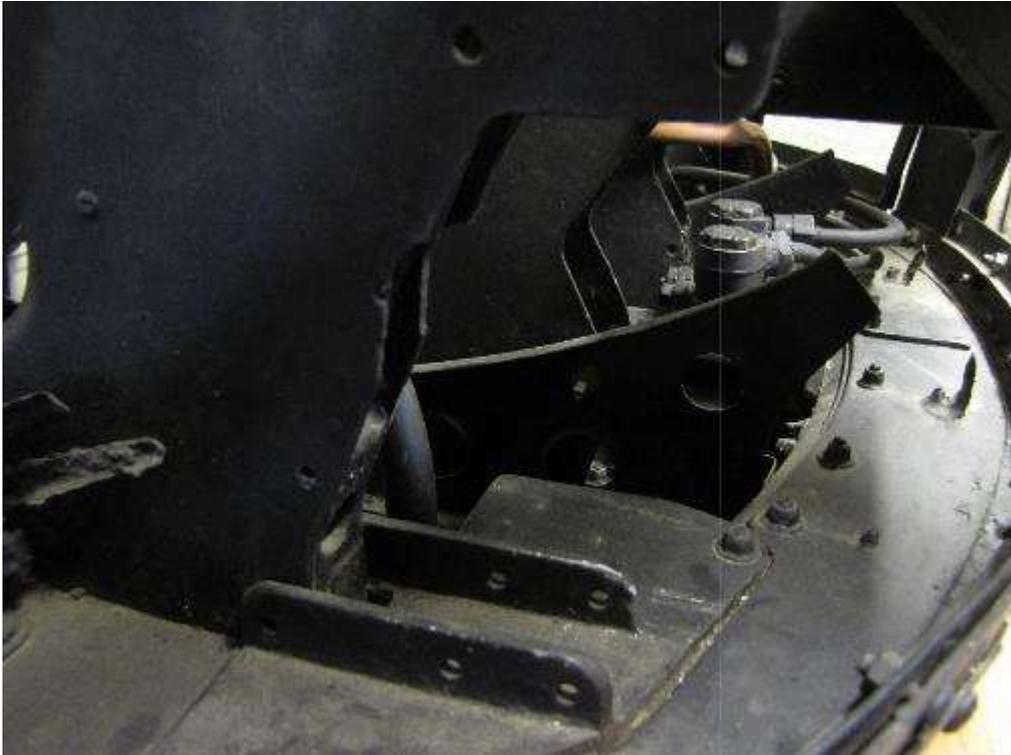
Whilst the left side support was present, the right side one was conspicuous by its absence. So, the first task was to make this assembly as it was needed to obtain the overall length of the control shafts.

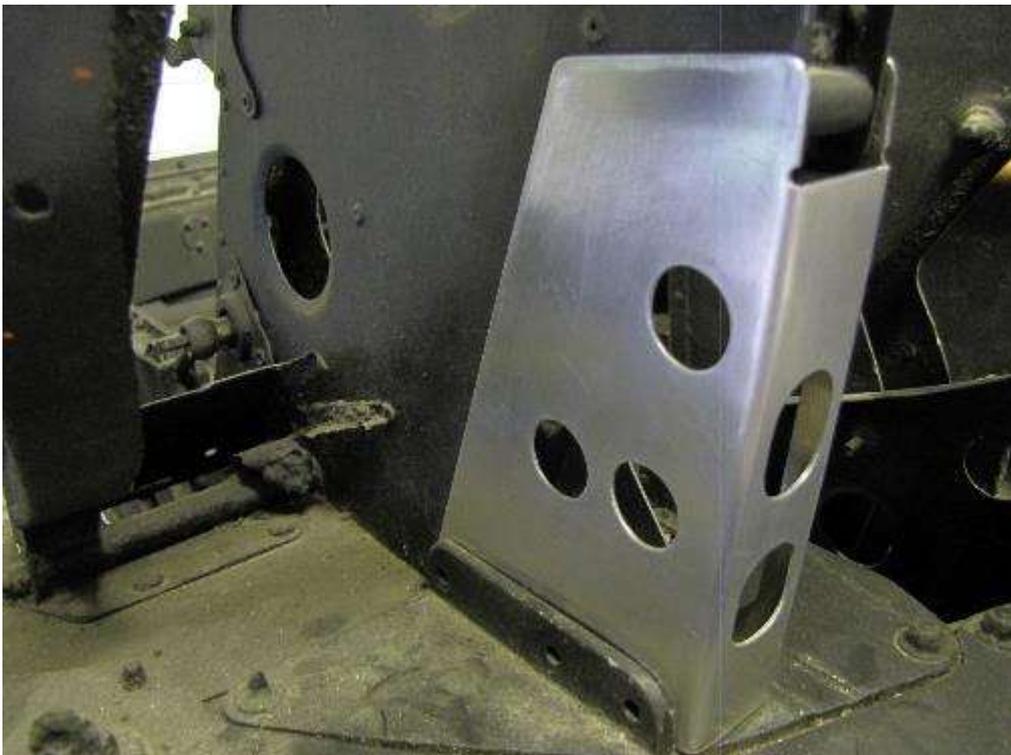
With the support made and loosely assembled it was possible to obtain the overall length of the control shafts.

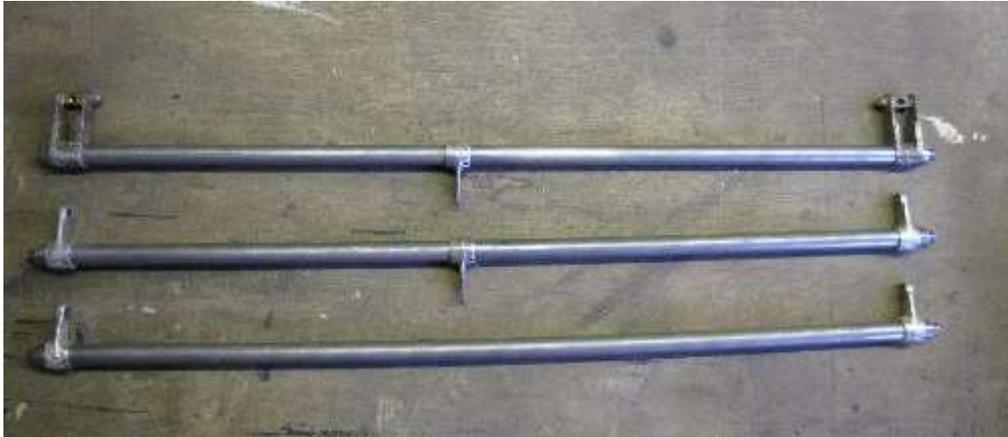
I tried and failed to recover the original shafts (I like original) and so had to get some ½" OD steel tube. The original levers were then transferred across – they are an inordinately tight interference fit. The sharp eyed will notice that there is a missing lever from the bottom shaft, so if anyone comes across it, I would be glad to hear from them.

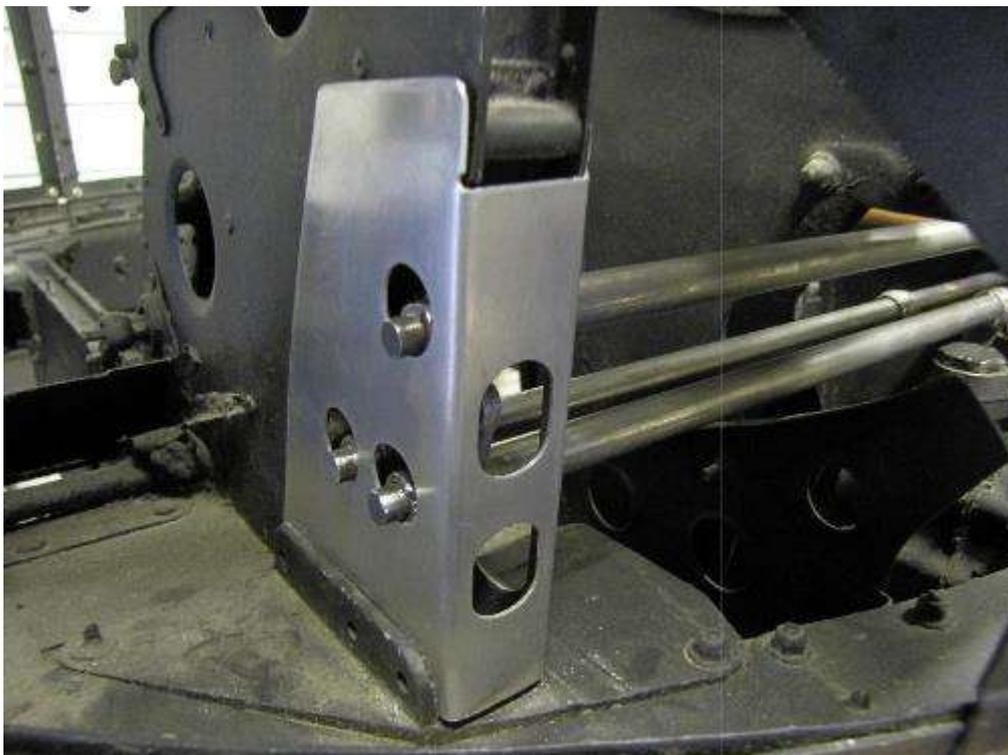
Now the shafts can be tried for size in their supports.

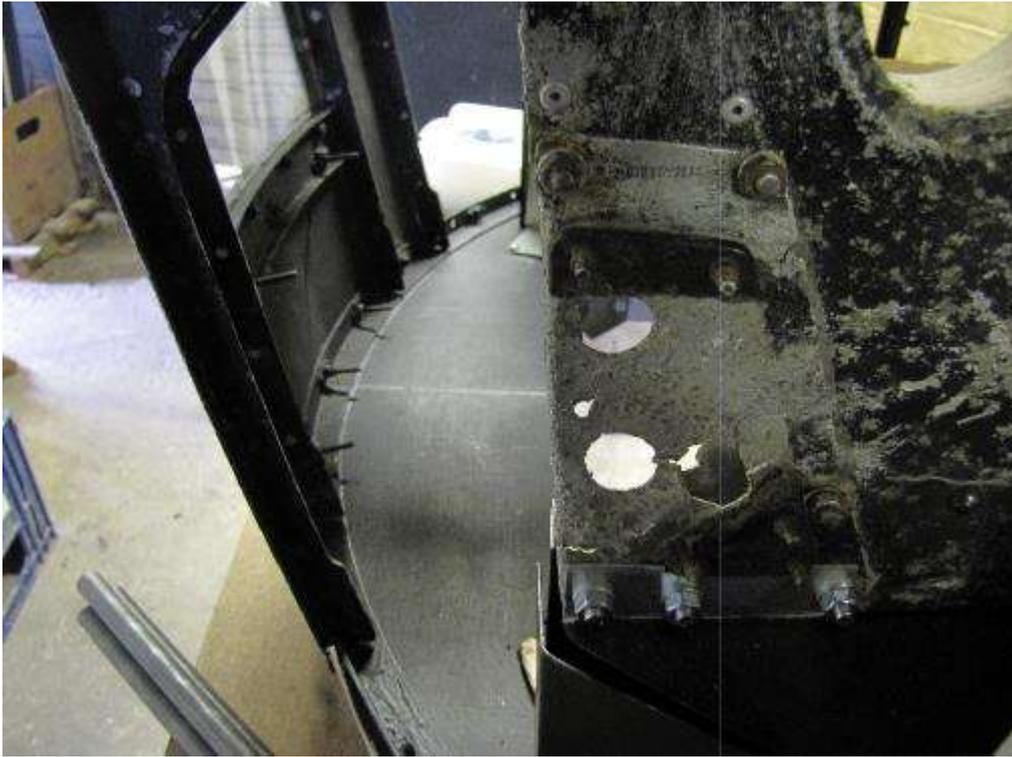
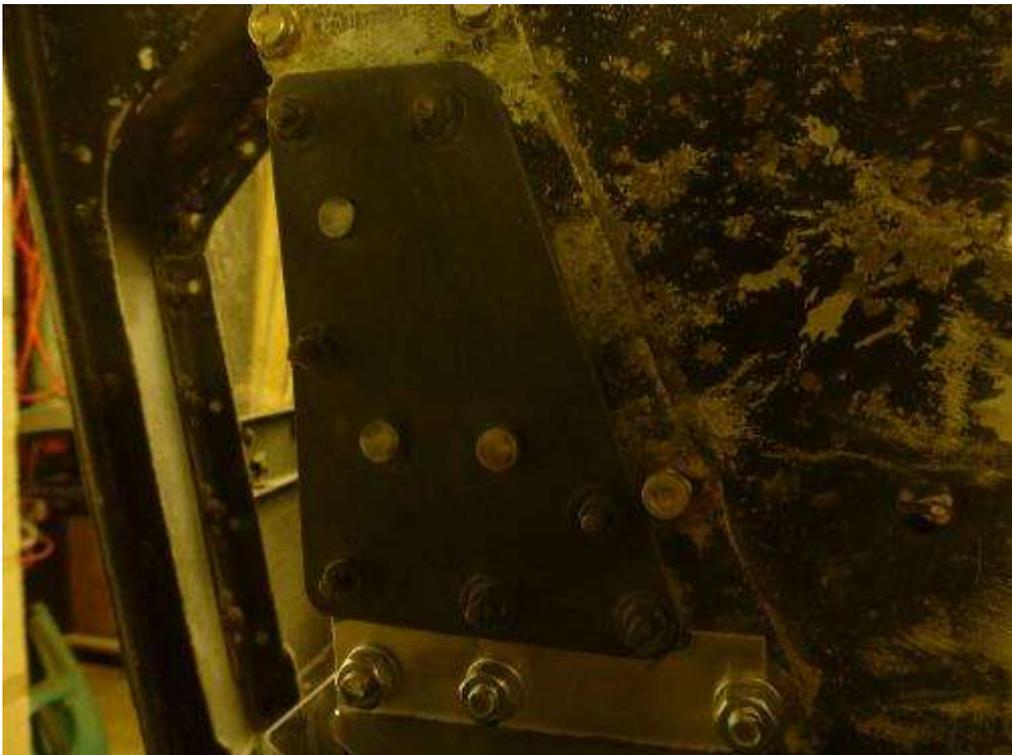
These shafts have end fittings that pivot in two black bakelite or possibly paxolin plates. These were also missing, but there are the remains of one on my FN5 turret which was enough to obtain dimensions, corner radii and the such like. So, I made two for each turret whilst I was at it, the one seen below is on the FN5.

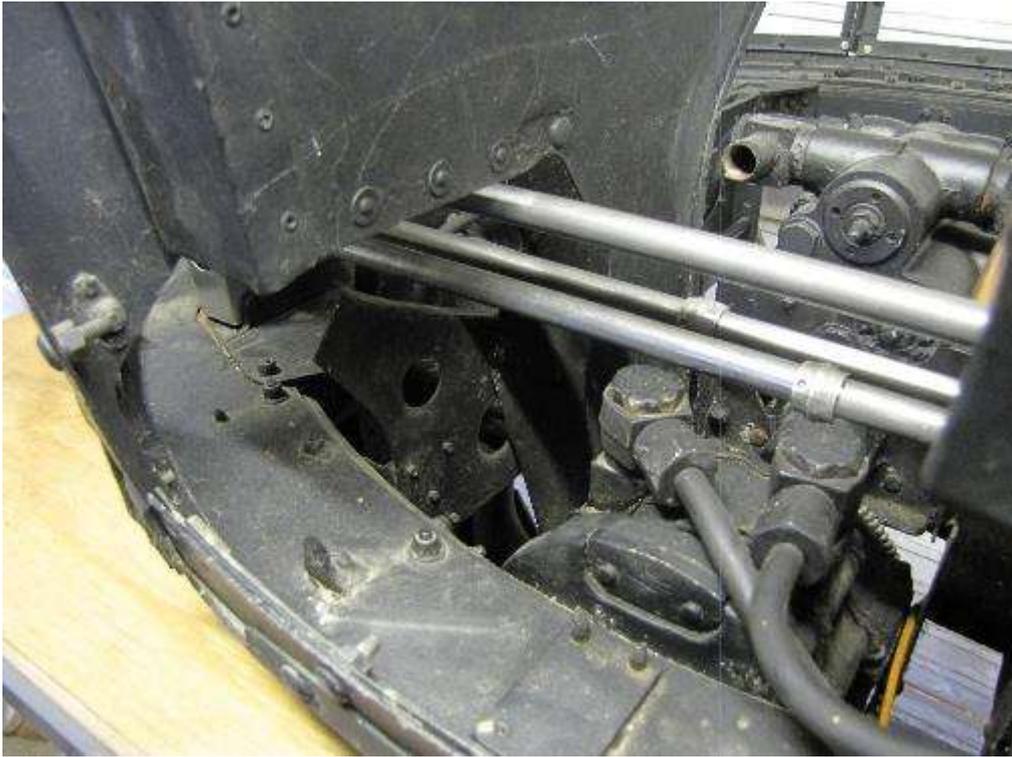
The space in front of the valve box already looks tight. However, there is still the shaft centre support (which also mounts the gun fire solenoids), another hydraulic feed line, the valve box links, the front part of each empty case chute and the armour to get into this area.

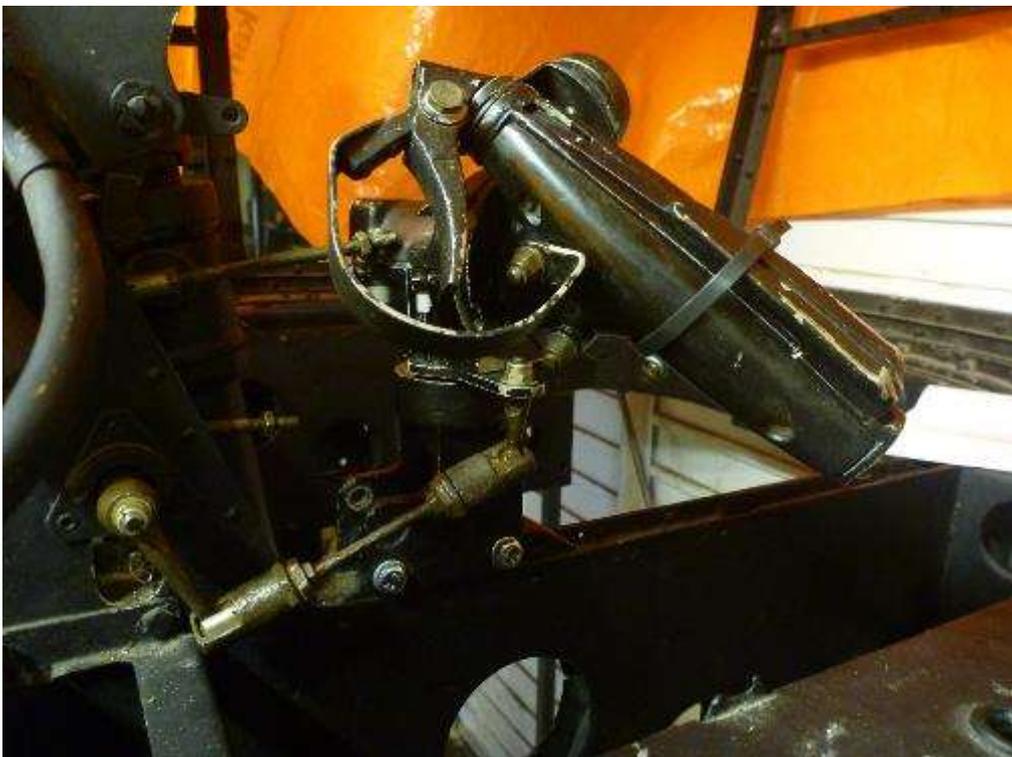
The left hand control handle was in very good condition and just needed reassembly. It has a small issue with the “squeeze” function – hence the cable tie, but it needs dismantling and re-finishing in any case. That said, the whole lot now needs to be removed, painted and then re-fitted

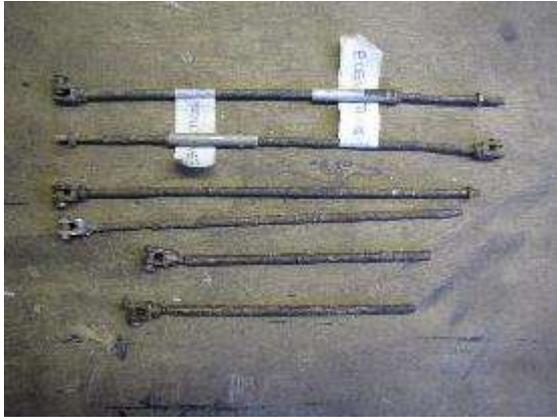
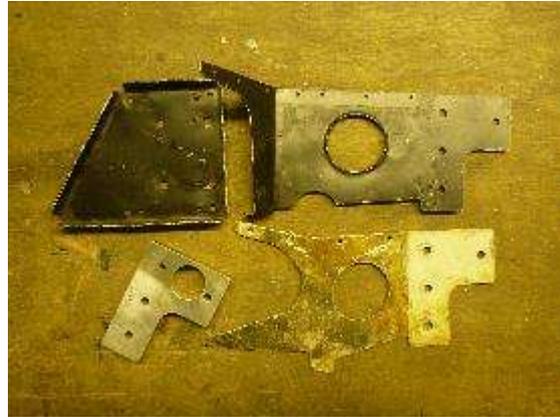
Next month. Sort out these rods that join the control handles to the control shafts and produce a new shaft centre support and solenoid mount. The centre support and solenoid mount is also missing but, luckily, I have the remains of one from the FN5 to copy.
