### FN-150 Turret update October 2018

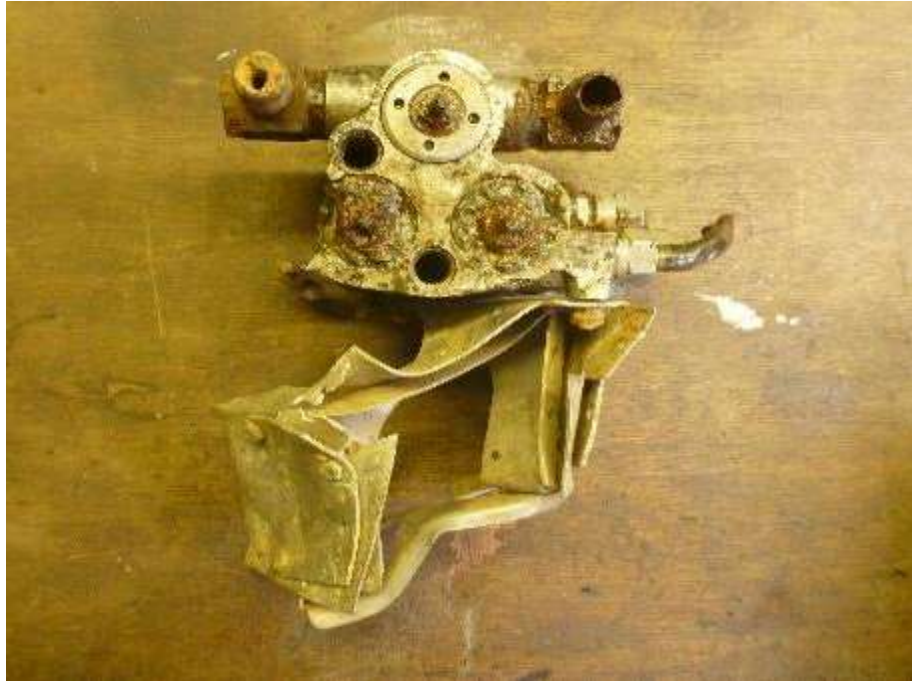
October's job was the Valve Box. The valve box is the control unit of the turret and houses three piston-type valves, that is the master valve, the rotation valve and the elevation valve. When the master valve is operated, pressure is admitted to the rotation and elevation valves and the turret is "live".

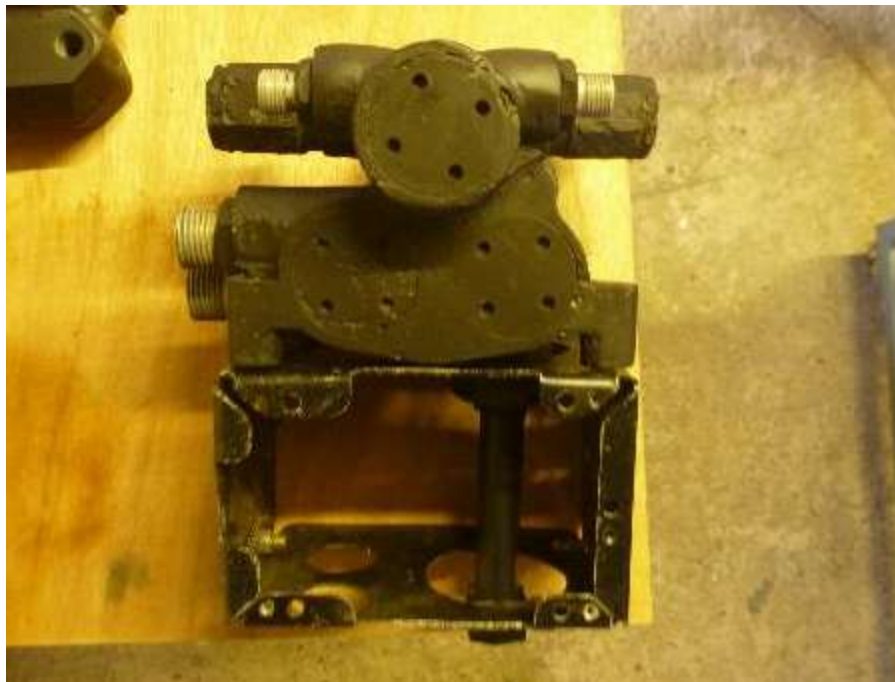
This crash recovered Valve Box will clearly never work again but with time and a fair bit of lateral thinking was made sound enough to support the eight hydraulic pipes that run to and from it.

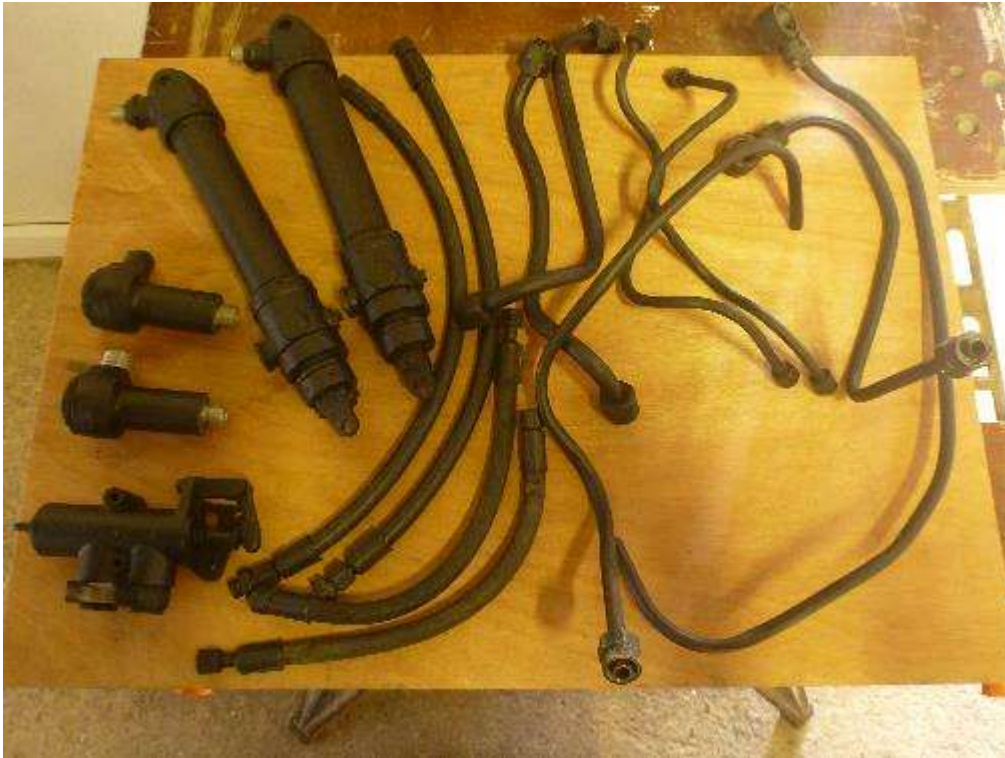
With the Valve Box restored, the rest of the hydraulic components were removed and sprayed.

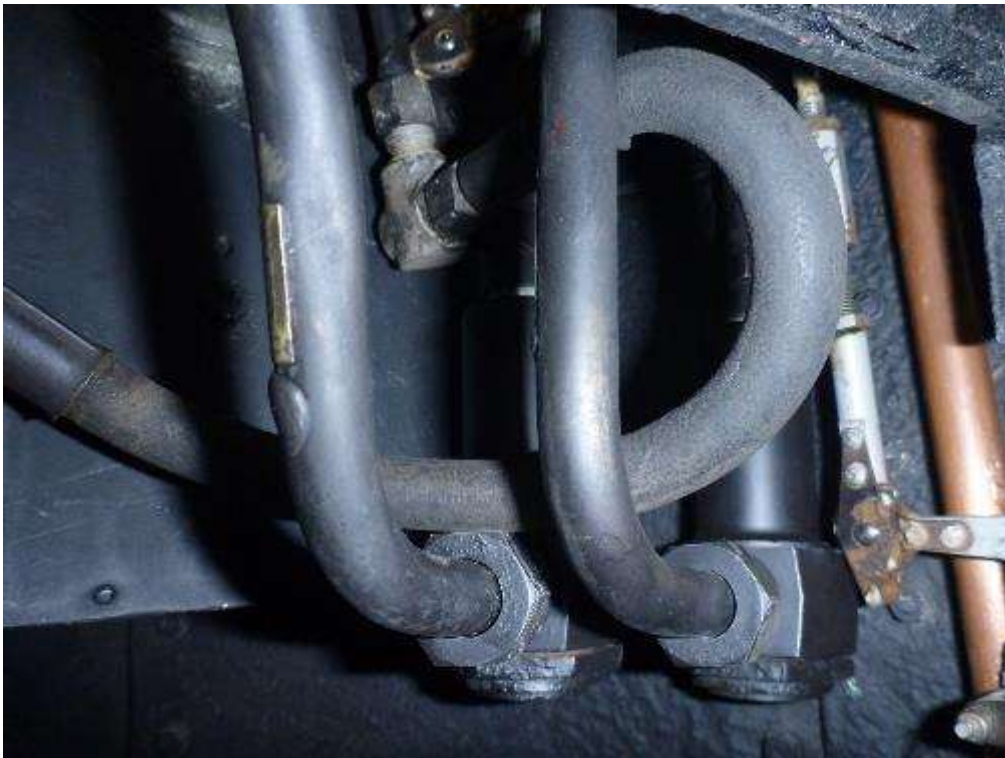
The two Filters and the Gun Ram lower flexible hose are a very tight fit next to the Interrupter linkage and must, surely, have caused problems in service.

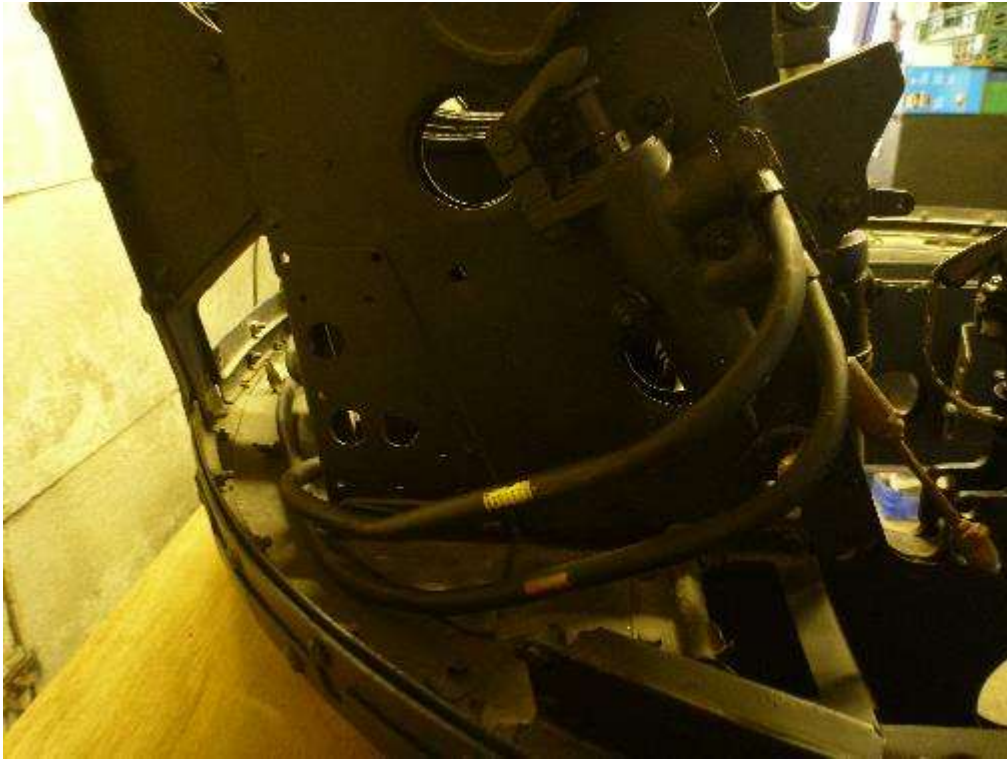
The Rotation Restrictor Valve goes back in, hopefully, for the final time. It has its re-manufactured pipes complete with original labels.

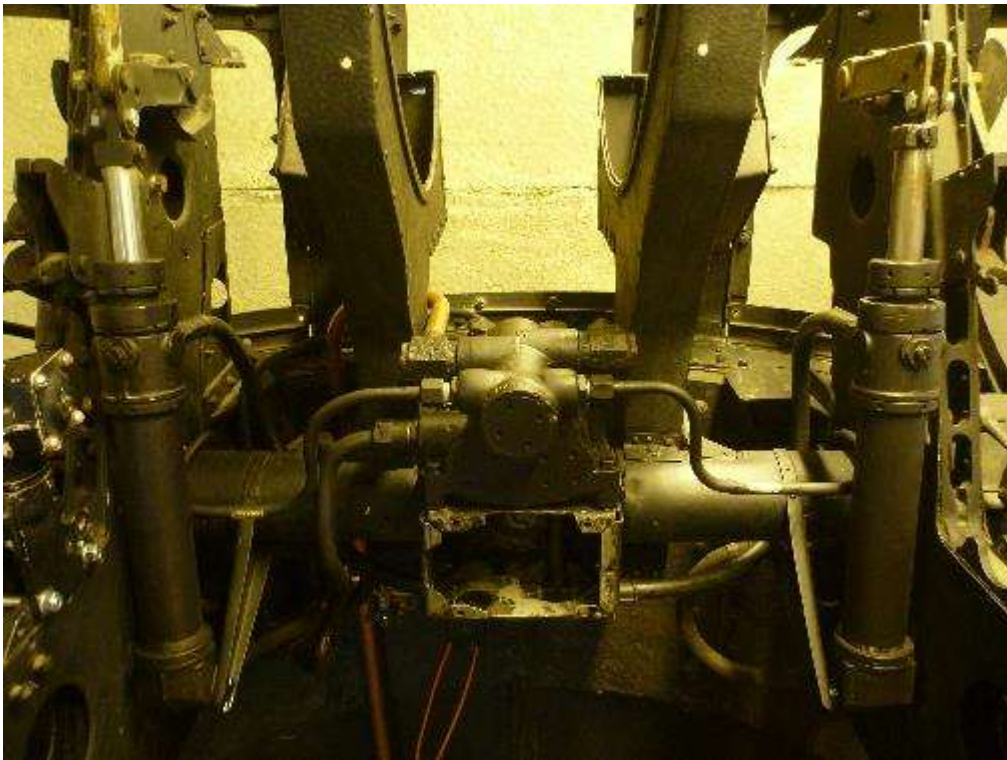
With the Valve Box, Gun Rams, Filters, Rotation Restrictor Valve and all pipe lines fitted the hydraulic services are complete with the exception of the main supply and return lines.

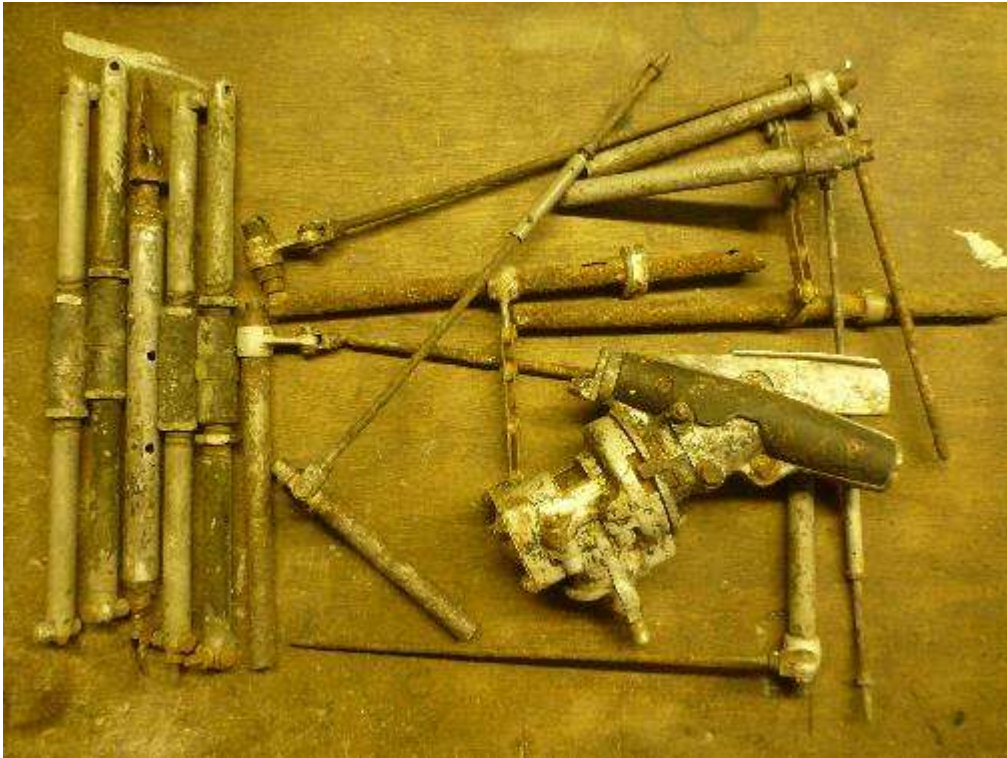
November's project is the gunner's control system. The rods appear to have been cut from a turret and the control handle is from a crash site – quite a challenge.
